PROCEEDINGS OF THE ROCKY MOUNTAIN GEO-CONFERENCE 2021

U.S. 36 Emergency Project—Geofoam Fill to Support Urban Roadway Traffic

An approximately 35-foot-high retaining wall supporting eastbound U.S. Highway 36 near Milepost 49.8 experienced a failure of the foundation materials below the wall system, resulting in closure of eastbound U.S. 36 on July 12, 2019. Vertical downward movement of the wall system was in excess of 8 ft by the end of July 2019. To assist the Colorado Department of Transportation (CDOT) in designing a repair option and to facilitate rebuilding the wall system, RJ Engineering and Consulting, Inc. (RJ) worked as a geotechnical sub-consultant designer to restore traffic within 12 weeks of the initial failure. This paper presents our evaluation, analysis, design, and monitoring for the rebuild of the wall system that utilized more than 23,000 cy of geofoam also known as expanded polystyrene (EPS) and drilled shafts (caissons) for global stability support. Peak and residual shear strength parameters used in the stability evaluation and analysis including the use of both ϕ (internal friction angle) and cohesion shear strength parameters are described and discussed.

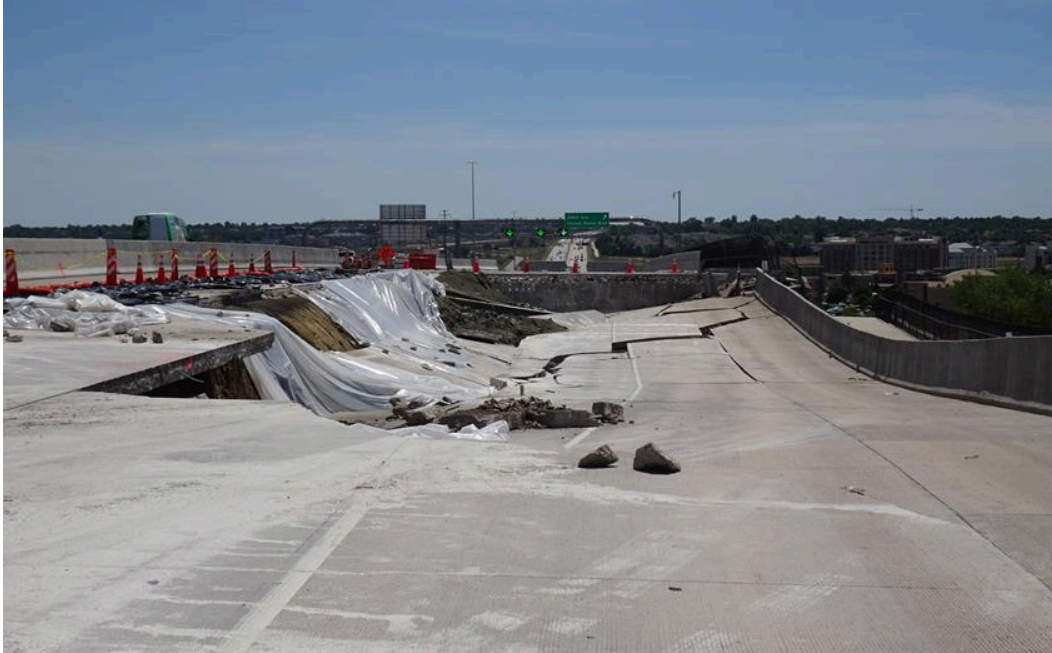
PHOTOGRAPH 1. US 36 Looking East along Eastbound Lanes on July 18, 2019
Wall supporting US 36 has dropped vertically more than 5 feet and moved laterally to the right more than 3 feet.

On July 13, 2019, observations by CDOT indicated that the retaining wall near MP 49.8 was experiencing a global failure of the underlying overburden and fill soil materials. Photographs 1, 2, and 3 depict the failing retaining wall system.

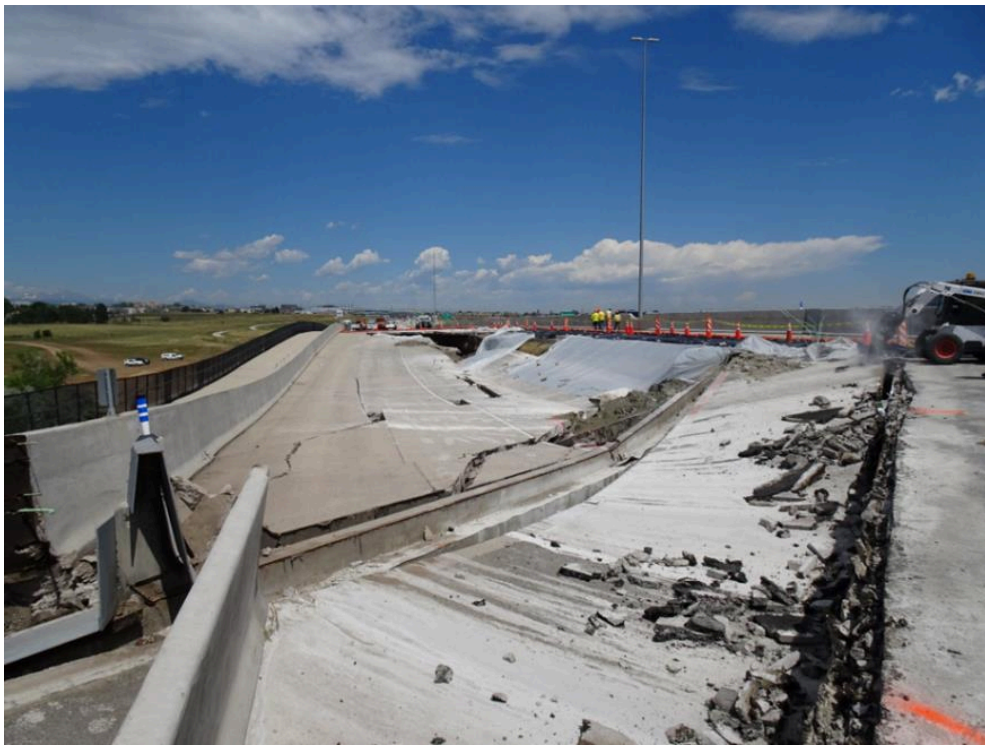
PHOTOGRAPH 2. US 36 Looking West along Eastbound Lanes on July 16, 2019
Note the lateral offset of the pedestrian guard rail barrier to the left.
