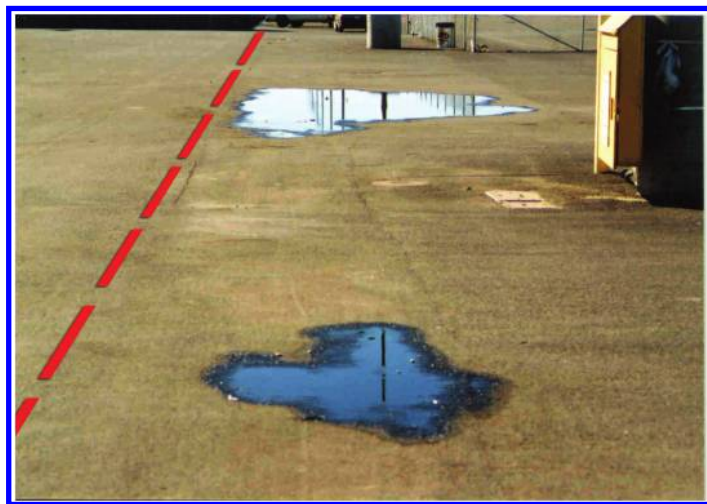
*Fig. A-36. The ponding seen in this photo indicates subsidence, probably through the pendant wall below (delineated by the dashed line)*

Evidence of soil migration underneath the pendant wall is shown in Figs. A-36 and A-37. The resultant void beneath the surface typically results in depressions in the pavement and ultimately pavement failure. Careful examination of the topside surfaces is warranted with these structures. If

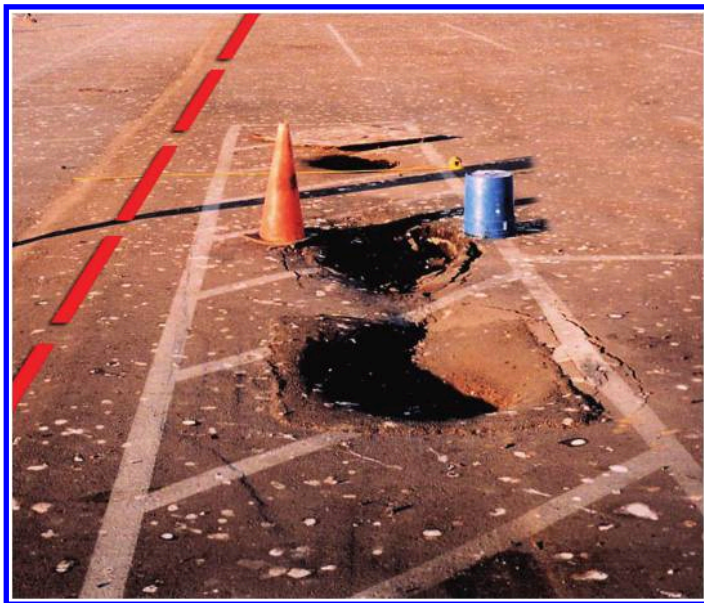
*Fig. A-37. The pavement has failed entirely as a result of soil migrating from beneath the pendant wall below (indicated by the dashed line)*
