Chapter 6

TELECOMMUNICATION SYSTEMS

6.3 Wireless System

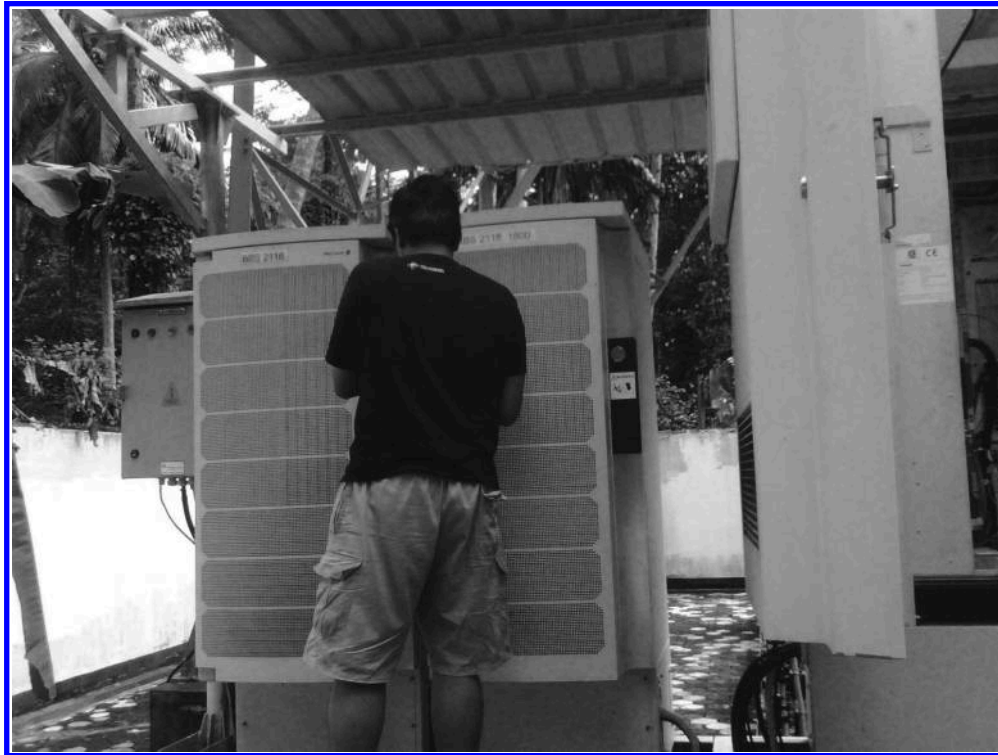
Figure 6.1. BTS with a self-contained unit, no building is required. The base is still enclosed with a wall for security. (Courtesy of Thomas Heriyanto)

Many BTSs have power supply units installed outside their buildings, which are air conditioned for the radio and controller units. A few BTSs were deployed with a self-contained, environmentally controlled unit within. Figure 6.1 shows one of these installations. Note the cabinet wall thickness; it is designed to reduce heat loss or gain. The cover protects service staff from the elements. Although these cabinets are designed with locks, a base perimeter wall provides added security. The majority of the BTSs are unmanned; that is, there is no attendant at the base. Monitoring is remotely done via data connection to a central control center within a region.

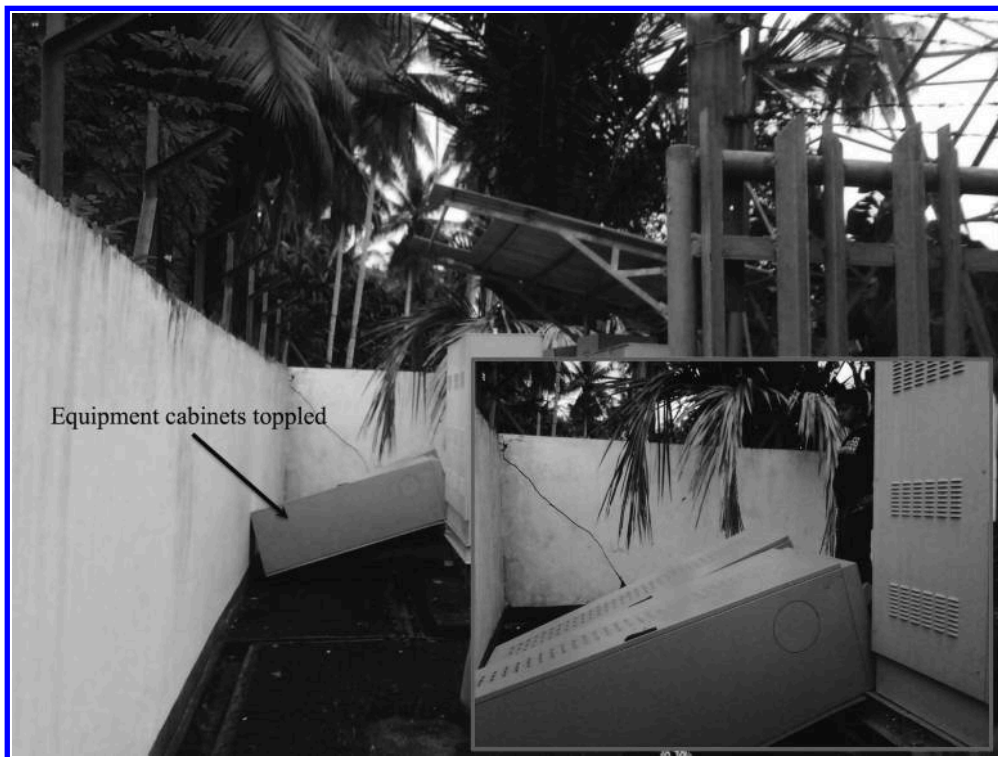
Figure 6.2. Toppled power cabinets at a BTS site outside of Padang. (Courtesy of Thomas Heriyanto)

In addition to electric power outages, toppled equipment caused BTSs to go out of service. When equipment is not anchored or is inadequately anchored to resist seismic load, toppling is most common failure mode. The equipment is also installed on a structural platform about 0.7 m above ground, which amplifies the seismic load on the equipment. The platform is designed to provide vertical load capacity; there is no bracing to provide rigidity to resist lateral load (Fig. 6.4). The platform is a raised floor providing cable access to the bottom of the cabinets (Fig. 6.6). It was noted that heavy power cabinets with moveable components inside toppled. Figure 6.2 shows the failure of two unanchored power cabinets. Figure 6.3 shows the unsecured batteries inside, which might have caused the cabinet to tip over. A power cabinet anchored on a concrete pad in a BTS site had about 8 to 9 cm uplift but did not topple (Fig. 6.5). It appears that the anchor was inadequate to resist uplifting.

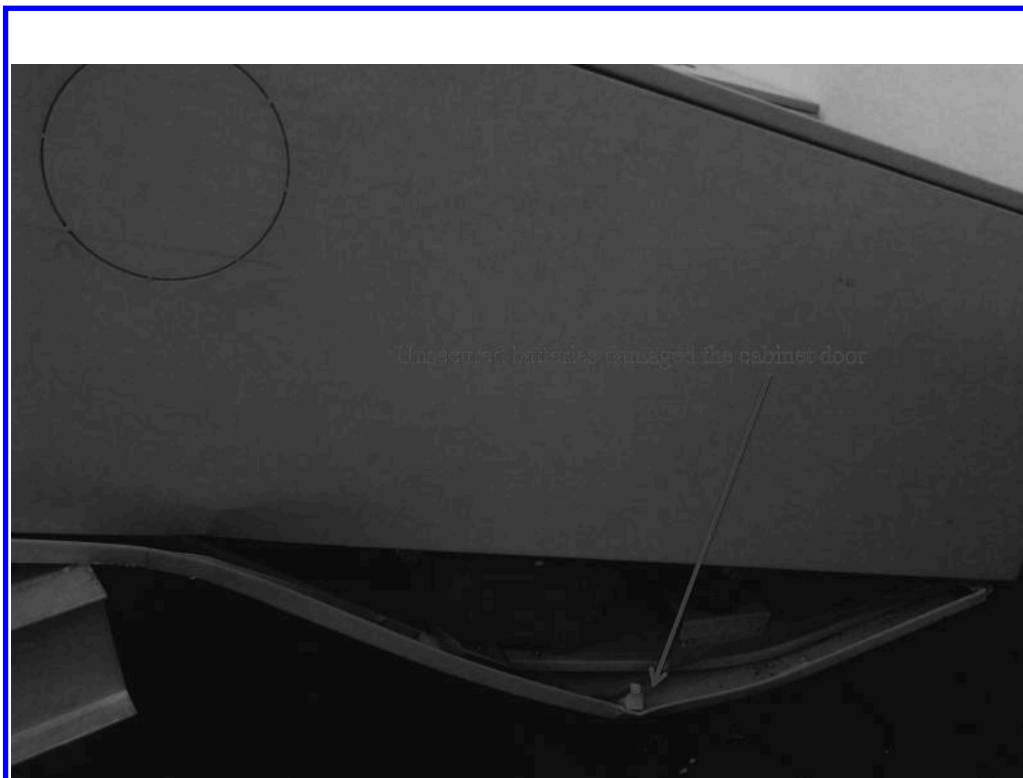
Figure 6.3. Damage to the batteries in the cabinet close to the cracked wall in Fig. 6.2. (Courtesy of Thomas Heriyanto)

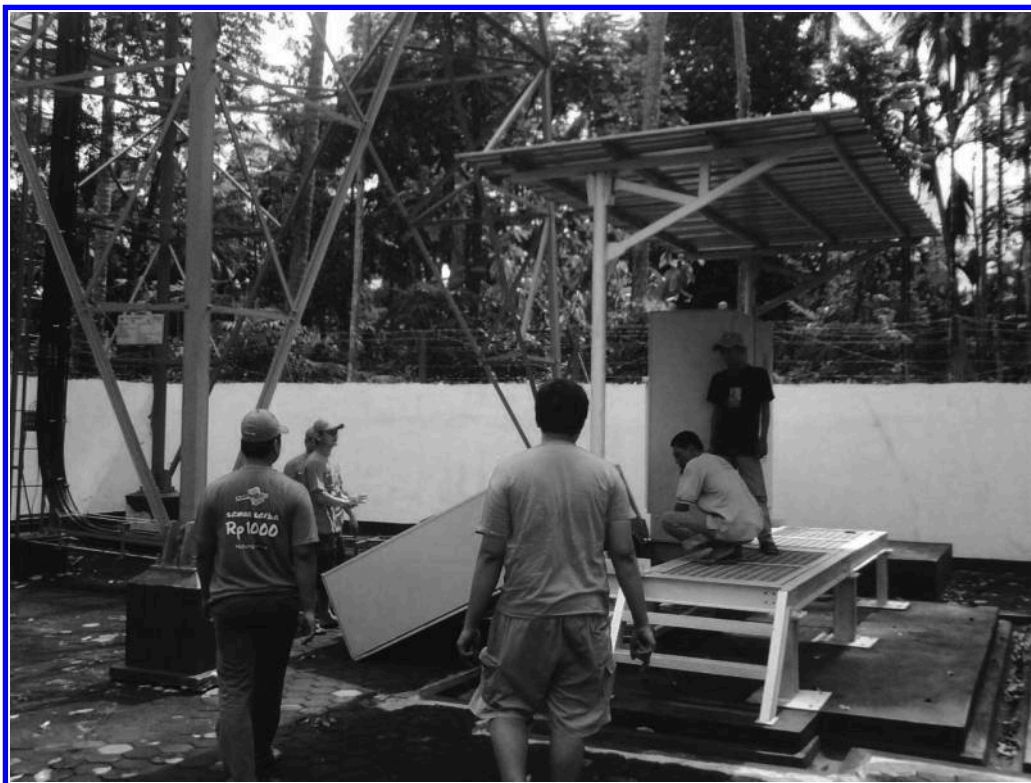
Figure 6.4. One of the two cabinets toppled at this BTS (Courtesy of Thomas Heriyanto)

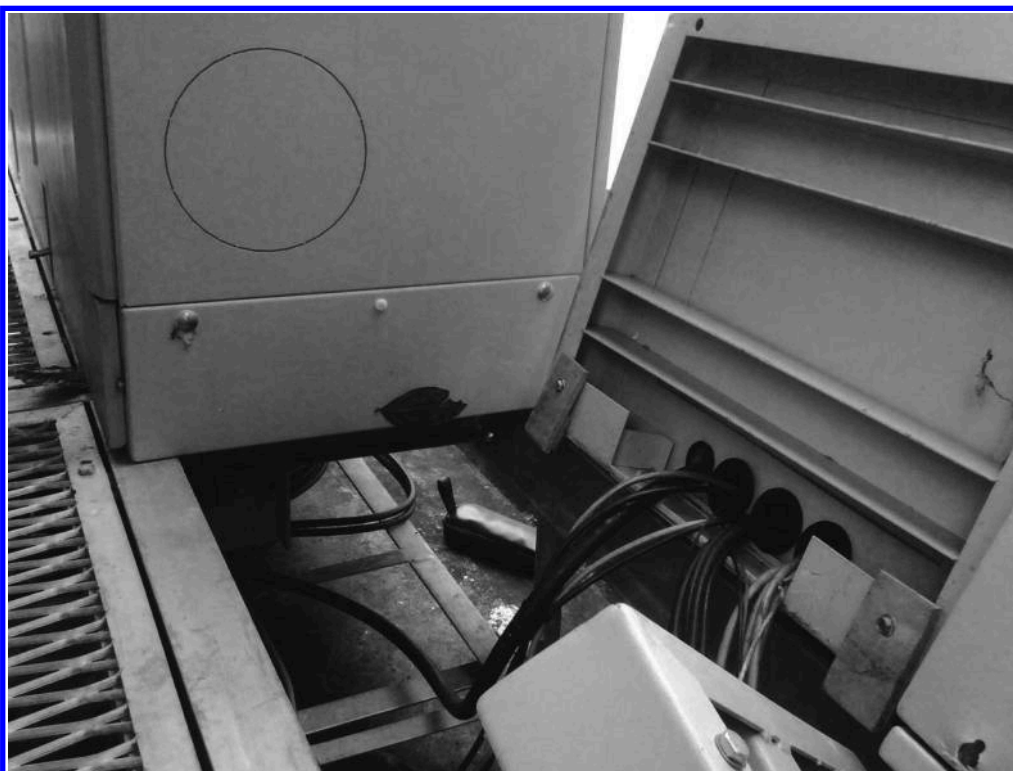
Figure 6.6. This toppled cabinet was saved by the wall. Note that there is no anchor for the equipment cabinet. (Courtesy of Thomas Heriyanto)

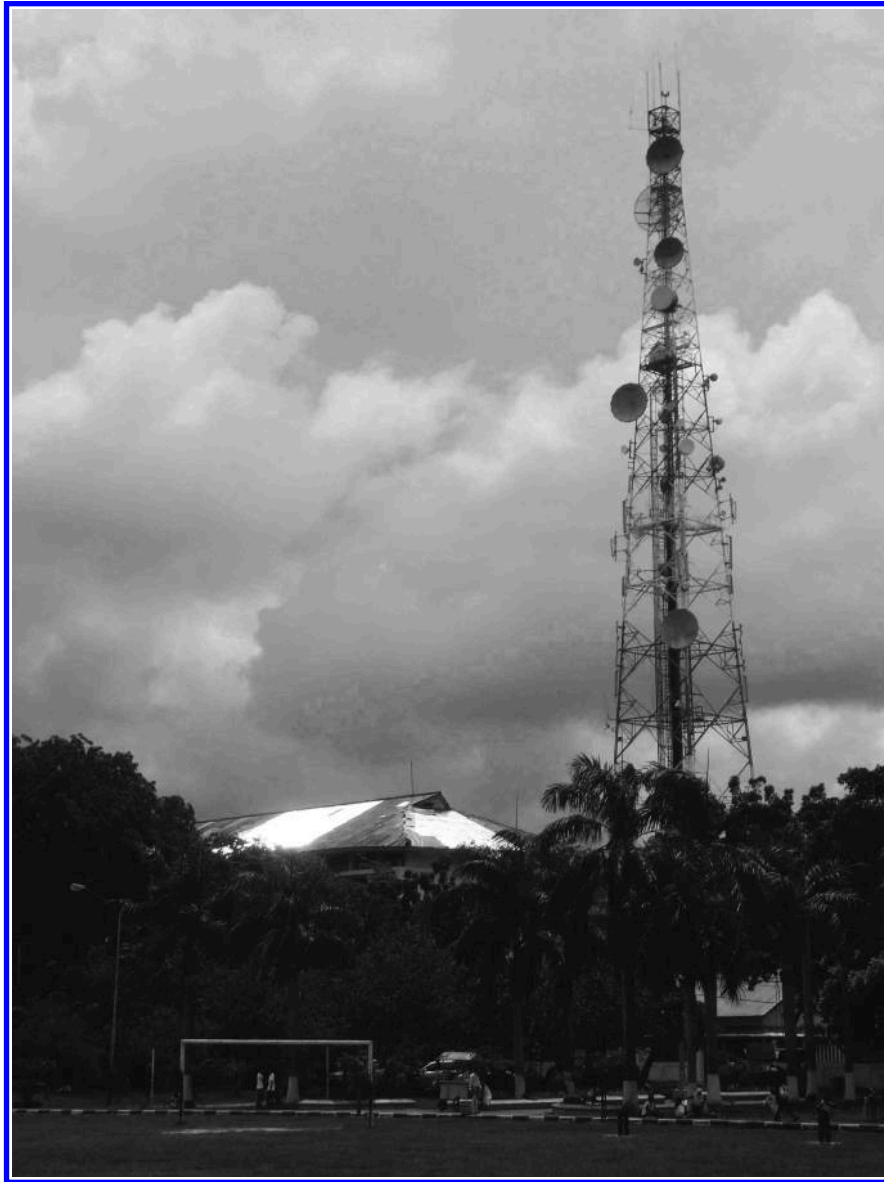
It was observed that the steel lattice style standalone towers performed well (Fig. 6.7). Wind load is the primary design factor. However, towers on roofs of commercial buildings shared the fates of the buildings. In most cases due to spectral amplification, the antennas mounting structures were damaged.

Figure 6.7. Typical standalone steel lattice tower shows good performance

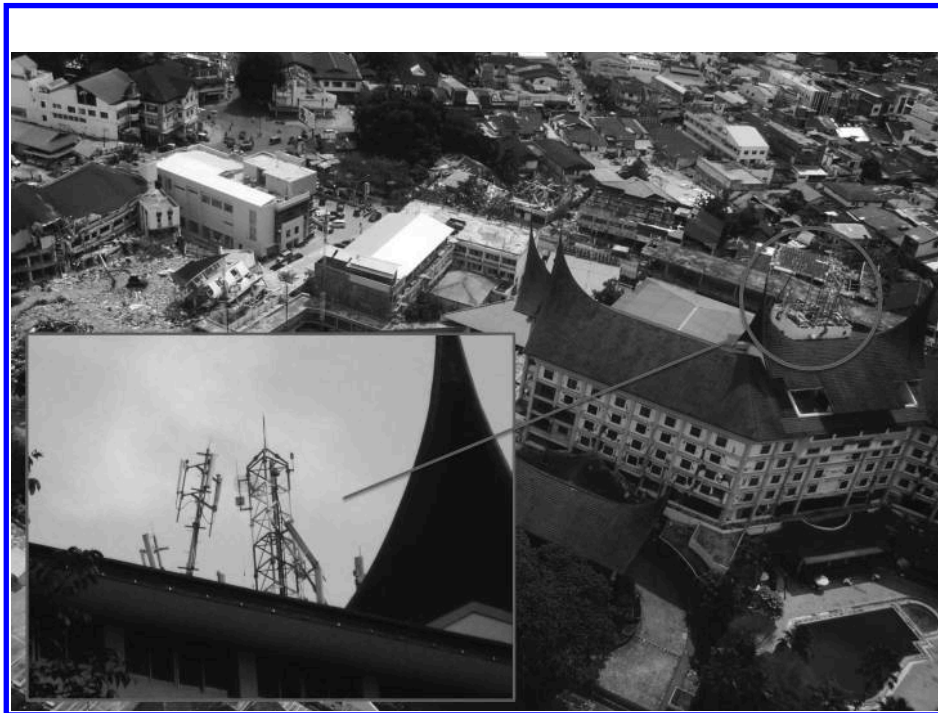
Figure 6.8. Roof-top mounted BTS antenna poles failed when the building failed. There were three service providers located on the roof of this 5-star hotel in Padang.

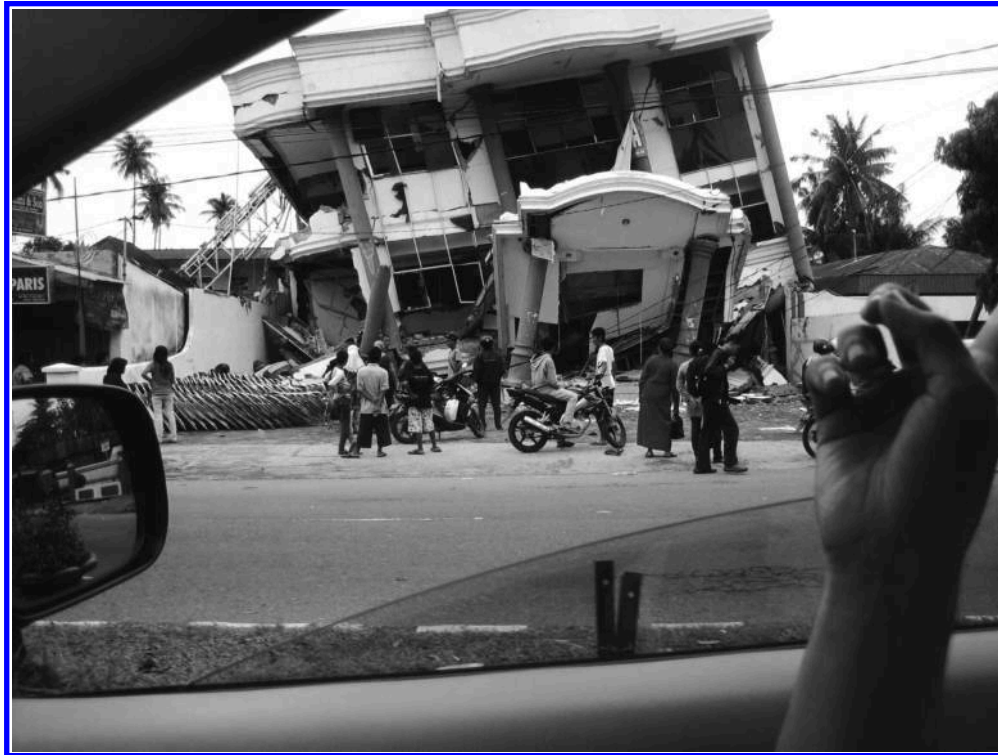
*Figure 6.10. The BTS tower on the roof (left side) of this building that collapsed
(Courtesy of Thomas Heriyanto)*

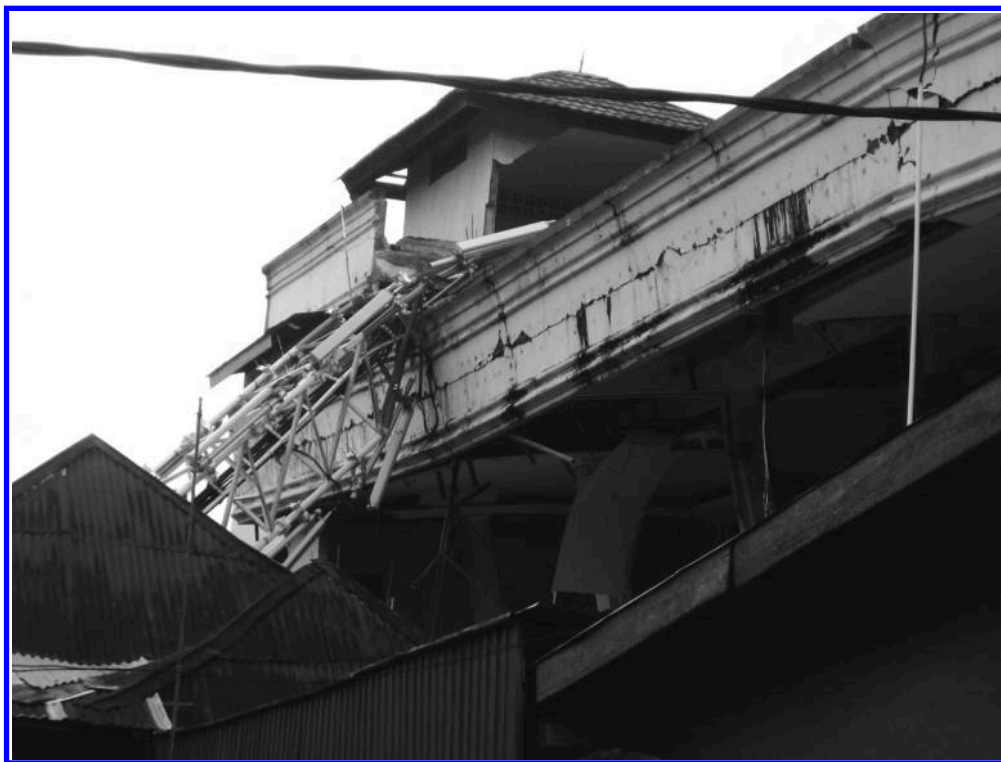
*Figure 6.11. Detail view of the collapsed tower and antennas
(Courtesy of Thomas Heriyanto)*

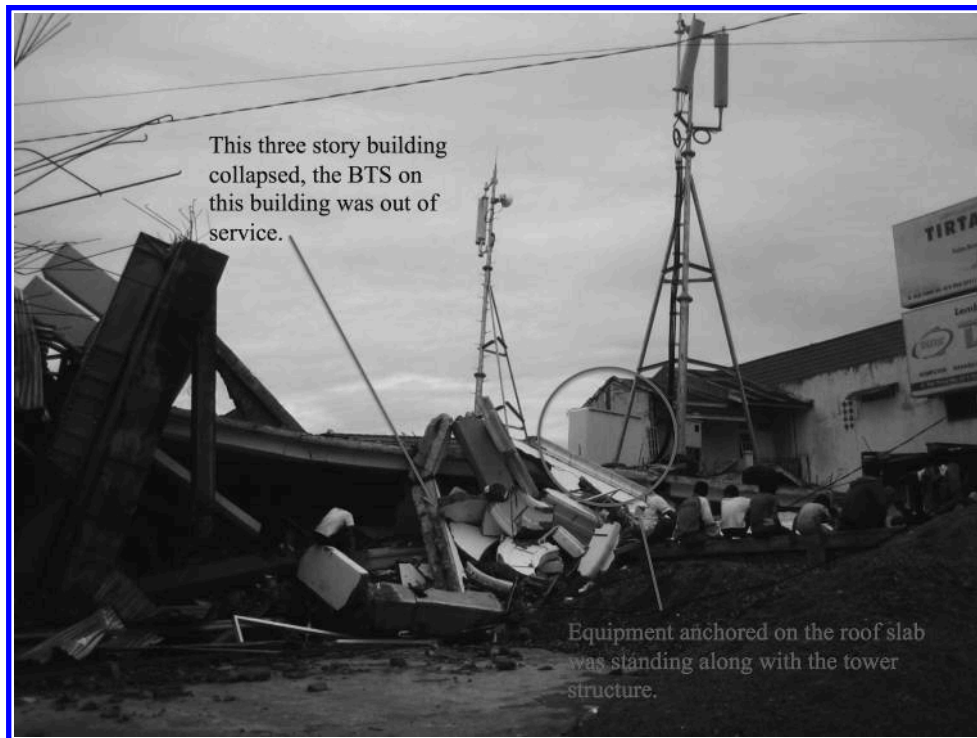
Figure 6.12. The tower and the equipment housing do not look damaged, but power was cut off when the building collapsed. (Courtesy of Thomas Heriyanto)

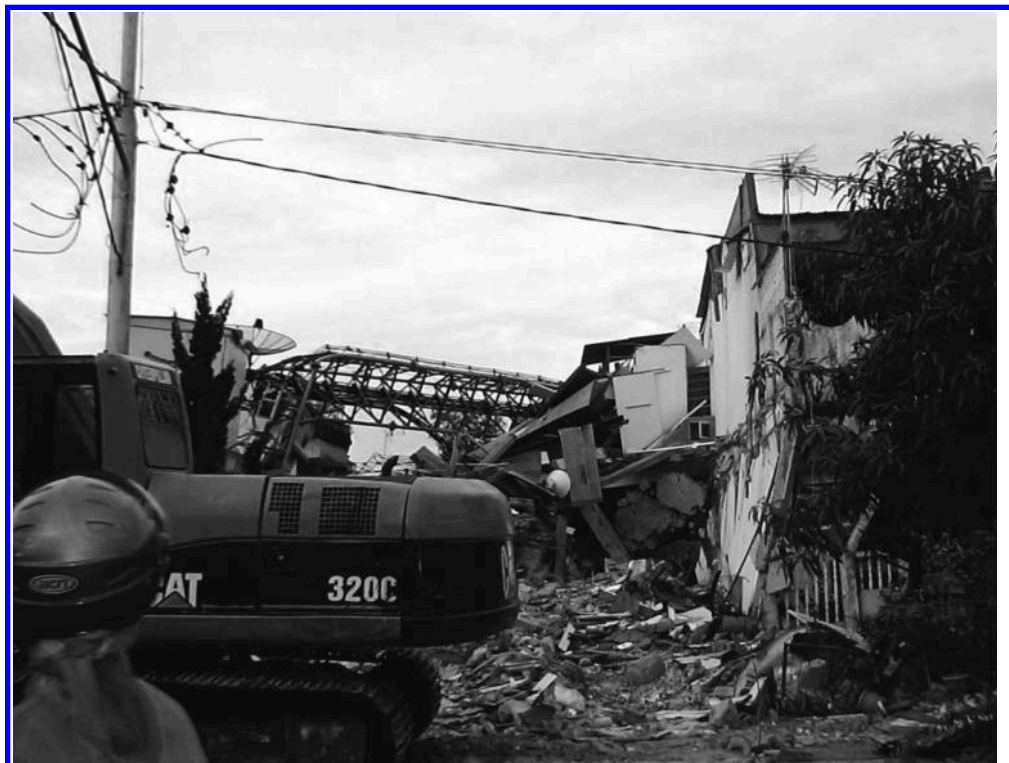
Figure 6.13. This BTS tower collapsed when the buildings around it collapsed in the earthquake. (Courtesy of Fire Department, Padang)
