Chapter 5: Performance of Fire Protection and Life Safety Systems

MULTIDISCIPLINARY ASSESSMENT OF CRITICAL FACILITY RESPONSE

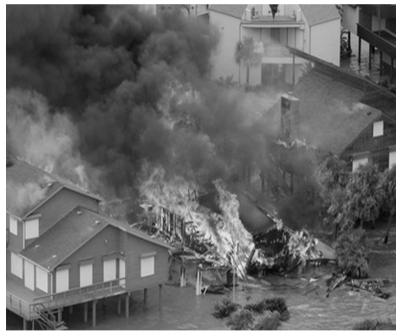
Figure 5.1: Example of fire hazard following a hurricane (FEMA P-757, 2009)

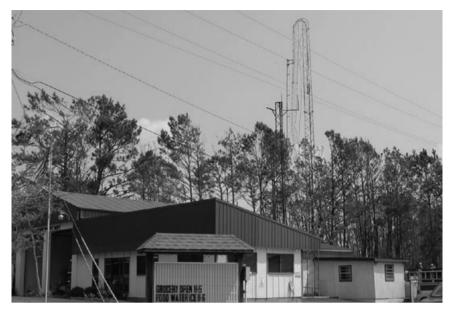
In general, the antenna towers remained standing after the storm but were blown out of alignment and/or failed due to loss of power. However, some towers were structurally damaged by high winds, even though these are the most hardened of facilities built to withstand severe hurricanes (see Fig. 6.1). Many back-up generators were damaged because they were placed too low and were flooded by storm surge. Other power failures resulted from the extended duration of the disaster, which exceeded the capabilities of most back-up generators and fuel reserves (base station generators are typically designed to operate for 24 to 48 hours). Back-up batteries generally have an 8- to 10-hour duty cycle; without access to power, these batteries were not able to recharge and eventually ran out of power.

Fig. 6.1. Example of buckled antenna tower at Mississippi fire station (Source: FEMA 543, Design Guide for Improving Critical Facility Safety from Flooding and High Winds: Providing Protection to People and Buildings, 2007.)

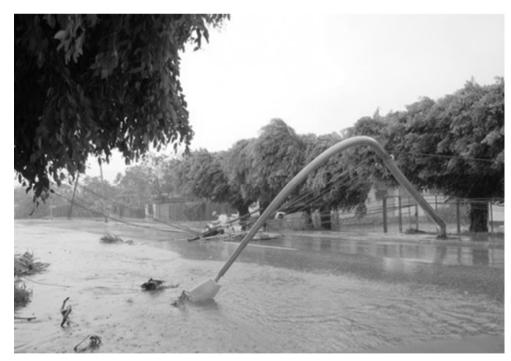
Fig. 6.2. Example of damage to cable infrastructure (Source: FEMA 543, Design Guide for Improving Critical Facility Safety from Flooding and High Winds: Providing Protection to People and Buildings, 2007.)
