## Rehabilitation of the St. John's Tunnel

### Abstract

The St. John's Tunnel, constructed in 1903, is located on the south slope of Pikes Peak, Colorado at over 3,350 m (11,000 feet) elevation. The majority of the tunnel is unlined and, because of past instability, houses a 0.76-m (30-inch) -diameter steel pipe for conveyance. The tunnel is a critical element of the water supply system for Colorado Springs Utilities (CSU). Because of past rockfall and its future potential, CSU was concerned about the long-term reliability and integrity of water conveyance through the tunnel.

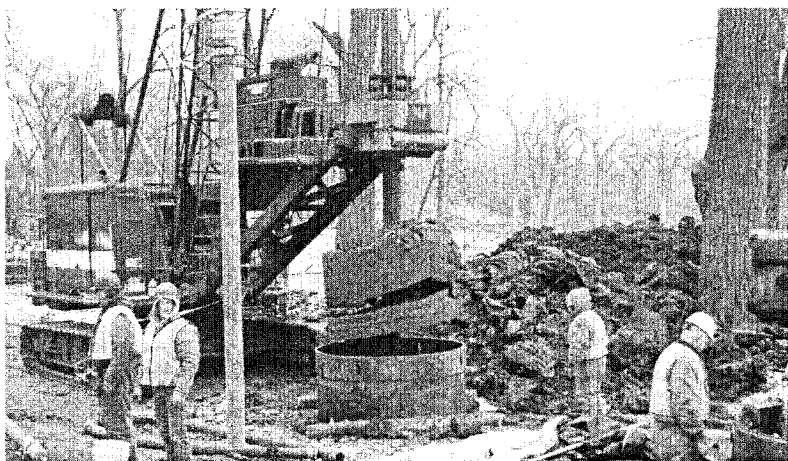
**Figure 16.** Drilling Operations – Reeves Drive Site.

Construction at the Reeves Drive site began in October 2002. The contractor set an oversize surface casing to a depth of approximately 6-7 m (20-23 feet), and then continued to drill the hole an additional 22.9 m (75 feet) to a final depth of 28.8 m (94.5 feet), as shown in Figure 16. The holes remained essentially dry throughout drilling operations. Each drilled shaft took approximately 3 hours to drill. Upon completion, the steel reinforcing cages were placed (Figure 17), and the holes were filled with water pumped from the Red River. Concrete then was placed by pumping from the bottom of the hole upwards with a constant 1.5-m (5-foot) head above the end of the discharge line, displacing the water back into the river (Riddick and Behling, 2004). As the pumped concrete filled the shaft hole, the displaced water flowed back to the river. Inclinometers were installed in two drilled shafts for long-term monitoring purposes. Construction of the Reeves Drive CPW and the flood barrier is now complete and is being monitored for performance.

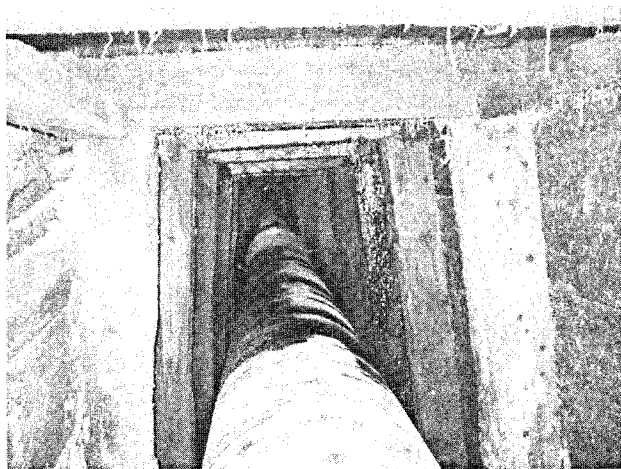
Figure 1. Timber Support in Shear Zone.

As previously discussed, a timber supported shear zone was observed in the tunnel (Figure 1). This shear zone defined the south sidewall beginning near one end of the timber supports, crossed the crown in the vicinity of the start of the timber sets and extended into the sidewall at the other end of the timber sets. The shear zone was estimated to be about 15-cm (6-inches) thick, 5 cm (2 inches) of which is filled with clay. The shear zone separated the very low strength and completely weathered granite on the south side (footwall) of the shear from the moderate to high strength, fresh to slightly weathered granite, which occupied the north or hanging wall side of the shear.

To determine the ground support requirements in this area, we used the Q System (Barton et. al., 1974), which is an empirically based rock mass rating system that is commonly used to estimate final rock support requirements for new tunnels. The numerical value of Q varies on a logarithmic scale from 0.001 to 1,000 and is defined as:

Using the above input values, the calculated Q is 0.14, which corresponds to very poor rock. Using this value and the Equivalent Dimension, the recommended ground support (Barton et. al., 1974) consisted of tensioned bolts installed on a 1 m (3.2-foot) spacing with 5 mm (2 inches) of mesh reinforced shotcrete. Grimstad and Barton (1993), recommend 7.6 mm (3 inches) of fiber reinforced shotcrete with 1.2 m (4-foot) long bolts spaced 1.2 m (4 feet) apart for similar parameters.

As an alternative, we recommended that steel sets blocked with timber and fully lagged with steel channel be considered as an alternative to rock bolt and shotcrete ground support for this area. To prevent further deterioration and fallout of the completely weathered granite, it would be appropriate to backfill with cellular or
