## CHAPTER 61

### SCOURING DUE TO WAVE ACTION AT THE TOE OF PERMEABLE COASTAL STRUCTURE

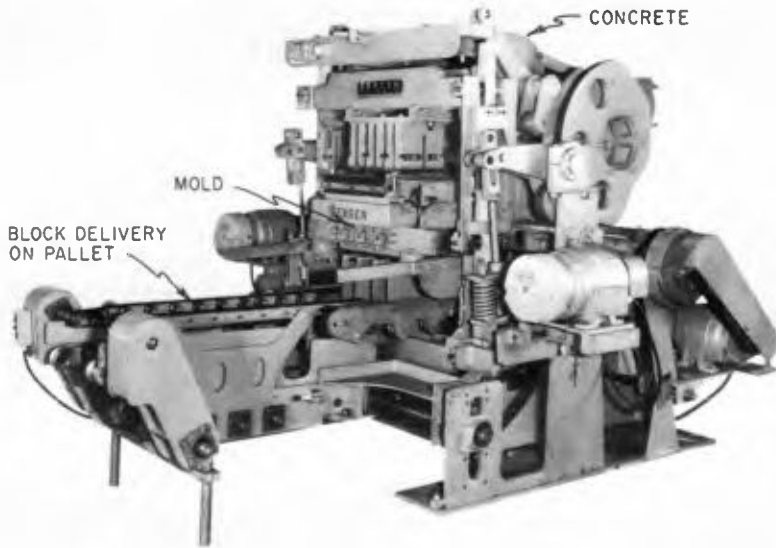
Fig. 2. Automatic concrete-block machine.

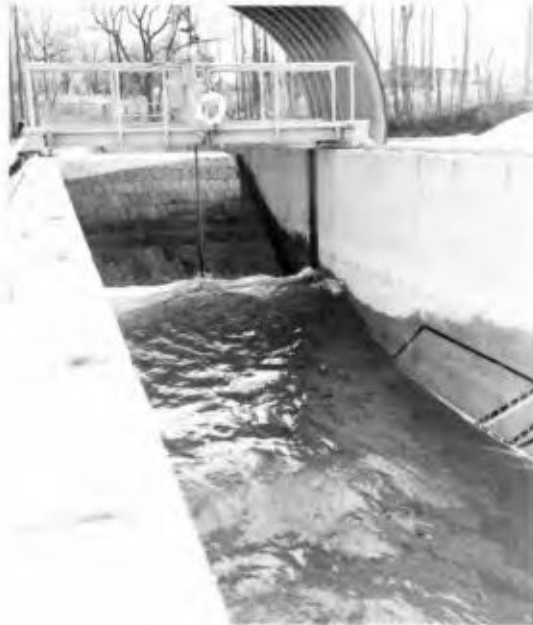
Fig. 7 shows the revetment in place ready for testing. The vertical pipe in the center of the Figure is a lift gage instrumented to record the vertical movement of the surface of the slope.

Fig. 7. Concrete block revetment in large wave tank.
