COMPARISON OF RELINING & SLIPLINING

Miami-Dade Case Study: Managing and Minimizing Pipeline Outages Through the Use of Carbon Fiber

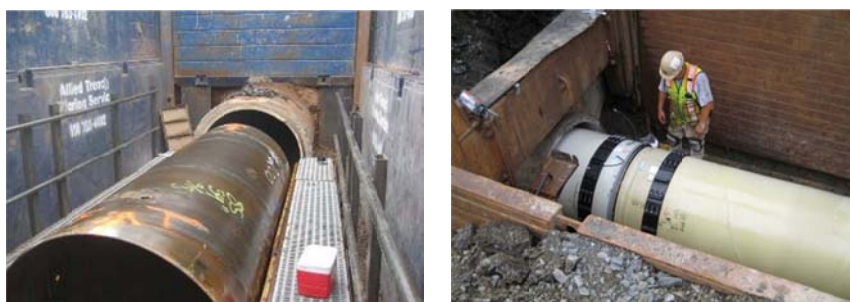
Ambroziak et al. (2009) describe the Sliplining of 8,300-ft of 60-inch PCCP on the Superior Waterline at the City of Phoenix, Figure 2a. Bass et al. (2011) report on the Sliplining of a 48-inch PCCP transmission main at Halifax Water with a unique gasket-joint design, Figure 2b.

Figure 2a, b: Sliplining 60-inch PCCP in Phoenix, Sliplining 48-inch PCCP in Halifax, Nova Scotia (Bass 2011)

Steel Cylinder Sliplining: Sliplining involves the insertion of full sections of steel pipe into the host pipe, Figure 2a, connecting the adjoining pipe sections, and then filling the annular space with cement-grout. A cement mortar lining is then applied to the cylinder. This method also meets the AWWA M28 classification of structurally independent Class IV Linings, and is suited for the structural renewal of long lengths of a PCCP line. Due to the conventional way in which the cylinders for Sliplining are made, manufacture is faster and less labor intensive than Reliner cylinders, and therefore, usually lower cost. Installation productivity is also faster with Sliplining than Relining, discussed further in the paper.

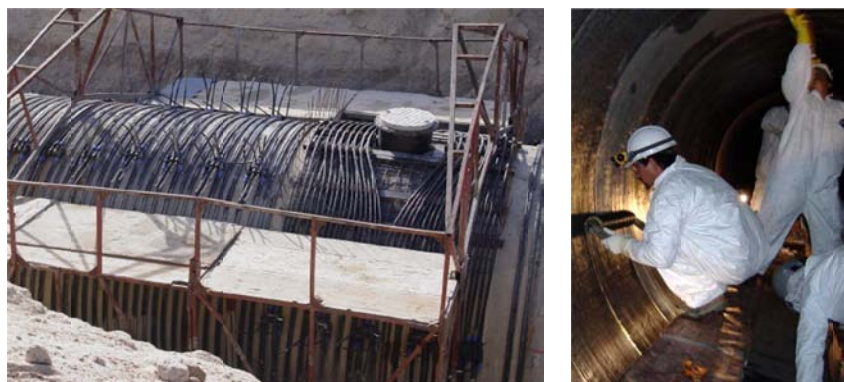
Post-Tension Tendon Repair: More often used in repairing above-ground circular structures such as tanks and silos, there are limited known uses of this technology in PCCP systems around the US. The process involves compensating for the strength lost in the host PCCP due to corroded prestressing wires with post-tensioned steel tendons placed externally around the pipe, Figure 3a. The distressed section of PCCP must be fully dug out, following which post-tensioned steel cables are wrapped around the outside of the pipe, then coated with a pneumatically-applied layer of shotcrete.

Figure 3a, b: Post-tension Tendon Repair in Libya (Elnakhat 2006), CFRP Application (Rahman 2008)

This technology is not suited to the repair of long lengths of PCCP and whenever employed, is rarely used to strengthen more than one to five sections of the host pipe at a time. Ojdrovic and LaBonte (2008) report on four sections of distressed PCCP in a power generation plant, one of which was repaired using post-tensioning, while a different technology was employed to repair the remaining three sections. The City of Tucson has used this repair option on a few sections of 66-inch diameter PCCP (Larsen 2009). The only known large-scale application of this process has been on the Great Man Made River pipeline in Libya (Elnakhat 2006). For long-term corrosion protection, the steel hoop-tendons rely on corrosion-inhibitors and are encapsulated in polypropylene sheathing, and are not known to be cathodically protected. An advantage of this repair method is that the host pipe does not have to be placed out of service or dewatered, even though most utilities that have used this technology usually put their system temporarily out of service during repair.

Carbon Fiber Reinforced Polymers (CFRP): First applied inside a PCCP cooling line at a nuclear power plant in Arizona in the late 1990's, carbon fiber composite repair has been used in several municipalities around the US since that time. However, many of these municipalities use CFRP as a temporary repair option until a more permanent solution such as steel cylinder Relining or Sliplining is applied. Work with CFRP is specialized and requires skilled labor (Rahman 2008, Arnold et al. 2008). Layers of epoxy-wetted CFRP are applied manually in layers, Figure 3b; the orientation of the fiber provides reinforcement to the host PCCP in the corresponding direction, while the number of layers determines the strength of the lining system.
