6.9 Case Study 2—State College Municipal Building: Work Face Practices

6.10 Case Study 3—Beaver Avenue Parking Garage: Fabricator Relations

6.11 Case Study 4—Food Science Building: Delivery Strategy

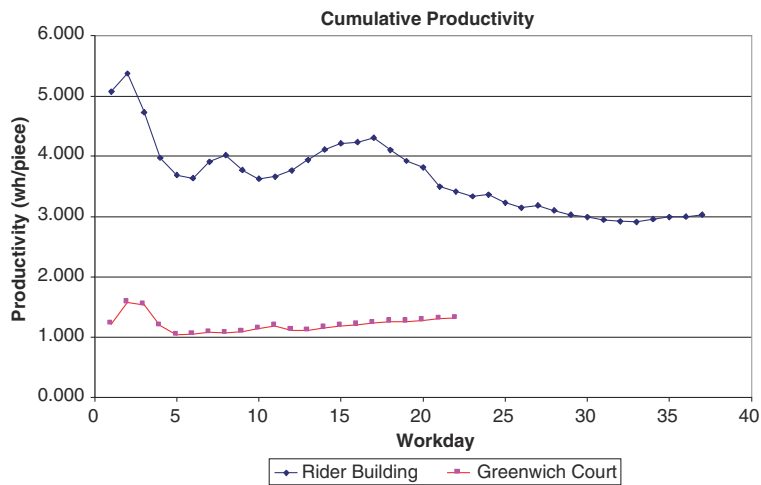
Fig. 6-30. Comparison of Cumulative Productivity, Rider Building and Greenwich Court

Based on 70 work hours/day and 1.20 work hours/piece, a daily goal of 58 pieces/day is calculated. The crew came close to this goal on only four workdays. The cumulative crew productivity was 2.06 work hours/piece compared with 1.32 work hours/piece on the Greenwich Court project described in Case Study 1. The cumulative steel erection productivity on the Food Science Building was about 60% worse than the Greenwich Court project.

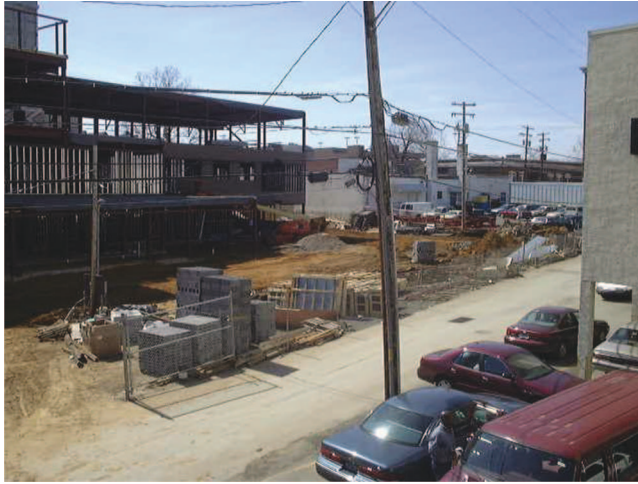
Fig. 6-31. Storage Area on North Side, State College Municipal Building

There was no material management plan for this project. Materials were stored on site in accordance with the layout shown in Fig. 3-3. The site was small, and material site access was at the one location shown. There were trailers, a tool storage shed, excavated spoil, and a parking lot located within the site boundary. Material was transported into the building in two places. Fig. 6-31 shows the material storage area on the north side of the building. This area was used to stockpile excavated soil, accumulate trash, and store miscellaneous materials. The temporary utility pole also impeded the free flow of materials. Because of the limited site storage, duct and other materials were stored inside the building. This aspect was shown in Fig. 6-9. The south side of the building was not available for storage because work on installing underground utilities was late.

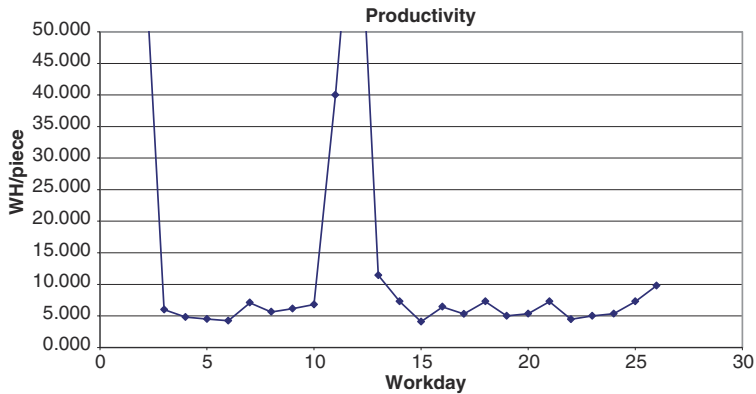
Fig. 6-33. Daily Productivity for Precast Elements, Beaver Avenue Parking Garage

The superintendent had an excellent opportunity to control the daily production because there was good communication and coordination with the fabricator. Most of the deliveries were made on time, and the off-site staging area meant that nonpermit pieces could be delivered as needed, so work for the crew was always available and there was little idle time. The productivity of the crew is shown in Fig. 6-33. Production variability was caused by the time differential needed for different components to be erected: columns took two to four times longer than other components to erect, the stairwells were complex and time consuming, there was an accident (workday 2), design errors affected the work (workdays 7–8), the crane needed to be moved as the work progressed from phase 1 to phase 2 (workdays 11–13), and precast permit pieces were delayed one day (workday 9). Output was low on another five or six workdays. But despite the unfavorable conditions, the goal of 14 pieces per day was exceeded most of the time.
