The 2008 Iowa Floods: Structural Challenges and Solutions

Electrical Transmission and Substation Structures Conference
8 – 12 November, 2009
Fort Worth, Texas USA

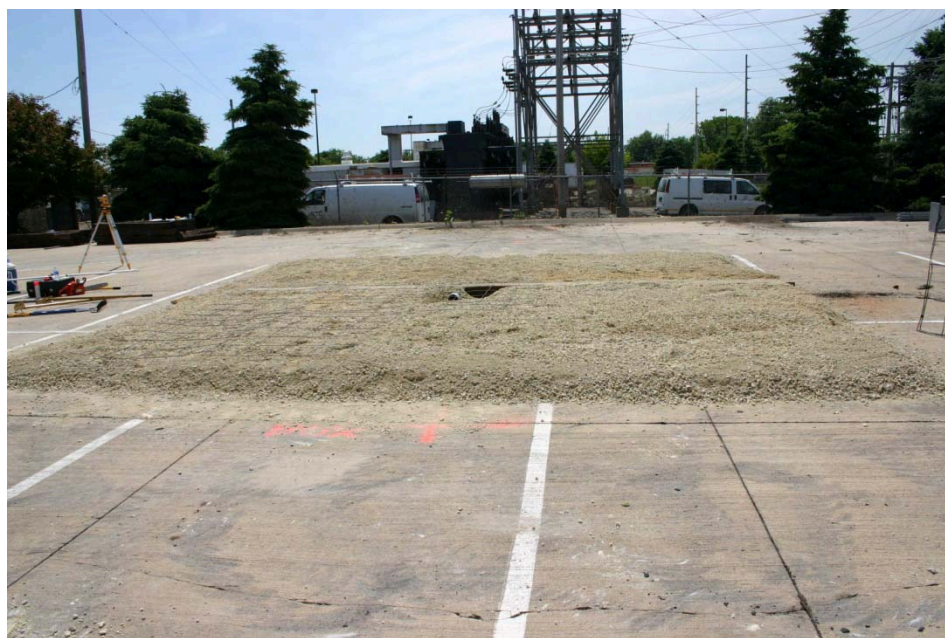
Figure 2 - Road Stone Foundation for the Power Transformer

We considered setting the transformer on the concrete and shimming the base, but the amount of shims required resulted in an unacceptable stability risk. The contractor suggested building a gravel pad for the power transformer (see Figure 2). The pad was sized to extend about four ft. past the transformer base on all sides to provide a working surface after the transformer was set in place. A line of 8" high railroad ties was set next to the lower edge of the gravel pad. The ties served two purposes. First, to establish the pad thickness, and second, to prevent the road stone from washing away during heavy rains.

An 8 inch layer of gravel (crushed rock with fines typically used to build secondary roads in rural areas) was then laid directly on the concrete surface and compacted, starting at the ties and gradually tapering off up slope. This gave us the required level surface for the transformer. Gravel was chosen because it compacts well, thus giving us the desired stable surface.

Next, copperweld ground mats were laid on top of the base and bonded together to provide a ground plane. The ground mat array was then bonded to the substation ground grid. Finally, a 2" layer of top soil mixed with road stone was placed over the ground mats. This layer provided a measure of self-leveling as the weight of the transformer pressed down onto the pad.

The result of this design was more than satisfactory. After the transformer was set in place, we put a level on the transformer base and found all four sides were almost perfectly level.

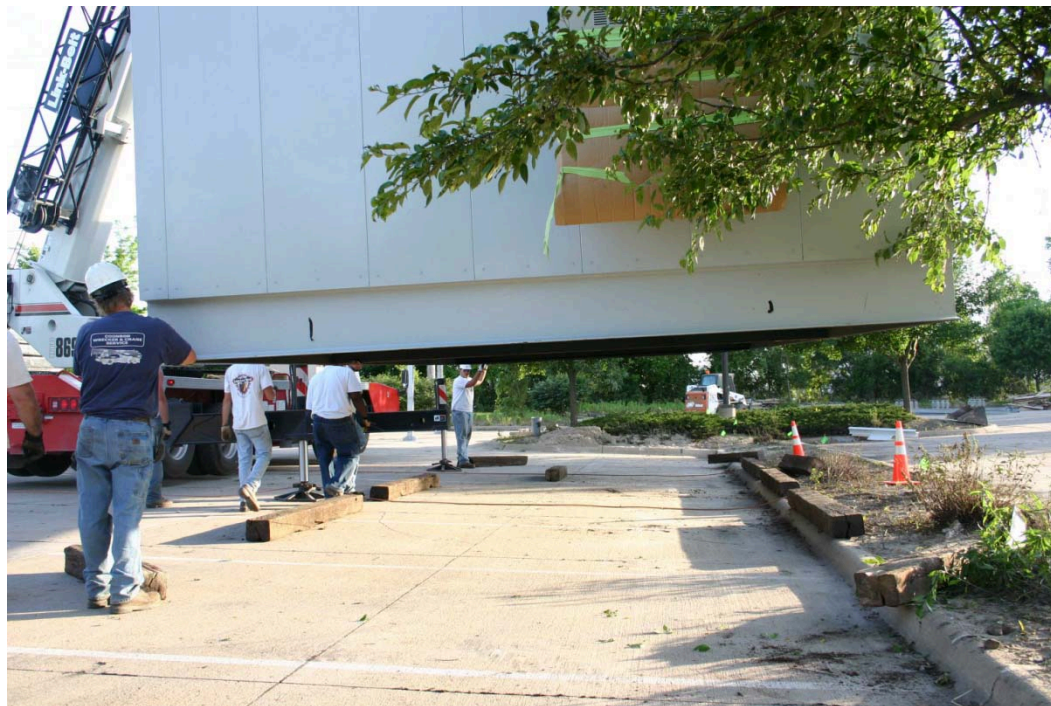
Figure 3 - Setting the 15kV Switchgear on Railroad Ties

Wooden railroad ties were cut in half lengthwise, and each piece of wood tie was placed appropriately on each footing spot. Allowances were made for power and control cable exits. After the ties were in place, we checked the height differential between the ties and the top of the curb. We found the top of the curb was actually lower, and the height difference could be made up by simply placing more ties on top of the curb.

When the 68,000 lb switchgear was delivered and set into place (see Figure 3), workers were stationed at each tie to ensure solid contact at each footing location. As the building was slowly lowered onto the ties, the alignment was verified and the building came to rest evenly (miraculously) on all the ties. Only some minor shims

under one corner of the structure were required to level the building. Out of curiosity, a worker put a level on the building's footing rail, and it was only a partial bubble off true level.

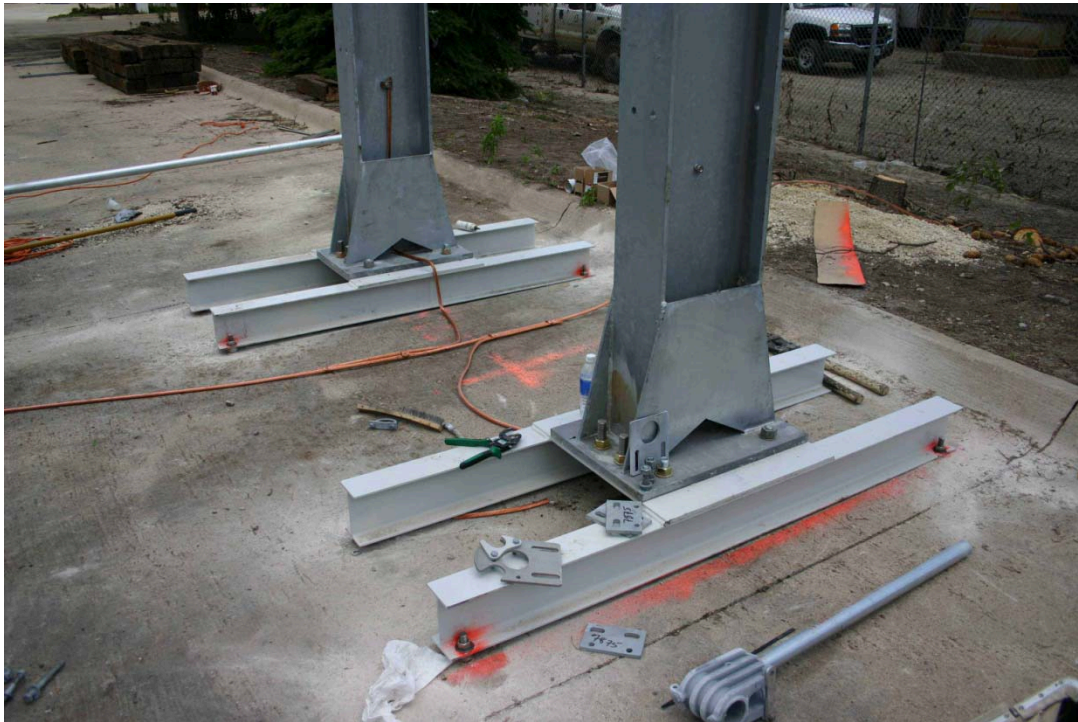
Figure – 4a Dead-End Tower Base

The dead end tower was a two-leg design, with a bottom plate. No one knew how thick or strong the parking lot concrete was, so it was decided to design a steel base to widen the bearing surface for the structure. The base consisted of two parallel I-beams and a square plate. The plate was welded to the top flanges of the I-beams to form an H pattern. Mounting holes were punched in the plate to match the anchor bolt pattern of the tower leg bases. The lower flanges of the I-beams were punched to accommodate epoxy type anchor bolts set in the parking lot concrete surface. We contacted a local steel fabricator to properly size the steel members and manufacture the bases. Figures 4a to 4d show the completed steel base and details of the bolted connections.
