Low Temperature Cracking Performance at MnROAD

Abstract

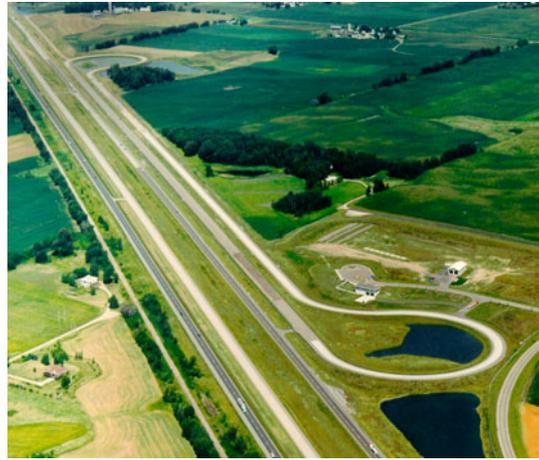
Figure 1. MnROAD Aerial View

- A 3.5-mile mainline interstate roadway carrying “live” traffic averaging 28,500 vehicles per day with 12.4 % trucks.
- A 2.5-mile closed-loop low-volume roadway carrying a controlled 5-axle tractor-semi-trailer to simulate the conditions of rural roads. Traffic on the LVR is restricted to a MnROAD-operated 18-wheel, 5-axle tractor/trailer with two different loading configurations of 102 kips and 80 kips.

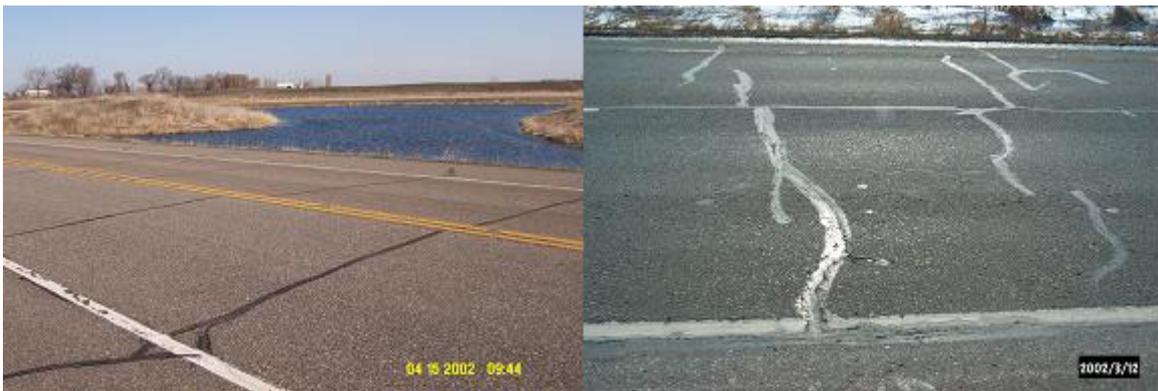
- The cells with PG 58-28 binder tended to crack in a typical transverse pattern with 30-50 foot spacing between adjacent cracks. The PG 64-22 cells displayed multiple short cracks with a random “shattered” appearance (see Figure 4 for examples).

Figure 4. Typical Cracking Patterns on PG 58-28 (left) and 64-22 (right) Cells
