Harnessing Advanced Inspection Technologies to Assess Metallic Water Transmission Mains

Victor Bernal Chimal¹; Brandon Hildebrandt, P.Eng.²; and Justin Hebner³

In October 2019, the City of Vancouver teamed with Pure Technologies, a Xylem brand (Pure) to perform a condition assessment on a section of the Charles Street Transmission Main. The project utilized a high-resolution ultrasonic condition assessment tool that inspects the pipeline while still in service, identifying areas of wall thickness loss, and assessing lining and out-of-roundness. The condition assessment tool is free-swimming, which allowed this critical transmission main to remain in service during the inspection. The inspection was completed on a 2.9-km section of the 800-mm riveted steel Charles Street Transmission Main, installed in 1912. As part of the project, Pure also inspected this section of pipeline using other technology as a prescreening acoustic tool to locate leaks and pockets of trapped air. While the prescreening inspection did not detect acoustic events characteristic of leaks, the free-swimming ultrasonic condition assessment tool identified five pipe sections with wall loss anomalies. Pure provi

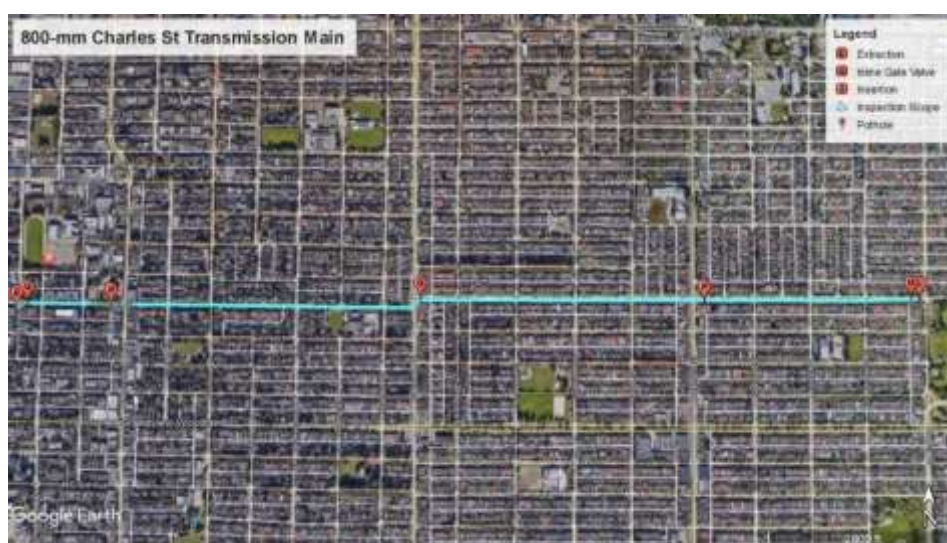
Figure 1. General alignment and inspection scope of the 800-mm Charles Street Transmission Main

The City of Vancouver worked with Pure to inspect a section of the Charles Street Transmission Main. The scope of work began near the intersection of Charles St and Windermere St at an existing 900-mm access and ended near the intersection of Charles St and McLean Dr. Figure 1 shows an approximate layout of the inspected section of the 800-mm Charles Street Transmission Main. The inspected alignment is comprised of approximately 2.9-km of 800-mm riveted steel pipe and it was inspected with the PipeDiver Ultra ultrasonic condition assessment tool and with the SmartBall acoustic inspection tool.

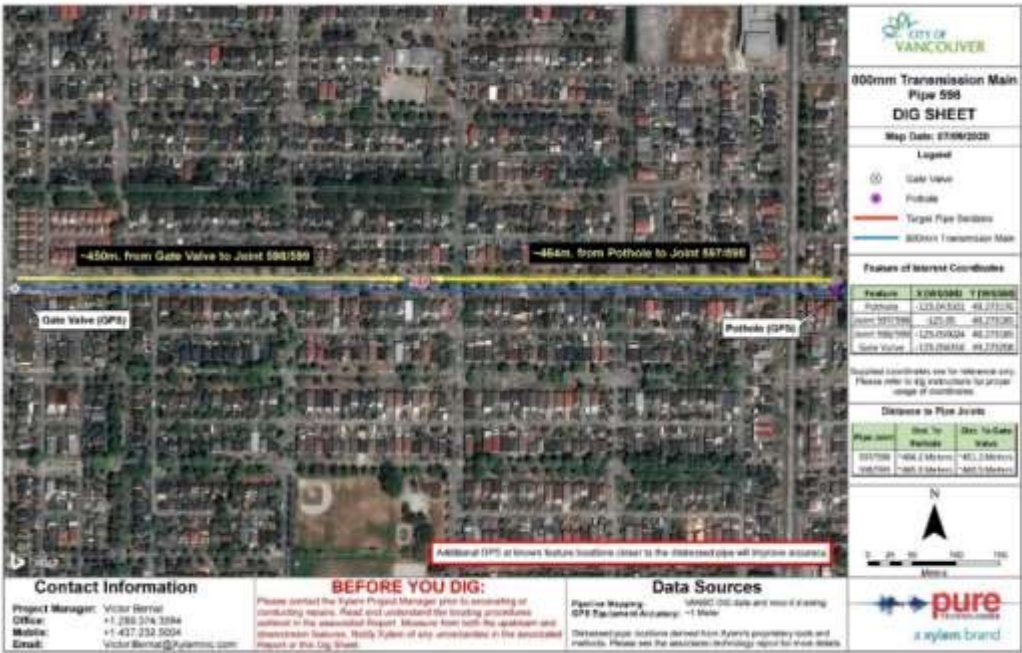
Figure 8. Example of dig sheet generated to pinpoint pipe sections with wall loss

On July 14, 2020 the City of Vancouver exposed the pipe section with the largest wall loss defect that was identified during the ultrasonic condition assessment and conducted a validation of the results. Dig sheets (Figure 8. Example of dig sheet) were provided to the City of Vancouver for the pipe section which was subsequently successfully located.
