A Study on Behavior of Ductile Iron Earthquake Resistant Pipeline in the Deformed Road at the 2011 Great East Japan Earthquake

Kiyoshi Kobuchi¹ and Nobuo Fujita²

ABSTRACT

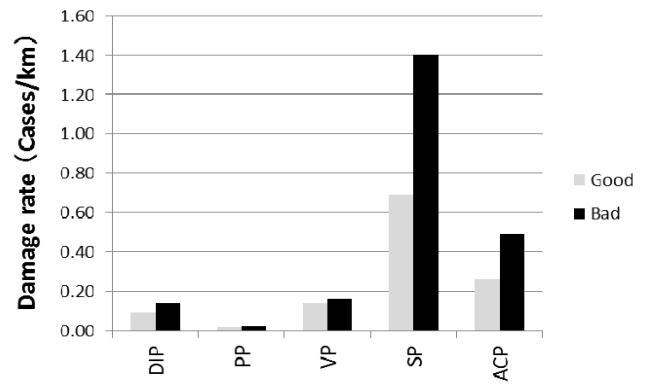
Figure 6. Comparison of damage rate of each pipe type in micro topography classification category.

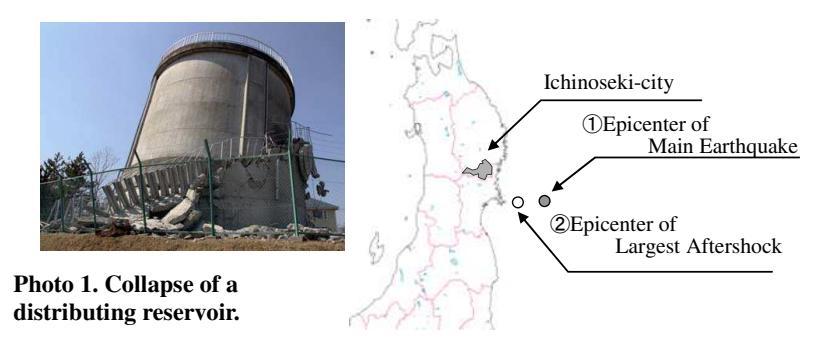
Ichinoseki-city where we investigated the behavior of ERDIP (DN150mm), had been struck twice by earthquakes measuring a lower 6 on the JMA scale on March 11, 2011 and April 7, 2011, and suffered great damages to waterworks facility such as a collapsed of distributing reservoir (Photo 1). Figure 1 shows the two earthquake epicenters and the outline of seismic intensity at Ichinoseki-city.

Figure 1. Ichinoseki-city and Earthquakes position.
