4.7 *Santa Maria Island*

4.8 *Caleta Tumbes*

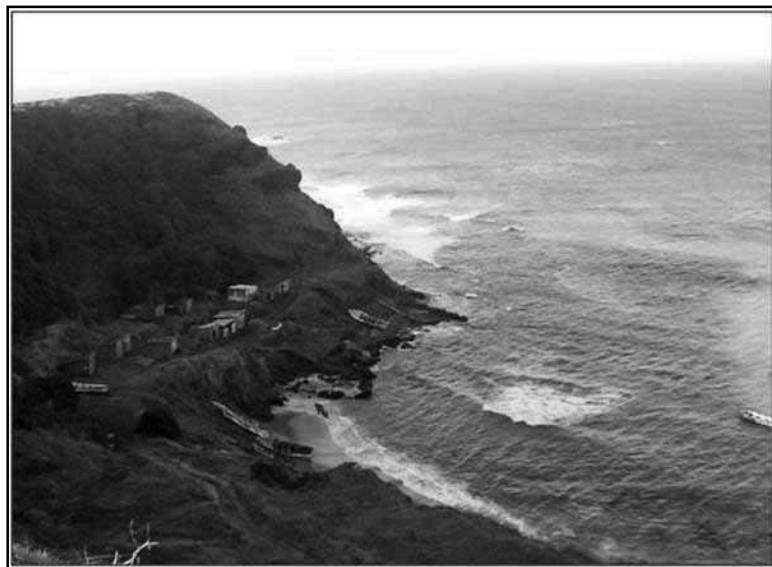
Figure 4.66 was taken before the earthquake of January 1, 2010 at 8:00 AM while Figure 4.67 was taken near high tide on April 13, 2010 at approximately 11:00 AM. Figure 4.67 shows the effect of the uplift is visible at the north end of the island. Notice that there are no exposed rocks in the surf in the earlier photo although it does appear that a wave is breaking over a shallow object. There is also a small jetty at the upper end of the beach. In Figure 4.67 there is no beach of sand as it has been washed away by the tsunami. In the surf zone there are many rocks now exposed and above the water. The evidence of the South American Tectonic Plate uplift and tsunami is obvious and the effect of this on the fishing community is apparent by the absence of the buildings and the boats.

*Figure 4.66 North Point of Santa Maria Island Before the Earthquake
(Photo by Simón Alvaro Muñoz U.)*

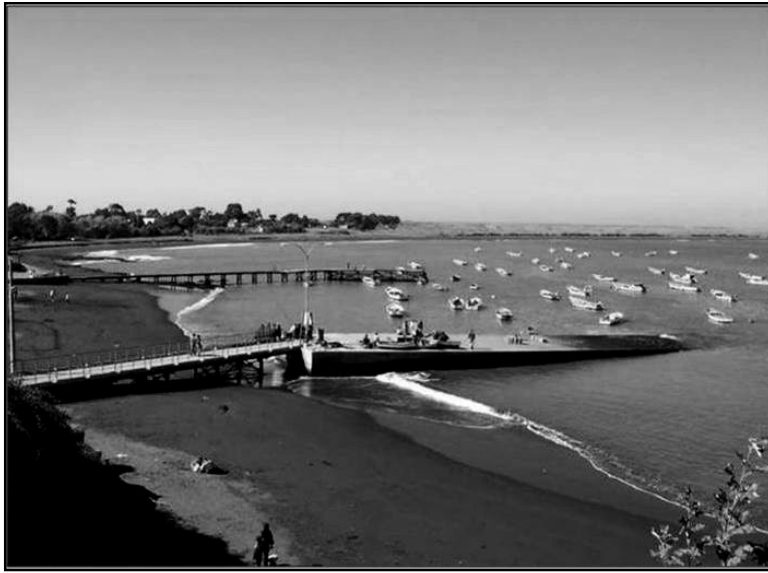
*Figure 4.69 Fishing Boat Launching Ramp Before the Earthquake
(Photo by Simón Alvaro Muñoz U.)*

The destruction of the ramp is probably a combination of the earthquake and the scouring action of the tsunami. The fishing pier in the distance was destroyed by the tsunami, although many of the pilings remained. There are many species of sessile organisms and sea grass that are now dehydrated on the shoreline as shown in Figure 4.71 and Figure 4.72. The latter figure was taken from about 70m and it is not as clear as the former that was taken close by the rocks. Nevertheless, it is clear that the sea bed has risen and the exposed organisms are now dead and decaying.
