5.2 Water Distribution Pipes

6 WASTEWATER

7 ROADS AND BRIDGES

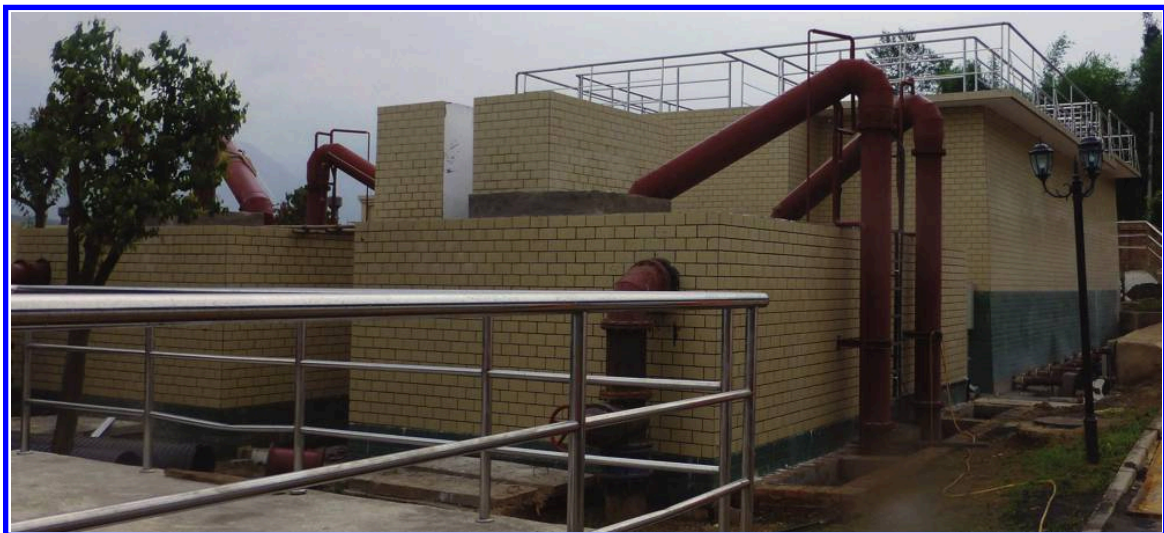
Figure 5-1. Entrance to Water Treatment Plant (ground motion estimated by field observations)

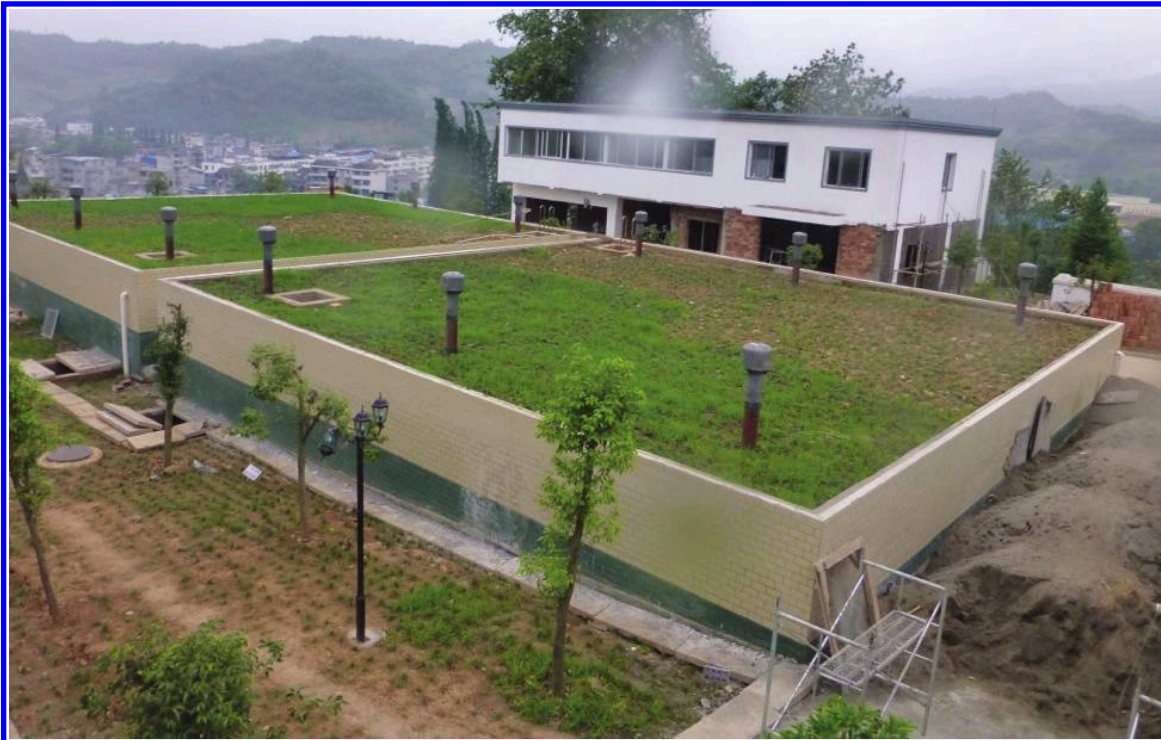
Figure 5-2. Settling and Filter Basin Structures

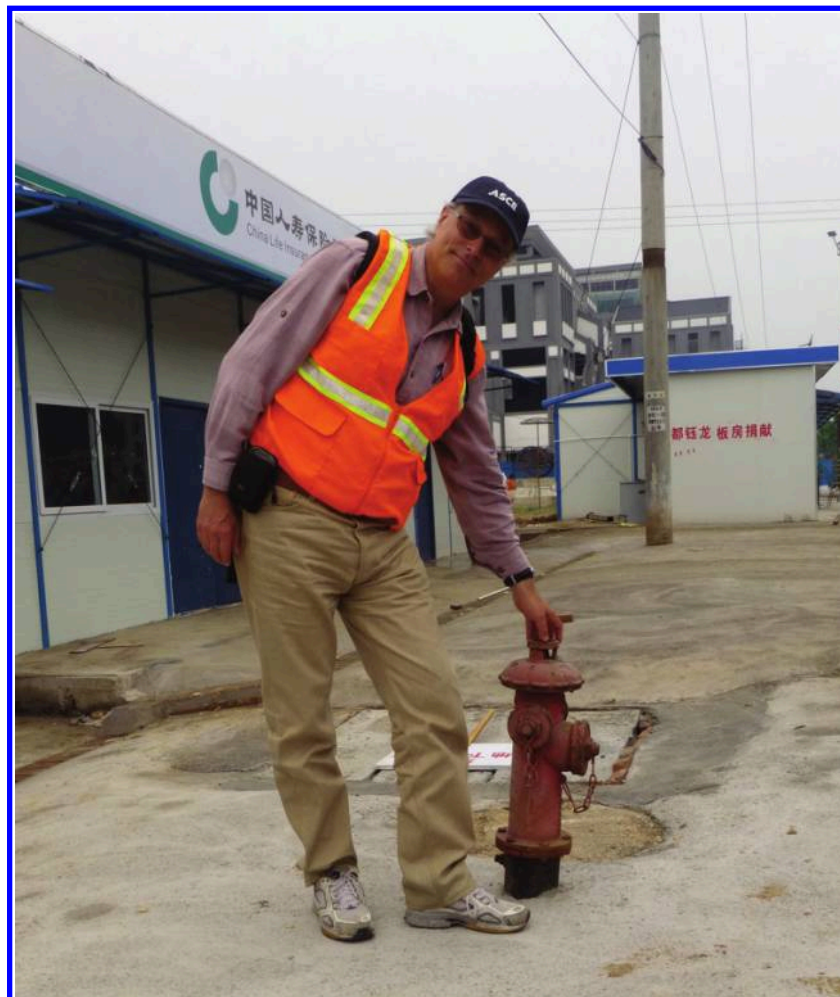
Lushan City has about 300 km of water distribution pipes. Most are cast iron (dating back more than 50 years). The newer pipes are PVC. Most distribution pipes are 100 mm in diameter; 500 mm in diameter is the largest pipe in the system. Figure 5-7 shows a TCLEE team member at a fire hydrant. Note the temporary office buildings in the background. Dozens of such buildings were placed on main city streets in Lushan City to provide needed services, such as life insurance, telecom, and banking.

Figure 5-7. Fire hydrant in Lushan City (John Eidinger)

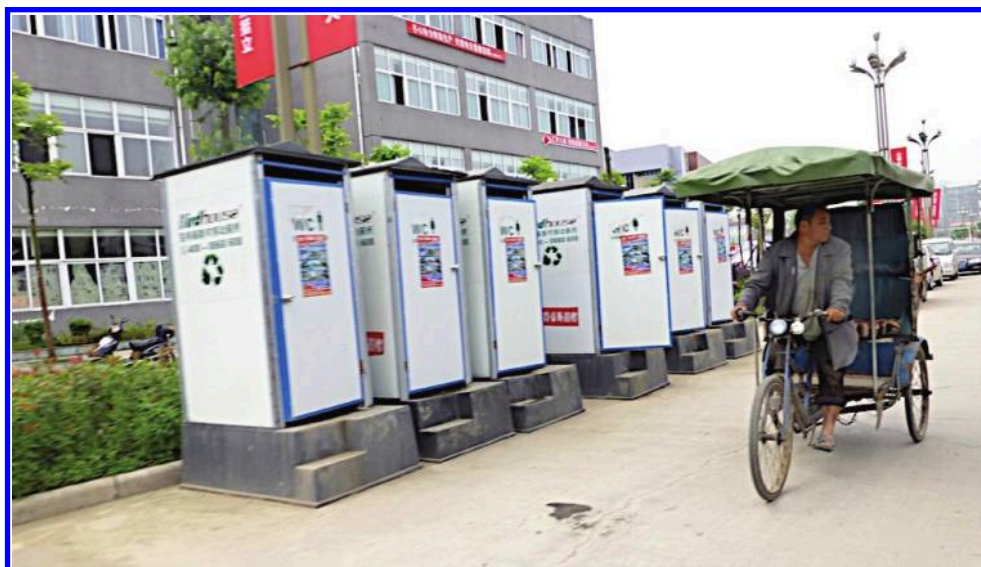
There were dozens of portable toilets in use, six weeks after the earthquake (Fig. 6-2). City staff reported there were no sewage backups to the street level.

Figure 6-2. Portable toilets

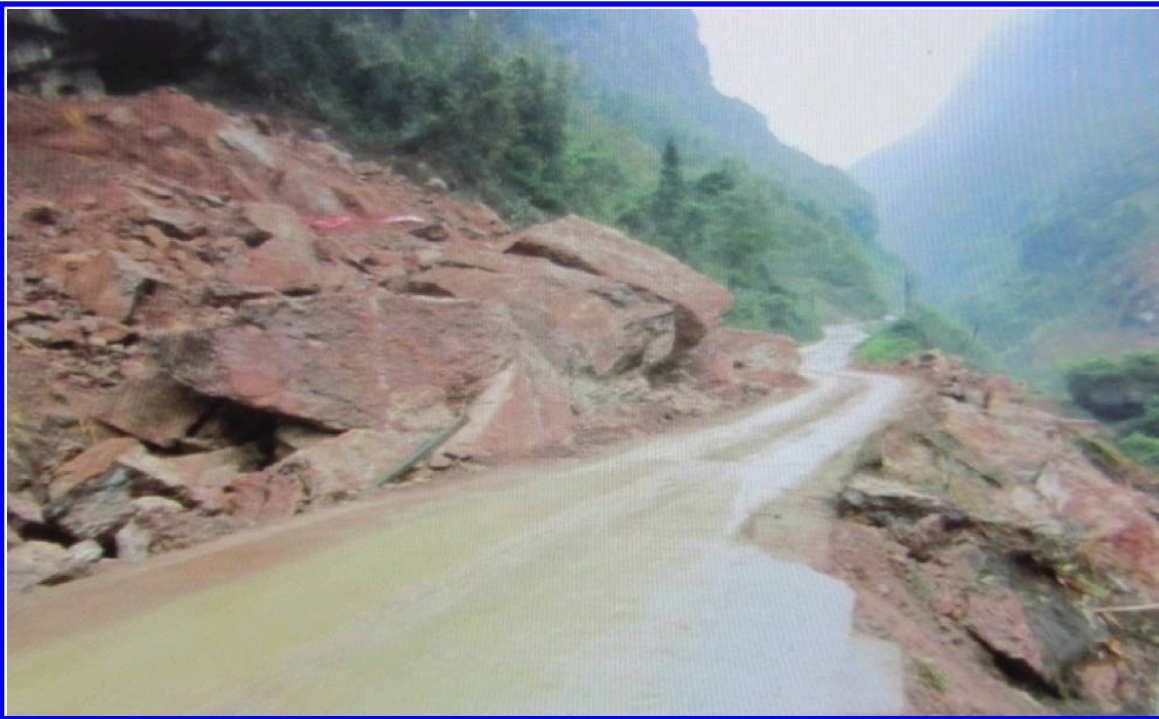
The area affected by the Lushan earthquake has steep mountainous terrain and narrow river canyons and valleys. Many roadways are cut into the steep slopes. These steep slopes are also highly susceptible to landsliding and rock falls when subjected to strong ground motions. As a result, the roads are highly susceptible to landslide damage. The two-lane paved road shown in Figure 7-1 was closed by landslides / rock falls, and the road was repaired to one-lane gravel status a month after the earthquake. Even so, local officials were prohibiting access to such roads even a month after the earthquake for fear of continued landslides should there be rain.

Figure 7-1. Typical terrain for roads in the mountainous areas near Lushan (photo late May 2013)

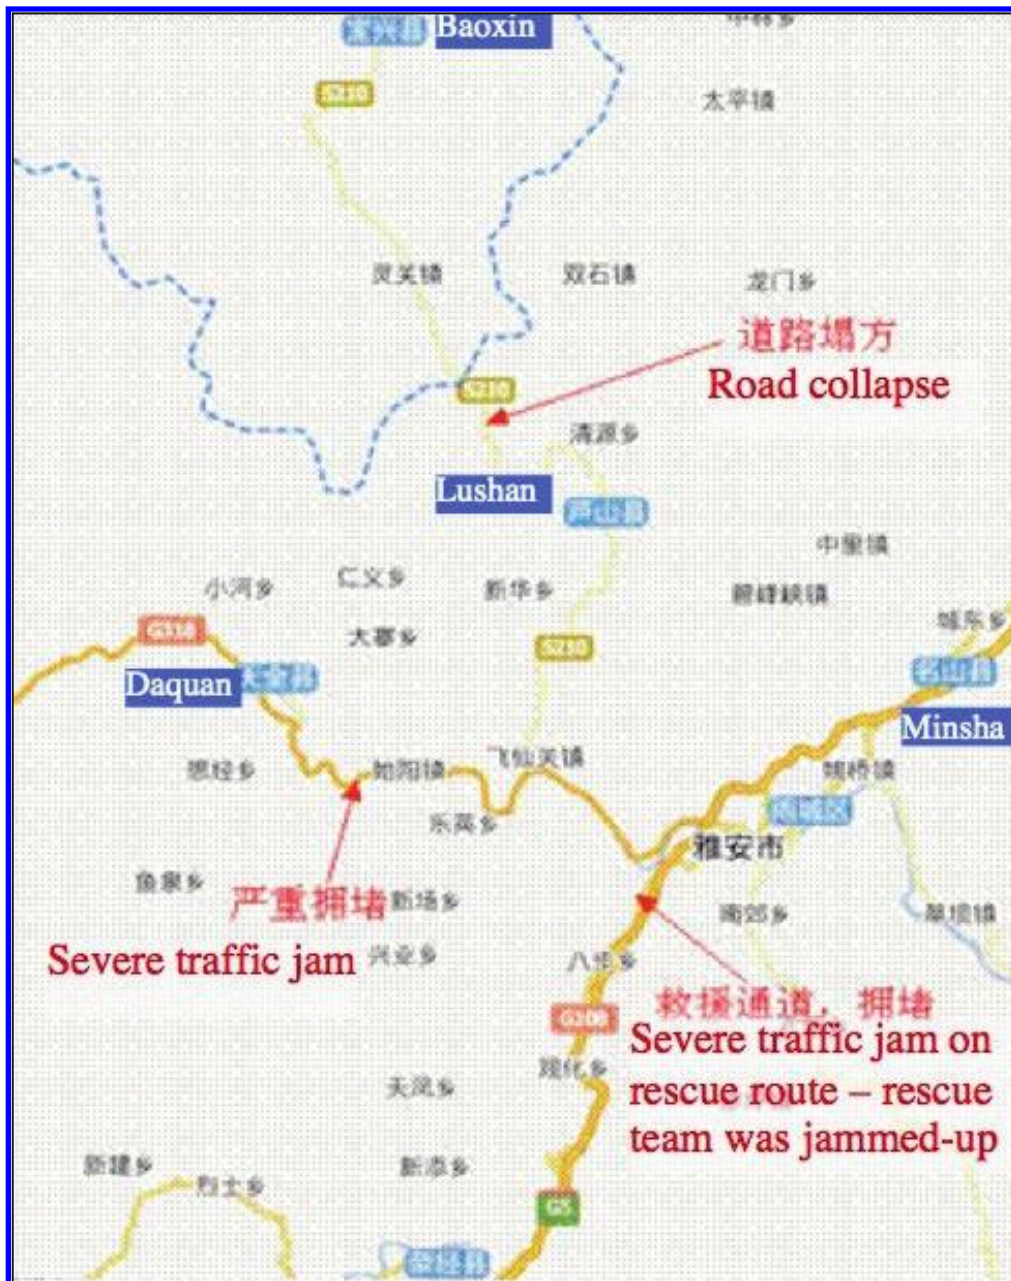
Figure 7-2 shows a map of important transportation routes in the Lushan earthquake affected area. Preliminary reports identified four Highways (G5, S8, S9, and G4201), two National and Provincial main lines (G318, S210) and six County Roads (X073, X074, Z001-Y004, XT26, XT27, XT06) that were damaged by either subgrade collapse, subsidence, landslides, or rock falls.

Figure 7-2. Map of roads and highways in Lushan earthquake damage area, some areas of severe problems noted for G318, G108, and S210 (Courtesy Dr. LIU Aiwen of CEA)
