Repairing a Damaged House by Watering Foundations: The MACH Project

David Mathon¹

Abstract

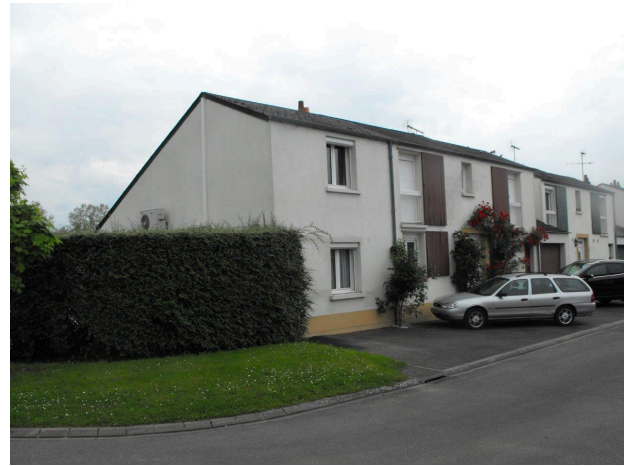
Figure 2: View of the house

After Summer 2015, the damages were noted only on the extension part of the house. Major cracks were drawn on figure 3. It was found out that the extension is tilting to the East.

Inside the house, the floor did not settle at all. However, the tiled floor is broken at the junction of the former construction and the extension. The tilting phenomenon induced damages on the interior finishing (cracks on partition and doubling walls, offset of windows panels, doors which doesn't close or open...). These damages reduced during Winter 2015/2016 and increased during Summer and Fall 2016.
