CONDITION RATINGS OF THE ELEMENTS OF THE ALBION RIVER BRIDGE

Table 1. Inspection Ratings of All Albion River Bridge Elements

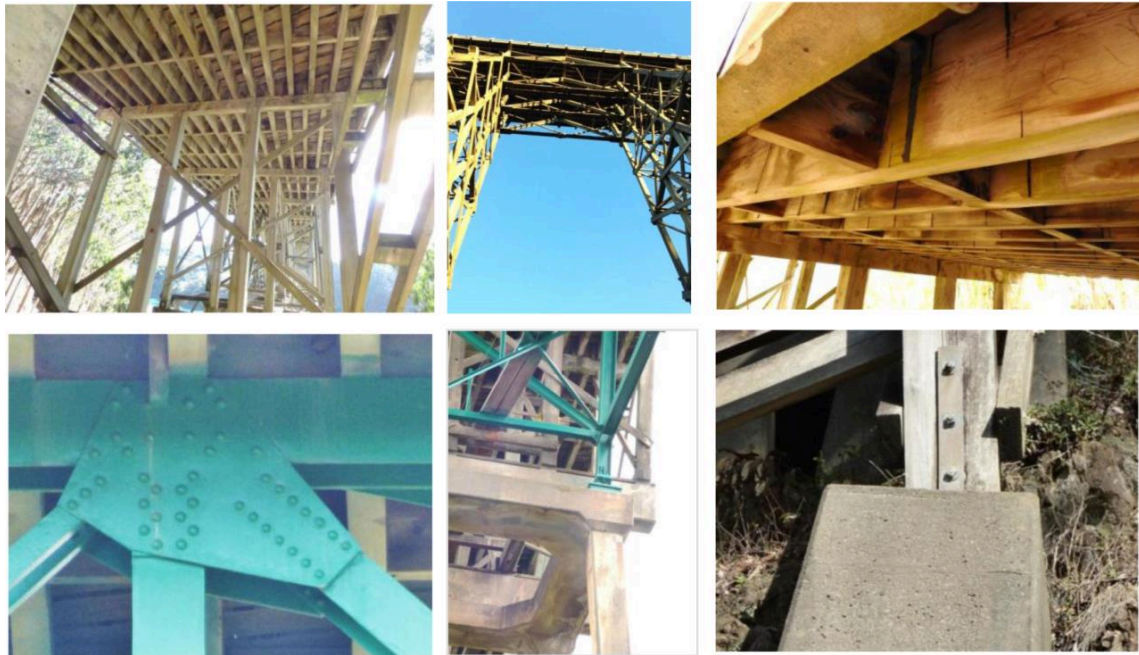
Figure 3. Close-up views of the components of the bridge.
Photos by A. Astaneh-Asl.

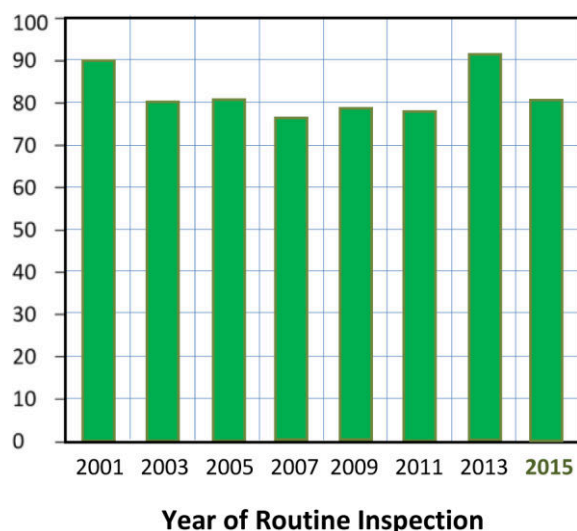
Figure 6. Variation of the “California Health Index” for the Albion River Bridge between 2001 and 2015

According to Figure 6, from 2001 to 2015, the California Health Index for the Albion River Bridge varied from a minimum of 78.6% in 2007 to a maximum of 93.5% in 2013. In 2015, when the latest inspection was performed, the CHI was 81.7%. The stated goal of Caltrans (TRB, 2001) is to have no more than 5% of the state's bridges with a CHI below 80%. This is done by allocating funding for repair and rehabilitation. Currently, more than 15% of bridges in Caltrans's District 1, where the Albion River Bridge is located, fall below this level (TRB, 2001). Given that the bridge has a CHI of 81.7%, it is impossible for this author to understand the justification for spending more than \$66 million on its rehabilitation or replacement when others with a CHI below 80% demand the state's attention.

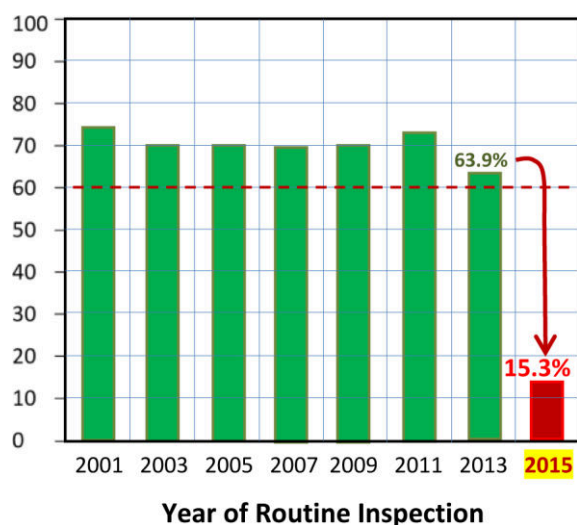
Figure 7. Variation of the “FHWA Sufficiency Rating” for the Albion River Bridge between 2001 and 2015

- Figure 7 shows the variation of the sufficiency rating. The FHWA uses this measure of the current condition of a bridge in allocating federal funding for its rehabilitation and
