Chapter 5

Assessment of Abastible San Vicente Liquefied Petroleum Gas (LPG) Terminal

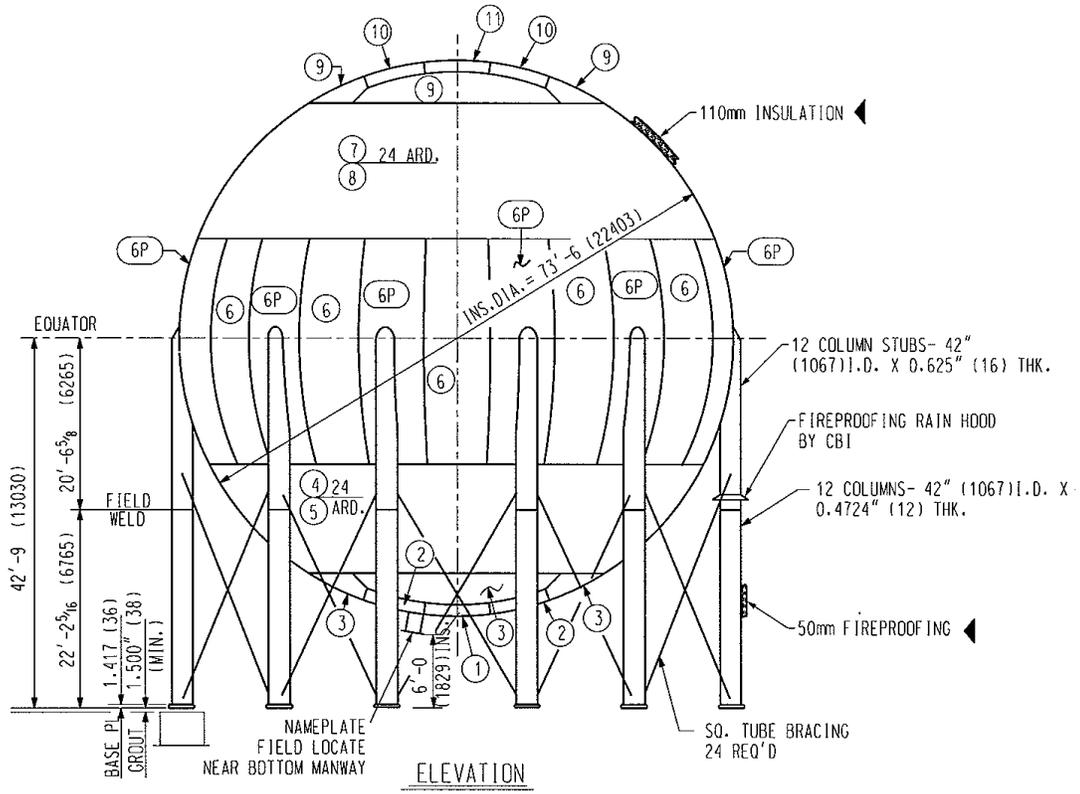
Figure 5-4: Sphere geometry. (Source: Courtesy of CB&I Inc.)

The two LPG spheres (Lat 36° 46' 22" S, Long 73° 8' W) are 73.5-ft in diameter and were designed to the ASME BPVC Section VIII, Division 1. The design pressure of the spheres is 110 psig and the specific gravity of the stored product is 0.625. The thickness of the vessels ranges from 1.237 in. to 1.496 in. The fundamental period of the spheres is 0.355 seconds. Other dimensional information is shown in Figure 5-4. The sphere, supporting columns, and bracing were designed to the seismic requirements of Zone 3 of the Chilean Standard NCh 2369-2003 using a response modification factor R of 3 and an importance factor of 1.2. Zone 3 of the Chilean Standard NCh 2369-2003 roughly corresponds to Zone 4 of the 1997 UBC without near field factor increases.

No damage of the LPG spheres, columns, bracing, or foundations were observed.

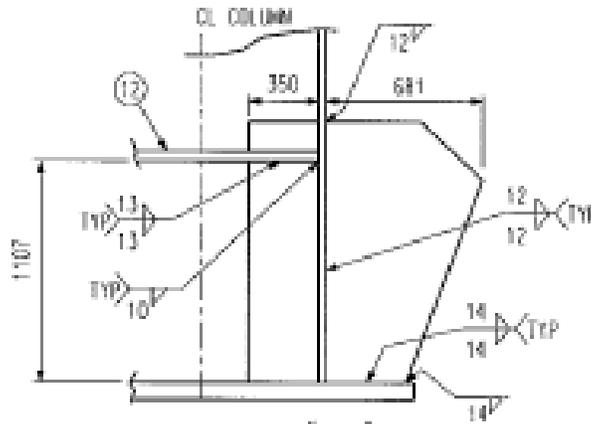
Figure 5-6: Wingplate attachment detail. (Courtesy of CB&I Inc.)

The bracing system is an ordinary concentrically braced frame. The bracing (Figure 5-5) is made up of built-up 12.8 in. x 5/8 in. thick square tubes fabricated from A572 Grade 50 steel plate. The wing plates are 1.25 in. thick and penetrate the tubular columns. The wingplates are welded to internal circular diaphragms in the columns (Figure 5-6).

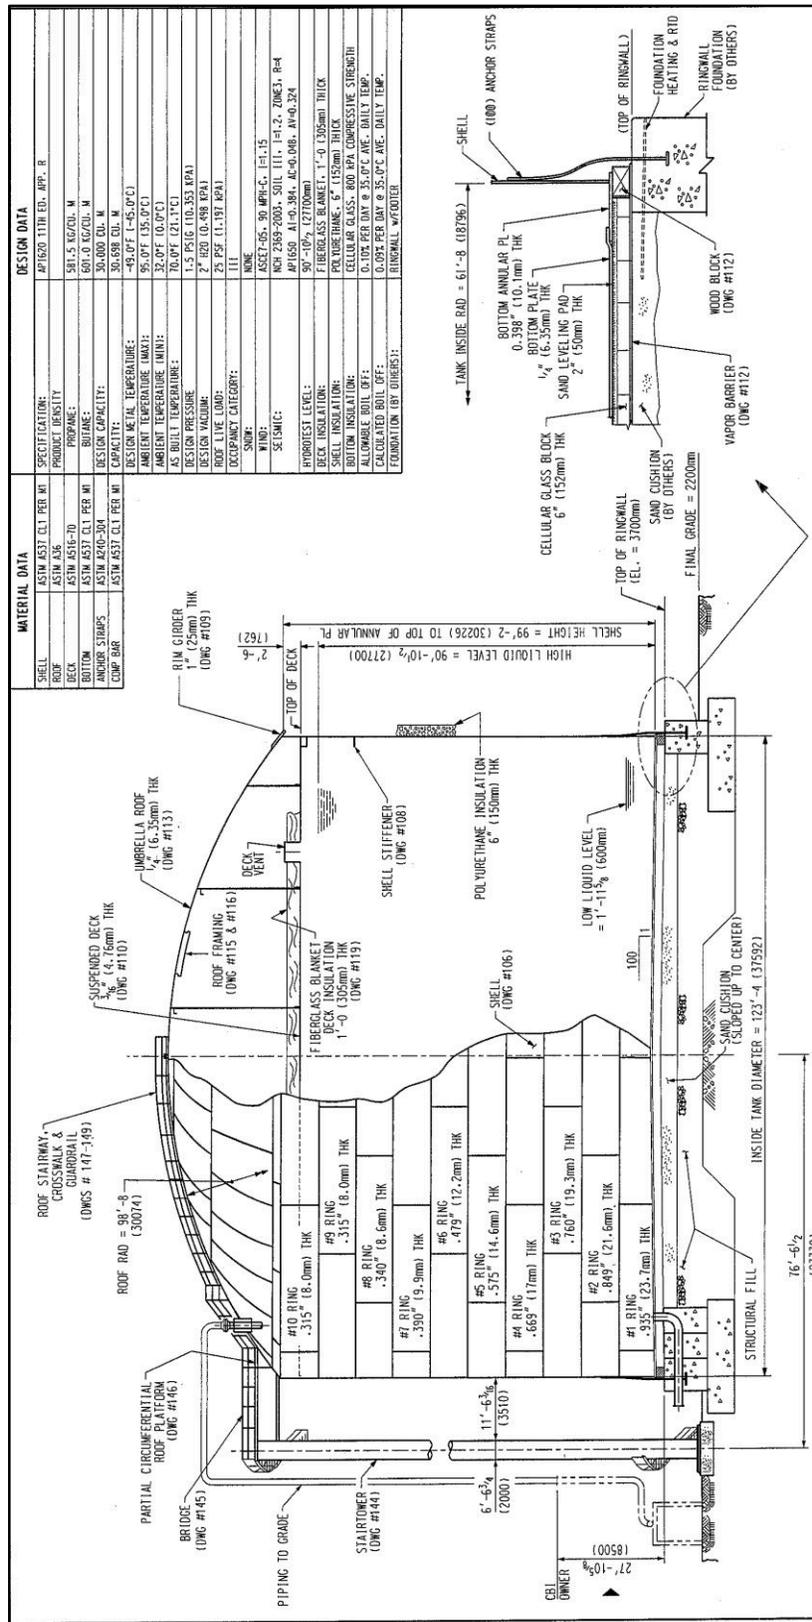
Figure 5-8: LPG tank geometry. (Source: Courtesy of CB&I Inc.)

The LPG tank is a 123'4" diameter by 99'2" high single wall dome roof refrigerated storage tank (Lat 36° 46' 21" S, Long 73° 8' 4" W) with a suspended deck designed to the requirements of API 620 Appendix R. The design pressure of the tank is 1.5 psig and the specific gravity of the stored product is 0.582 (propane) and 0.601 (Butane). The tank is designed to store LPG at -49 °F. The thickness of the tank ranges from 0.315 inches to 0.935 inches. The fundamental period of the tank is 0.30 seconds and the sloshing period of the tank is 6.44 seconds. Other dimensional information is shown in Figure 5-8. The tank was designed to the seismic requirements of Zone 3 of the Chilean Standard NCh 2369-2003 using a response modification factor R of 4 and an importance factor of 1.2. Zone 3 of the Chilean Standard NCh 2369-2003 roughly corresponds to Zone 4 of the 1997 UBC without near field factor increases.

Because the LPG tank was empty at the time of the seismic event, no conclusions can be drawn on the possible seismic performance of the tank. However, the performance of the improved soil beneath the LPG tank can be evaluated. The Abastible facility sits on liquefiable soil. As can be seen in Figure 5-9, lateral spreading due to soil liquefaction did occur near the tank. The lateral spreading stopped at the point where the improved soil began. The soil improvement must be viewed as a success.
