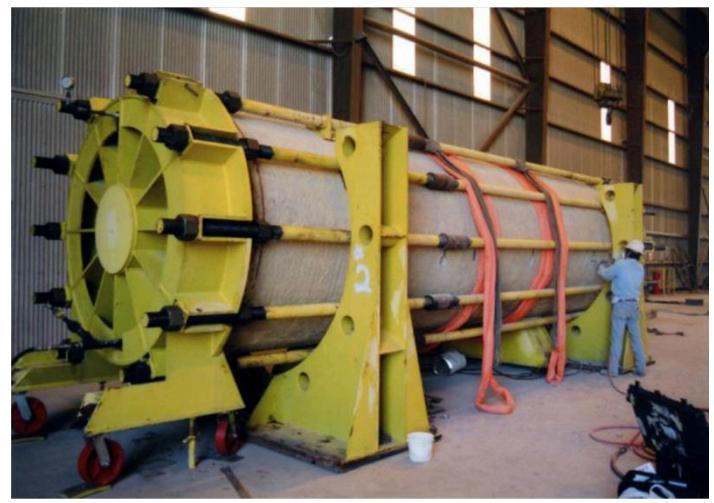
Fig. 14 SGH PCCP FEM Agency Funded Study

During the fourth year of Tucson's PPP, nine agencies teamed up to support a game changing research project that would approximate the remaining useful life of PCCP containing broken or damaged wires. The study would lead to the widely adopted and used "risk curves" or "failure curves" often used in the industry today to predict remaining useful life of one stick of pipe (Figure 13). The team included Tucson Water, Metropolitan Water District of Southern California (Metropolitan), Palo Verde Nuclear Generating Station, Calleguas Municipal Water District, Central Arizona Project, Tarrant Regional Water District, San Diego County Water Authority, and Denver Water. The team entered into a contract with Simpson Gumpertz & Heger Inc (SGH) for a study on "*Predicting Strength of Prestressed Concrete Cylinder Pipe with Broken Prestressing Wires*". The American Pressure Pipe Association had funded the cost of hydrostatic pressure testing of pipes with broken wires (Figure 14).

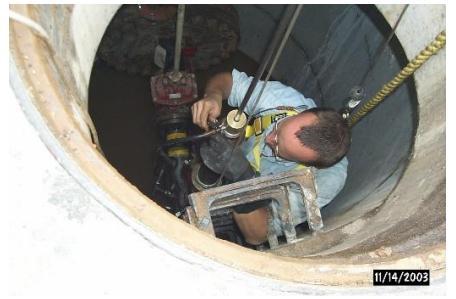
Fig. 18 Hydrophone Installation

During the seventh year of Tucson's asset management program for PCCP, acoustic fiber optics (AFO) technology was introduced to the North American industry (Fig. 19 and Fig. 20). This was another tremendous technological advancement to the industry and to Tucson's Pipeline Protection Program (PPP). The AFO permitted Tucson and other owners to monitor the health of its PCCP, and record any wire breaks that may occur in real time. Now, for the first time Tucson was able to combine nearly real-time wire break events, with the historical baseline of wire break events detected by EM, apply a risk curve for the particular design of PCCP, and start estimating the pipe's remaining useful life. With this important integration of technology, Tucson had all the right tools to manage its PCCP inventory. Tucson replaced its 2003 era hydrophone inventory with AFO (Figure 18).
