### **Stability of the Galveston Seawall**

### Sand-Filled Geotextile Tubes

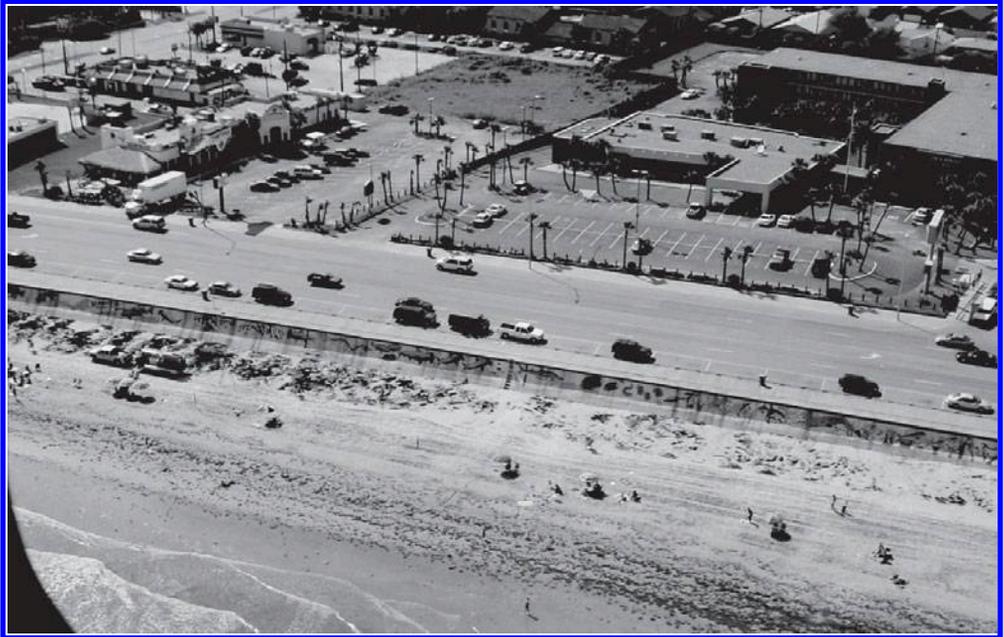
Figure 5-11 shows the condition of the Galveston Seawall before Hurricane Ike. It can be seen that behind the wall is Seawall Boulevard which has a sidewalk on either side. The paved area is in general sloped seaward to allow overtopping water to escape without running through the city.

*Figure 5-11. Condition of Galveston Seawall before Hurricane Ike*
