## REHABILITATION TECHNOLOGY SELECTION

## Narragansett Bay Commission Rehabilitation of Large Diameter Brick Sewer with Geopolymer Mortar

### 1. ABSTRACT

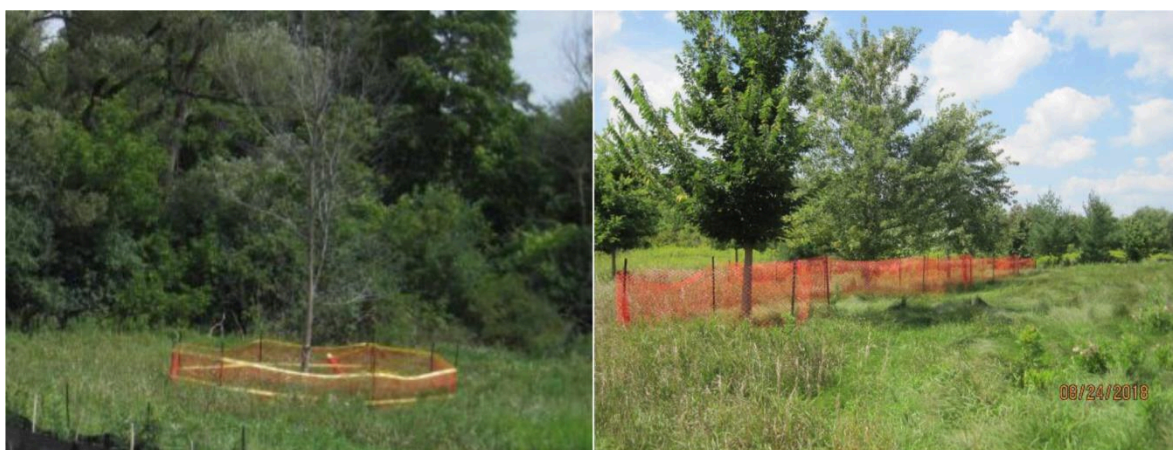
**Figure 3: Examples of temporary tree protection measures**

existing trail infrastructure where available and minimized disturbance to vegetation to the fullest extent possible by utilizing temporary wooden mats to extend access roads where trail networks did not exist. Erosion and sediment control measures were employed prior to construction, including heavy duty silt fences and filter socks, in order to prevent any migration of sediment into the creek. Tree protection measures (Figure 3) were implemented throughout the project to provide protection zones around the trees and eliminate the potential for impact of any rehabilitation operations. Given that Area 5 is identified as an Ecologically Significant Forest, measures were implemented to minimize or eliminate disturbance altogether on the trees.

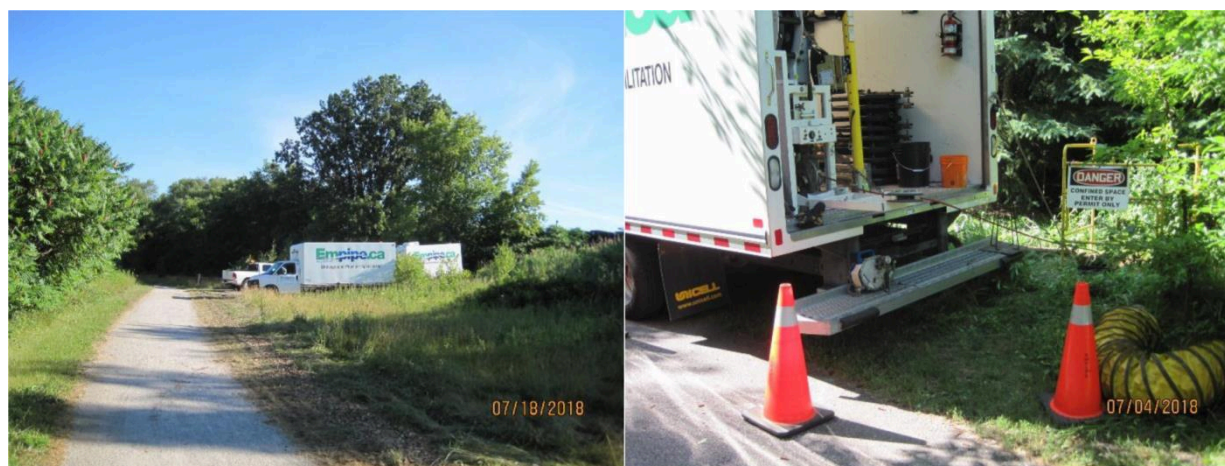
**Figure 4: Typical equipment mobilizations on municipal walking tails**

Several of the sewer sections that required rehabilitation were located within forested areas and flood plains, where the only access to the maintenance hole was by way of municipal trails and pathways, shown in Figure 4.

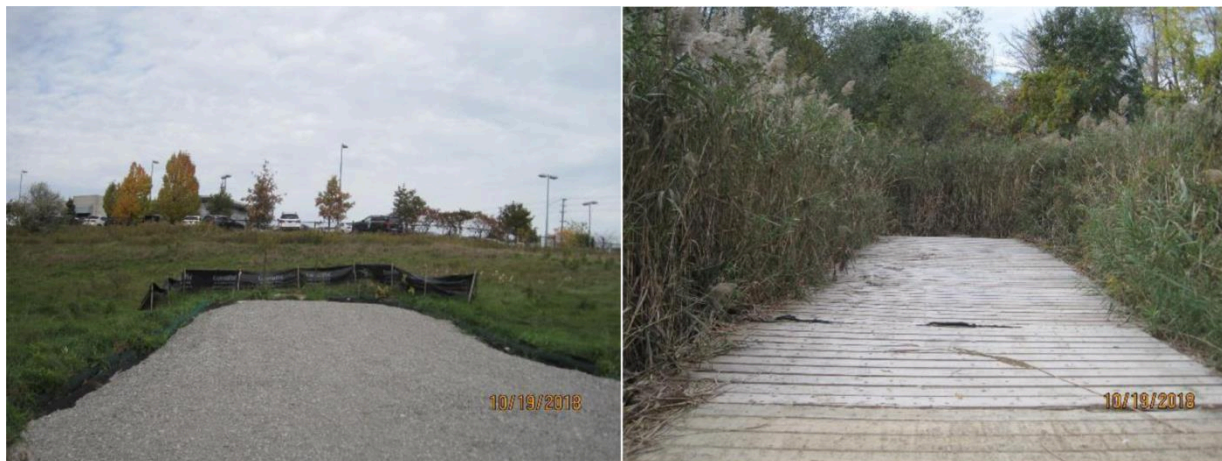
**Figure 5: Temporary gravel access road (left) and swap mat installation (right)**

Two methods of temporary access road construction were utilized, depending on conditions: i) gravel access roads were used for manicured grassy areas, and ii) wooden swamp mats were used for natural meadow areas and areas with wet soil conditions (Figure 5). The temporary construction access roads consisted of laying a non-woven geotextile fabric, minimum 12 inches (300 mm) depth of 2 inches (50 mm) limestone at 13 feet (4 m) width, lined with the installation of sediment control logs and heavy-duty silt fence barriers. Following the removal of the access road, the affected areas were restored with compost seeding in accordance with York Region requirements and restoration occurred immediately following removal of the road. If the time of year did not allow for sufficient germination prior to or during winter months, all disturbed areas are required to be covered with erosion control blankets until such time when vegetation can be established (i.e., following spring). The wooden swamp mats used for this project were 8 feet (2.5 m) length by 14 feet (4.3 m) wide, by 5 inches (0.13 m) thick and provided zero ground disturbance where the ground vegetation or marsh-like areas were not suitable for the installation of an access road. Temporary access roads and swamp mats were used to preserve the ground from access by heavy vehicles that enabled sewer cleaning and sewer rehabilitation installation crews and associated heavy equipment to reach their destination safely and reliably with minimal impact to the natural environment.
