## Anatomy of Glass Damage in Urban Areas during Hurricanes

K. Butler<sup>1</sup>, A. Kareem<sup>2</sup>

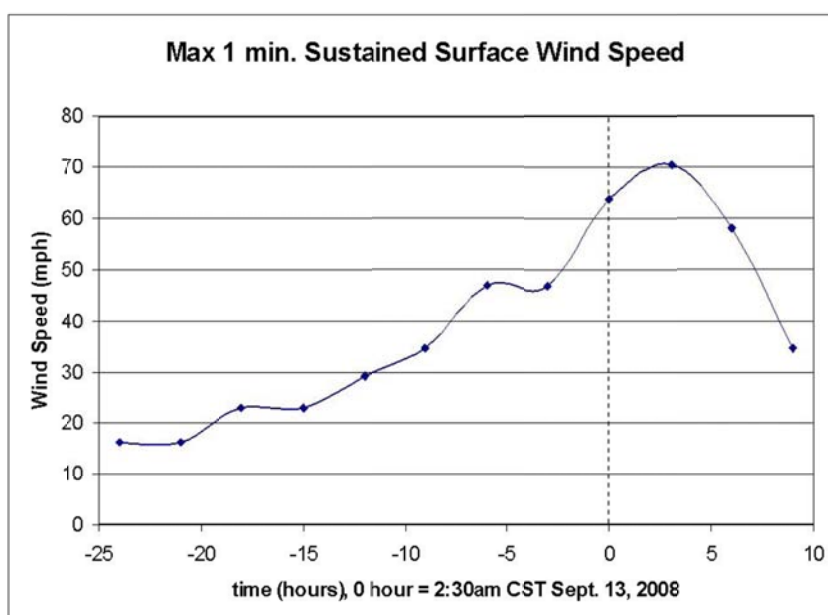
According to the available information as recorded by the weather instrumentation at Houston's George Bush Intercontinental Airport and the NOAA H\*Wind Project surface wind analysis (National Oceanic and Atmospheric Administration 2008), the eye of Hurricane Ike approached and bypassed the downtown Houston area between 2:30am and 5:30am (local time), on September 13, 2008. At that time, Hurricane Ike was a category 2 storm. The winds were identified to be predominantly blowing from a north-to-northwest direction, having one minute sustained wind speeds of 70mph (approximately 85mph in terms of 3 second gust), well below the 107mph (exposure C) 50-year design hurricane wind speeds for the region (based upon ASCE 7-05). The winds for 20-year return period design are approximately 97mph. Therefore, winds during Hurricane Ike were probably below even a 20-year return period event. An approximate time line of the surface wind speeds for the Houston CBD is shown in Figure 1.

Figure 1: Time history of surface wind speeds acquired from NOAA H\*Wind.

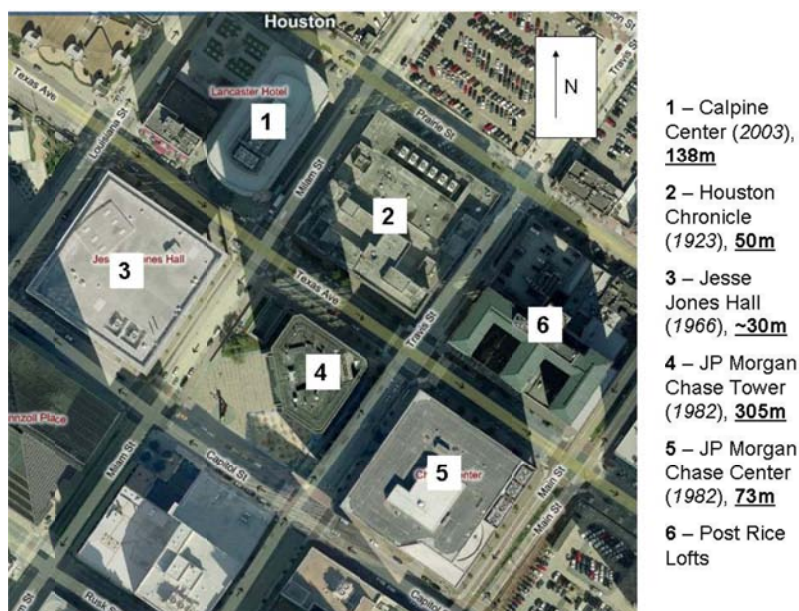
The JP Morgan Chase Tower is situated in the CBD of Houston, TX. The building is roughly prismatic in shape with a truncated corner facing northwest, giving the structure five surfaces. The layout of the buildings in the immediate vicinity of the JP Morgan Chase Tower (JPMCT) is shown in Figure 2. The JPMCT was built in 1982 along with the Chase Center, a complementary building that houses other offices and parking facilities, located on the opposite side of Travis Street. Field observations following Hurricane Ike revealed that the damage to the JPMCT was primarily focused on the lower third of its face adjacent to Travis Street and the

Figure 2. Layout of structures within Houston CBD.
