**Claro, Pisco, Cell Site (S13.7103, W76.2045)**

**Telefónica, Ica City, Central Office and Cell Site (S14.0666, W75.7289)**

**Cell Sites Near Paracas (S13.8214, W76.2443)**

### **Telefónica Cell Site Outside of Ica City**

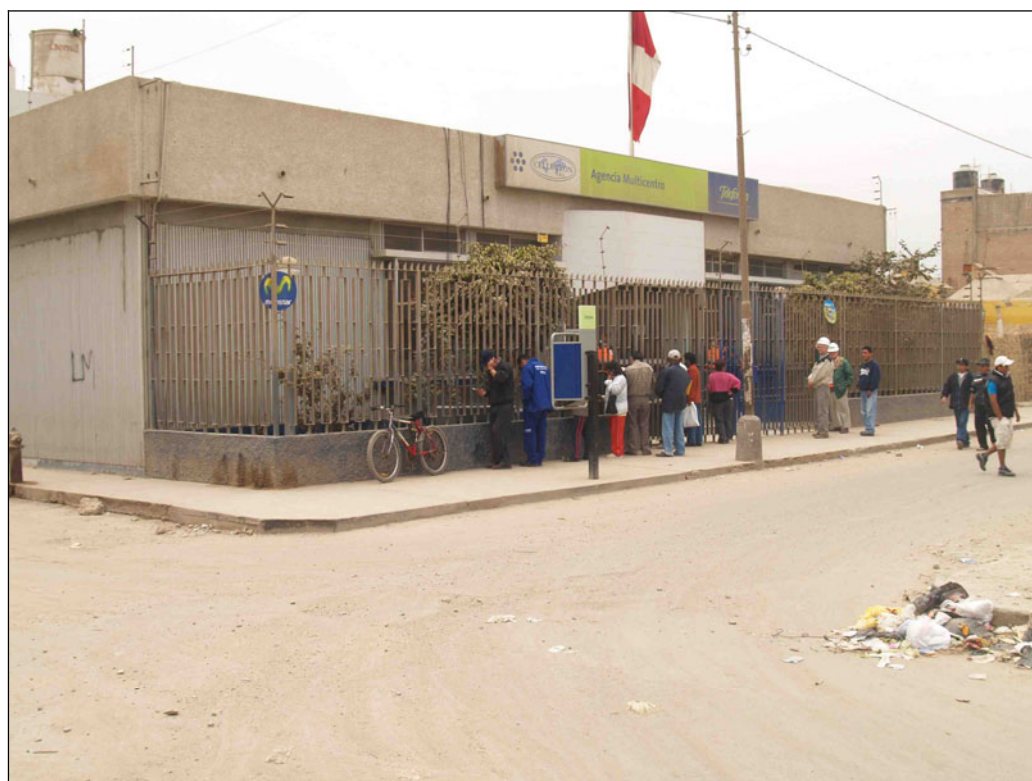
*Fig. 7.23. Free telephone call service provided by Telefónica in Pisco*

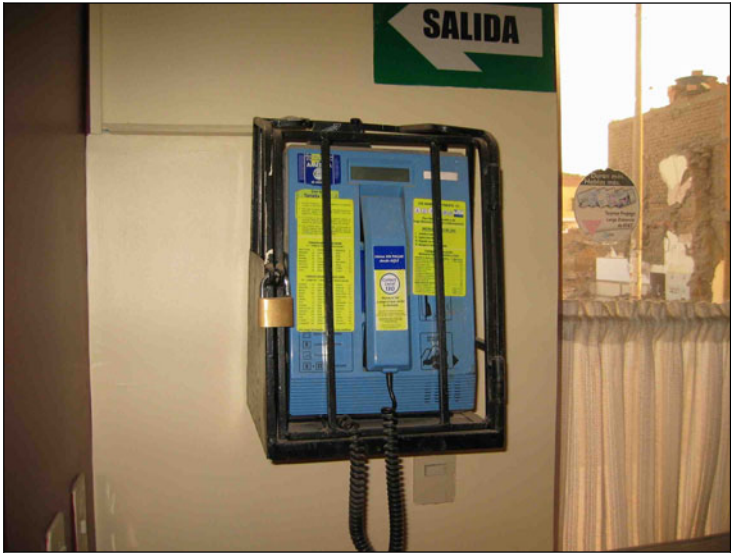
This cell site is on the roof of the eight-storey Hotel Candelobra building, which was closed due to extensive damage. There is a public phone in the hotel lobby (Fig. 7. 24), which seems to be a rare item in Pisco.

*Fig. 7.24. Public phone in the lobby of Hotel Candelobra, Pisco*

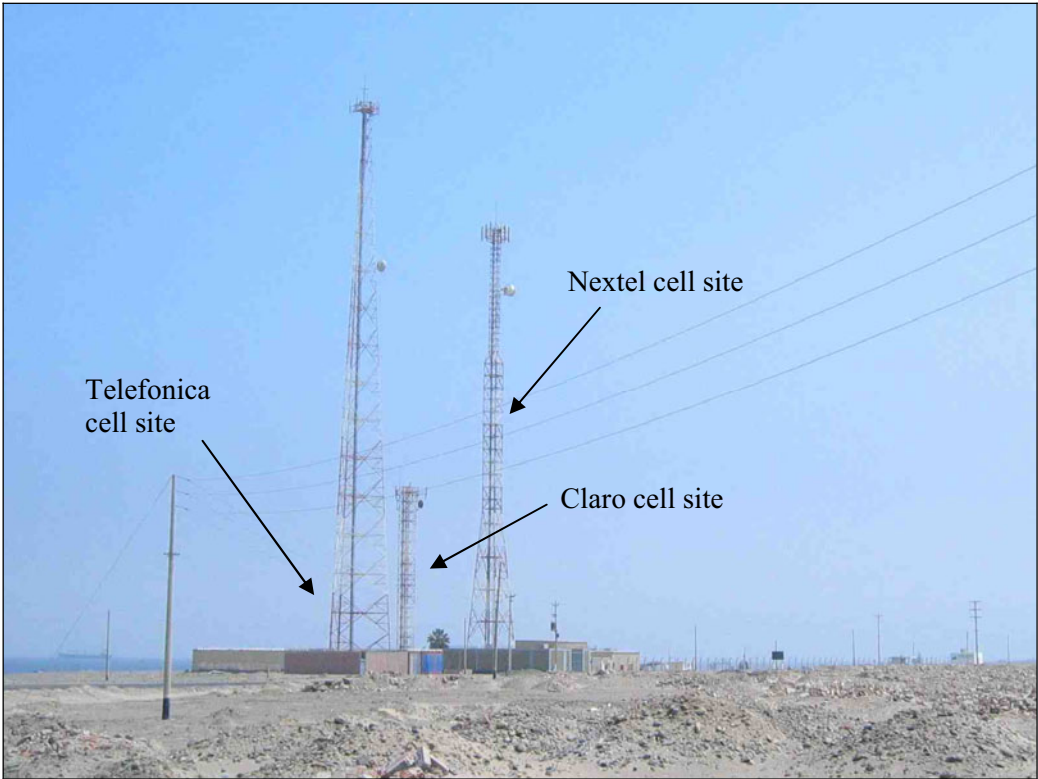
The cell sites of Telefónica, Nextel, and Claro are located very close to each other on the west side of the highway leading to the Port of San Martín (Fig. 7.29). This location is less than 1 km from the coast. These cell sites were built on sandy ground. We did not observe any signs of ground deformation or liquefaction. The only damage observed was the wall above the doorway of the Telefónica cell site (Fig. 7.30).

The equipment was anchored to a concrete pad. The power equipment was anchored to two steel beams that were secured to the concrete pad by four U-shape brackets (Fig. 7.31). This installation method is typical of the other cellular service providers. The only difference is the design of the antenna towers (Fig. 7.29).

*Fig. 7.29. Three cell sites near Paracas along the coast south of Pisco*
