### 3.1 Tsunami Overtopping without Structural Failure

### **3.2 Tsunami Overtopping with Structural Damage or Failure**

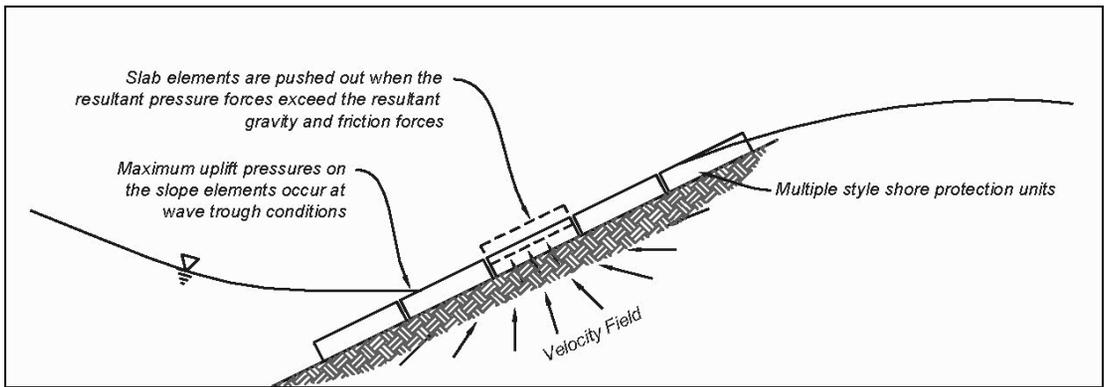
Figure 27. Hydrostatic uplift forces

When tsunami waves completely or partially submerge a structure, or when they pass underneath a structure resulting in entrapment of the waves on the underside of the structure (i.e., bridge decks, piers), the structure experience uplift forces due to the hydrostatic buoyancy including effects of excessive pore pressure and hydrodynamic forces. The hydrodynamic forces result from the vertical difference in the dynamic pressure forces over the surface of the structure, and the Bernoulli (aerodynamic) effect as water flows around the structure (Figure 27). The uplift forces reduce the structure’s total effective dead weight, which may affect the structure’s resistance to overturning and sliding (Figure 28). Excessive tsunami-induced uplift forces can lift a structure from its foundation, especially when the structure does not have sufficient anchorage. Figures 29 – 35 show examples of structures subjected to tsunami uplift forces.

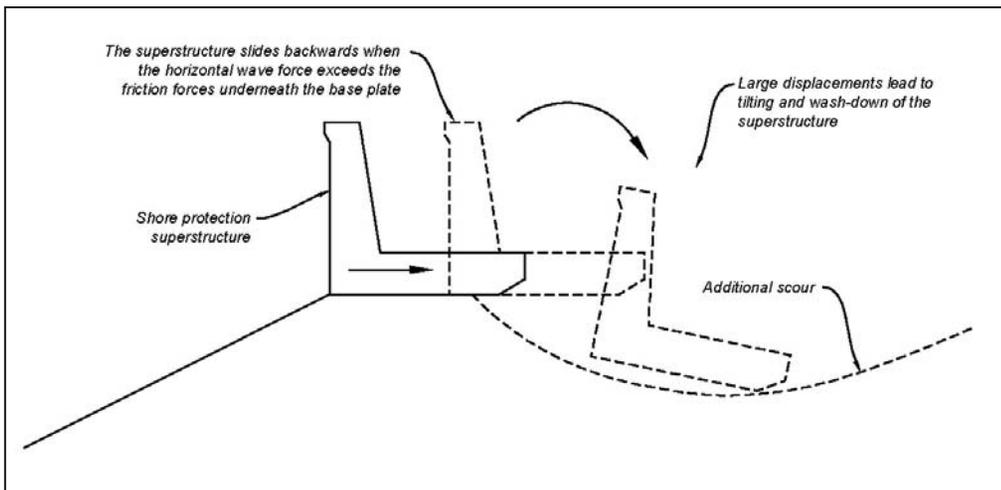
Figure 44. Structural displacement, sliding, rotation, and movement

Structures submerged or partially submerged during tsunami inundation are subjected to hydrostatic pressures (see Figure 27). The net hydrostatic force in the vertical direction, the buoyancy force, is equal to the volume of the fluid displaced by the structure times the specific weight of the fluid. The buoyancy force reduces the total dead weight of a structure and therefore reduces its resistance to sliding and overturning. A difference in the hydrostatic pressures in the horizontal direction, acting on the front and back surfaces of the structure, creates a net lateral pressure force, which will also impact the stability of the structure and its resistance to movement. Figure 44 shows this failure mechanism. Figures 45 – 50 show examples of structures that failed due to this mechanism.
