The Effects of Poor Design and Construction Workmanship on a Mechanically Stabilized Earth (MSE) Segmental Retaining Wall (SRW) in North Carolina

Antonios Vytiniotis, Ph.D., P.E., M.ASCE¹; David W. Sykora, Ph.D., P.E., D.GE, M.ASCE²; and Brendan Casey, Ph.D., P.E., M.ASCE³

A two-tiered mechanically stabilized earth (MSE) segmental retaining wall (SRW) system with a maximum height of approximately 90 feet along its curving, concaved section was built at a new residential development near Asheville, North Carolina, in 2011. The two-tier section of the wall was approximately 400 feet in length where the upper wall was nested within the lower wall to account for a topographic depression and the site-specific grading. During the last layers of fill placement of the two-tier portion, substantial bulging, vertical deformations, and cracking along the face blocks of the wall were observed. As a result, the owner of the wall decided to demolish a significant portion of the upper wall. A detailed field investigation was performed, before and during the wall removal, to evaluate the as-built conditions of the MSE/SRW wall and to assess the potential factors that contributed to the observed

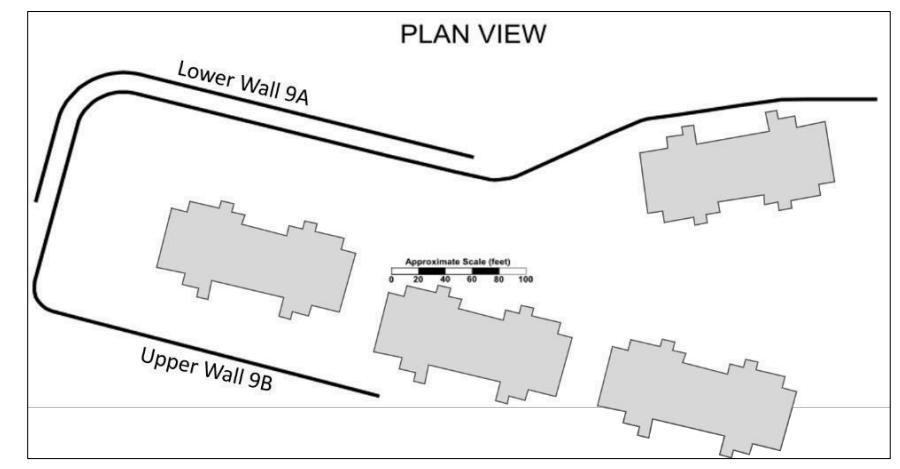
For Buildings 4 and 5, a two-tier MSE/SRW wall was planned as shown in Figure 1. Wall 9A ("Lower Wall") varied in height from 4 to 48 feet and was approximately 400 feet long. Wall 9B ("Upper Wall") varied in height from 4 to 50 feet and was approximately 1,050 feet long. Construction for Wall 9A started approximately on May 19, 2010.
