4.12 Masonry Barrel

4.12.1—Purpose

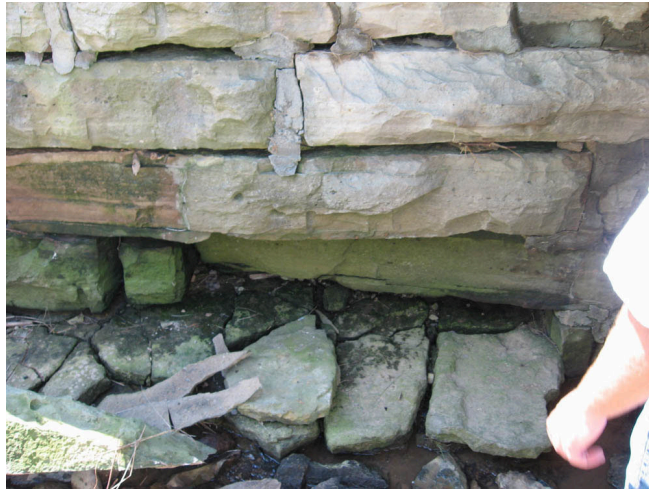
The individual stones, bricks, or blocks should be checked for displaced, cracked, broken, crushed, or missing units. For some types of masonry, surface deterioration or weathering can also be a problem and can cause spalling.

Figure 4.12.2-1—Missing Units in Masonry Barrel Wall with Cracked and Missing Mortar

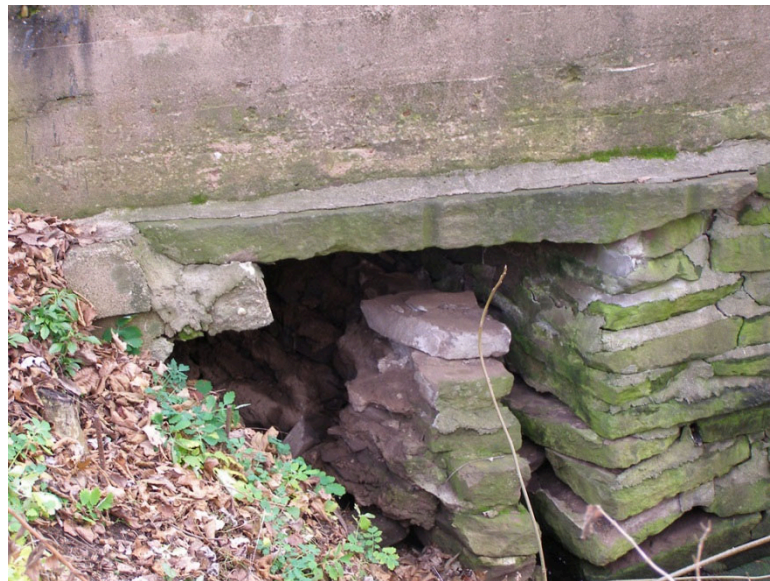
Movement of individual or grouped masonry units may occur due to freeze–thaw action, vegetation growth, mortar deterioration, or stress. The Inspector should identify loose or dislodged units.

Figure 4.12.2-2—Structure Condition is Severe and Unstable Due to Movement of Foundation Wall

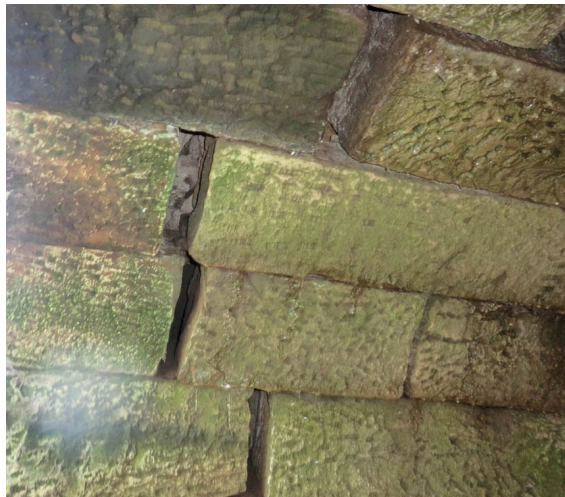
In most masonry arch culverts, mortar is used to bond the masonry units together. The condition of the mortar should be checked to ensure that it is still holding strongly. It is particularly important to note cracked, deteriorated, or missing mortar especially if other deterioration is present such as loose or missing masonry units. The presence of dirt or vegetation between masonry units should be noted as these can be indicators of loss of backfill or erosion behind the structure. Water infiltration can also contribute to mortar distress in cold climates as freeze–thaw cycles break the mortar apart.

Figure 4.12.2-3—Missing Mortar between Masonry Units

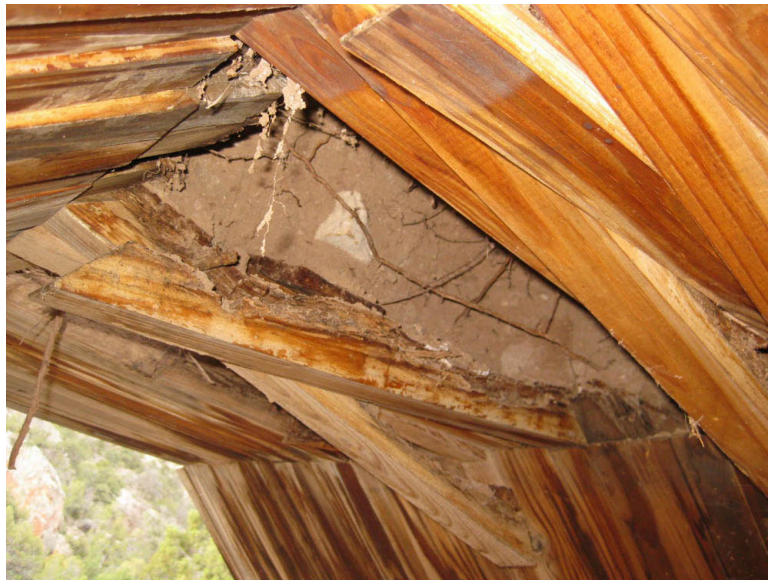
Missing members may be due to structural failure of the member or its connection, or impact from stream or ice flows. Other activities such as installation of utilities or structure modifications may remove a member in whole or part (i.e., notched or cored beam for utility conduit).

Figure 4.13.2-2—Connection Failure Causing Partial Collapse of Member and Missing Members Allowing Loss of Backfill

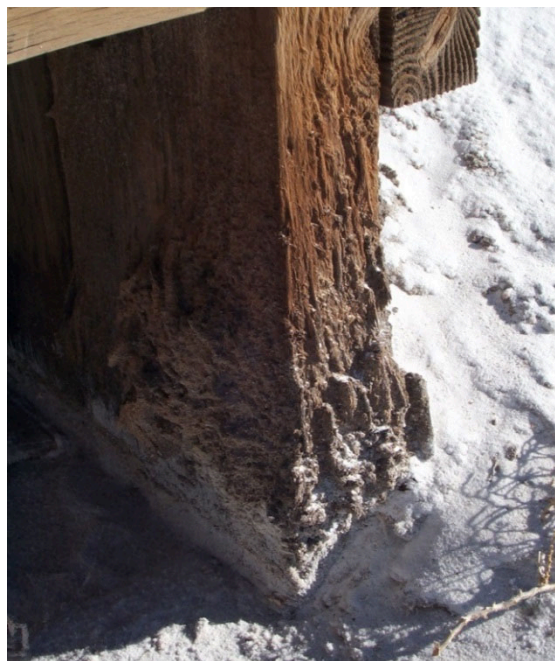
Visual inspection for decay requires good lighting and is suitable for detecting intermediate or advanced surface decay. It will not detect decay in the early stages, when control is most effective, nor will a visual inspection reveal internal decay. Consequently, visual inspection should never be the sole method employed. Decay indicators should be sounded and probed to assess the extent of decay. Some common decay indicators include fruiting bodies, sunken faces, staining or discoloration, insect activity, and fire damage.

Figure 4.13.2-3—Decay on Timber Culvert Member near Ground Level

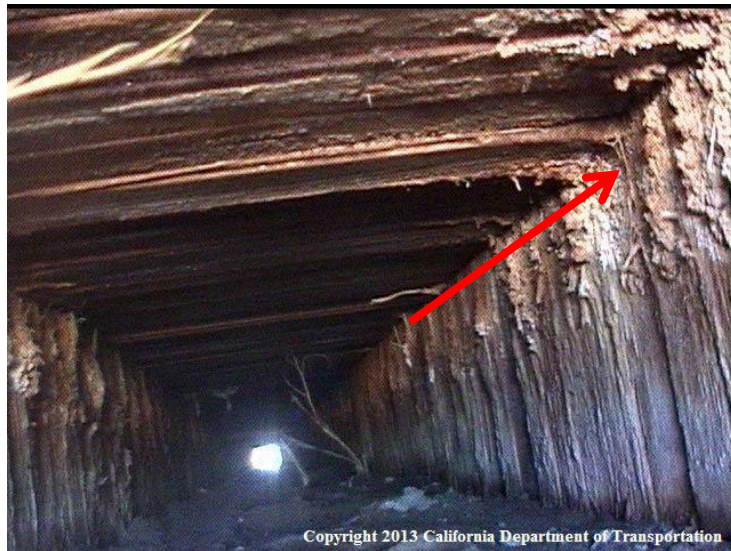
club-shaped fungi. Fruiting bodies provide positive indication of advanced fungal attack, but do not indicate the amount or extent of decay. Some species of fungi produce fruiting bodies after small amounts of internal decay have occurred, while others develop only after decay is extensive. Fruiting bodies almost certainly indicate serious decay problems when they are present.

Figure 4.13.2-4—Fruiting Bodies on Timber Culvert Members

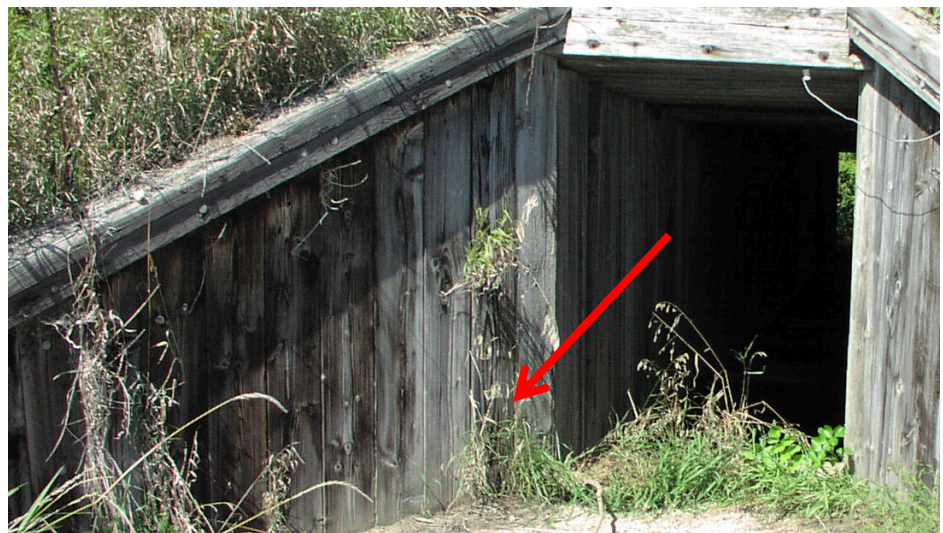
Sunken faces or localized surface depressions can indicate underlying decay. Sunken faces occur when a thin layer of intact or partially intact wood forms a depression over voids or pockets near the surface of the member.

Staining and discoloration are indicators of potential decay. Members with staining have been subjected to water and potentially high moisture contents and stained areas may mean conditions are suitable for decay. Rust stains on a member face may indicate wetting-induced deterioration of the connection hardware. These areas should be noted for future monitoring.

Figure 4.13.2-5—Staining and Sunken Faces on Timber Culvert Members

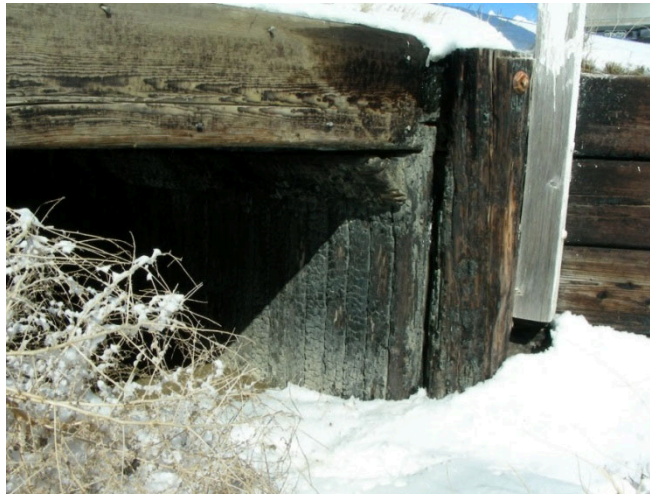
The extent of any charring and fire damage should be noted by the Inspector. Large wood members often retain structural strength after fire damage and an in-depth inspection by an Engineer is required to determine the residual capacity or to design for repair or replacement.

Figure 4.13.2-6—Fire Charring on Timber Culvert Members

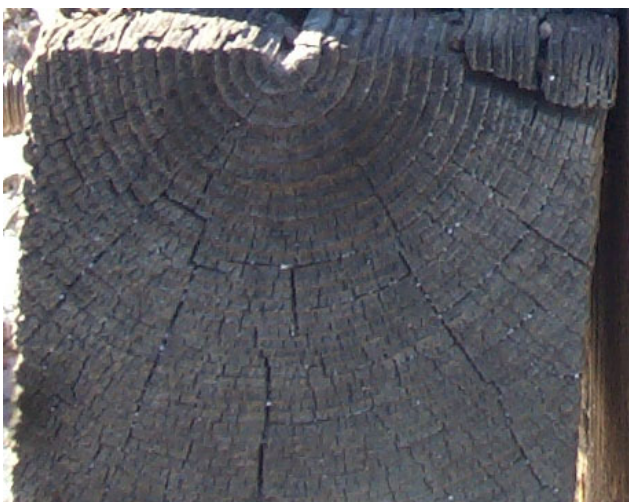
Checks are shrinkage cracks that occur along the radius of solid sawn timber, usually perpendicular through the growth rings. Checks can be seen along the face of members and are typically not a structural problem as they are accounted for in the engineering design values for strength. Severe checking at connections can weaken the ability of fasteners to carry load and should be flagged during inspections.

Figure 4.13.2-7—Checks in Timber Culvert Member
