Prestressed Carbon Strands Utilized in Repair of Football Stadium Ramp

by C.R. Alburn and C.W. Dolan

Synopsis: Prestressed concrete planks using CFRP tendons were used to replace badly deteriorated hollow core planks for the access ramp to the University of Wyoming football stadium. The test program for the planks is described followed by the issues associated with the construction and installation of the replacement planks. The planks have been in service for five years and no signs of deterioration have been observed.

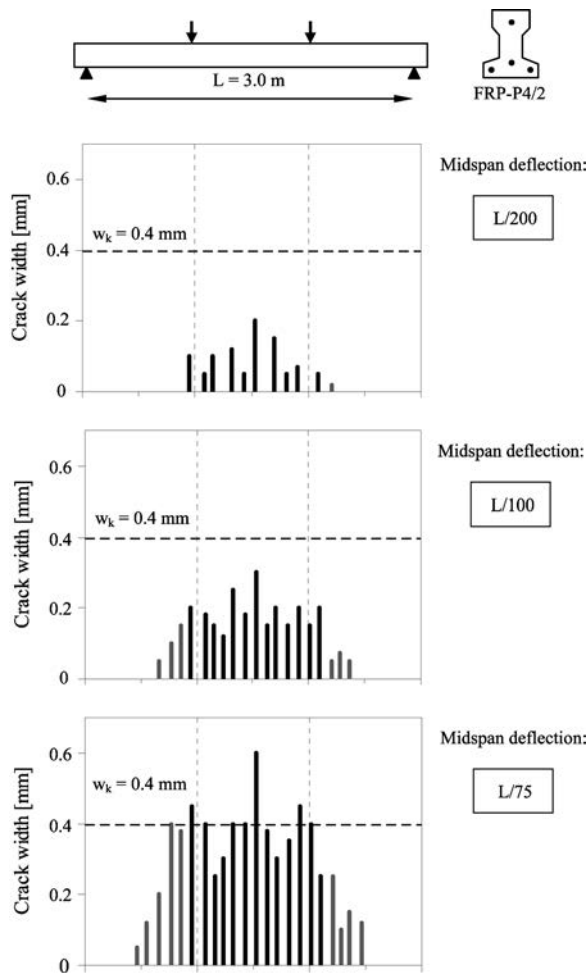
Figure 7—Crack pattern of test beam prestressed with four FRP wires to various midspan deflections $L/200$, $L/100$, and $L/75$. Note: Designation of beam is given in Table 2. Columns in diagrams represent observed cracks, height of columns represent measured crack widths.

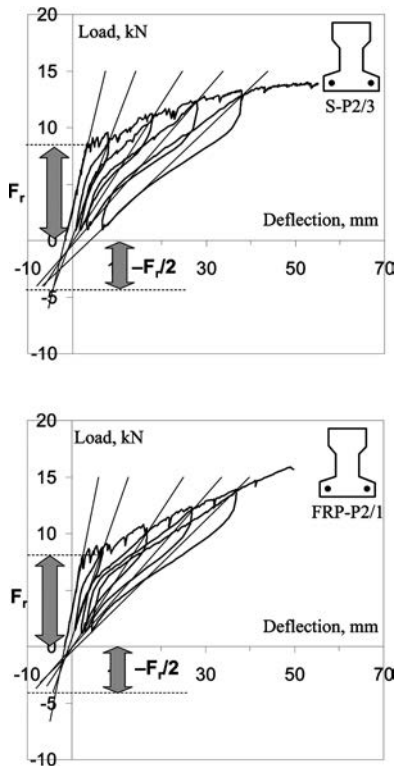
Figure 12—Pivot hysteresis behavior under repeated loads, low reinforcement ratio.
Note: Designation is given in Table 2.

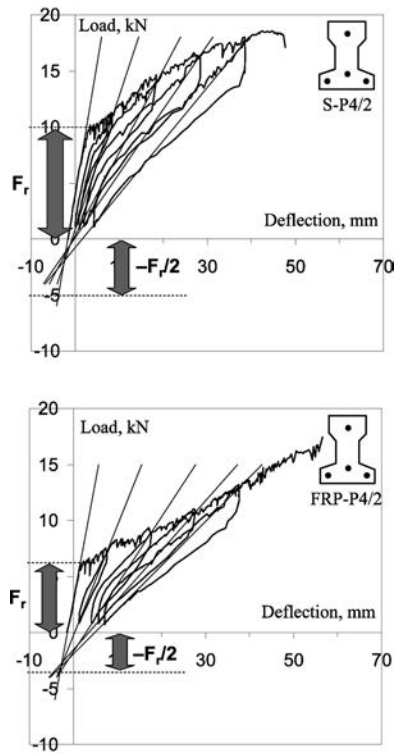
Figure 13—Pivot hysteresis behavior under repeated loads, higher reinforcement ratio. Note: Designation is given in Table 2.
