## Deep Power Compaction Vibro-Compaction Testing Program at Treasure Island

### Abstract

The full-scale densification testing program and corresponding results presented in this paper are part of a multi-phase geotechnical study for the Treasure Island development (TID) project. Geotechnical design considerations for the project include ground improvement techniques for liquefaction mitigation, and shoreline seismic stabilization.

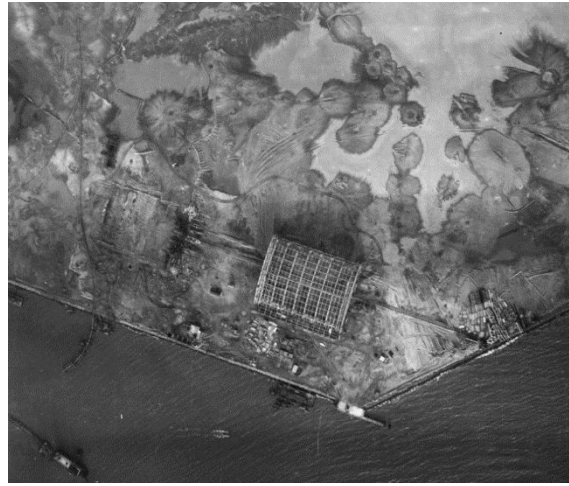
**Figure 2. Construction Photograph: Early stages of hydraulic filling (February 1936) showing distribution lines and sand cones emanating from nozzles in the lines as well as shallow pools between sand cones**

To place the hydraulic fills, sand slurry was pumped from dredges to an on-shore distribution pipe network. Sand was discharged from nozzles, typically forming depositional cones separated by shallow pools where discharged water drained away. This method commonly results in a layered sandy fill that is well washed and poorly graded in the sandy cone areas near the nozzles, with irregularly distributed lenses of clayey sand, silt and clay in areas deposited in pools between nozzles. This depositional pattern is visible in the construction photograph, Figure 2.

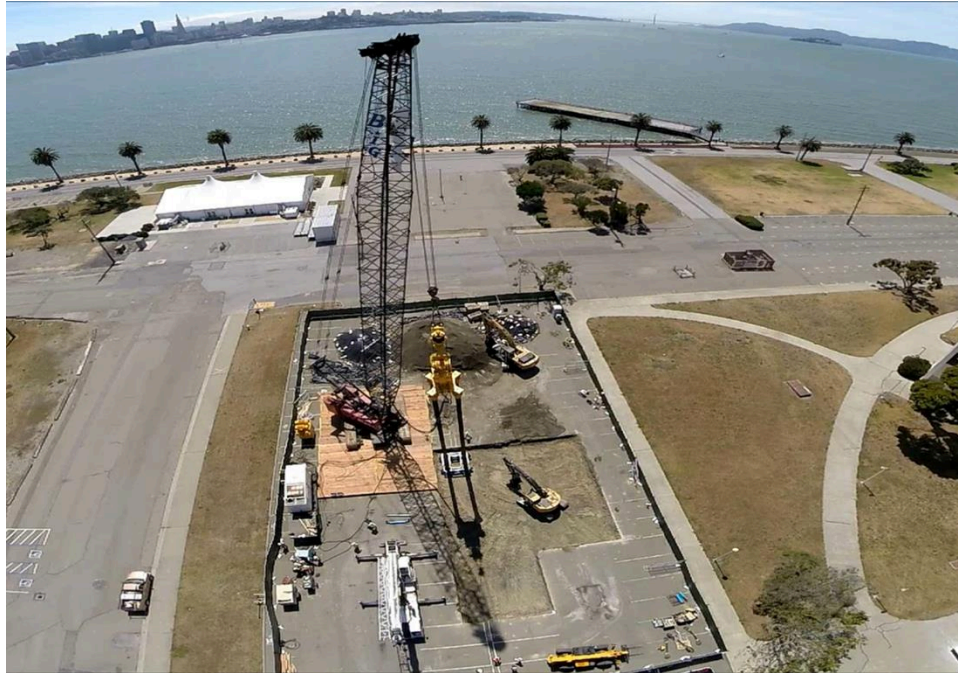
**Figure 4. DPC four-probe apparatus (JAFEC USA)**

The DPC method employed for the field test is a vibro-compaction technique widely used in Japan that densifies loose sandy soils by vibration and compaction. JAFEC USA was contracted to perform the DPC work. The DPC equipment used at the test site included a vibratory hammer suspended from a vibration isolation mount, which in turn was suspended from the main cable of a 270-ton crawler crane. The hammer was attached to four probes through a holder. Figure 4.
