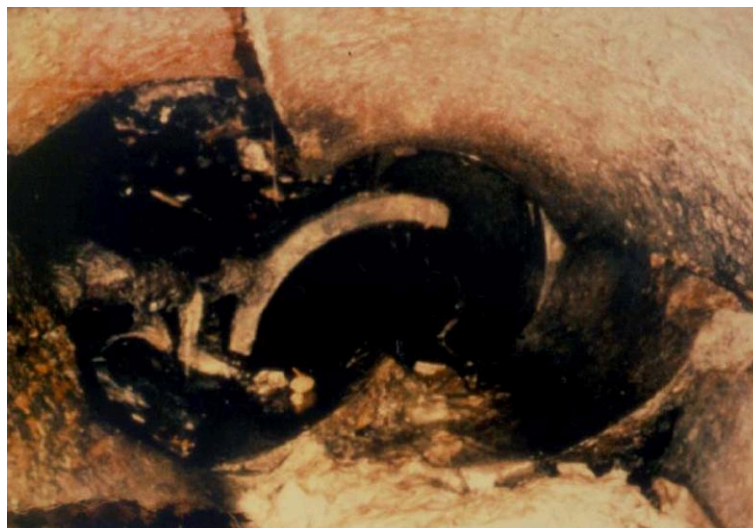
| Code | Characterisation | | Quantification | | Circumferential location | | Joint | Remarks |
|---|---|--|---|--|---|---|---|---|
| BAC | C | | 600 | | 07 | 07 | | |
| BAO | | | | | 08 | 11 | | |

Figure F.12 — Example of collapse

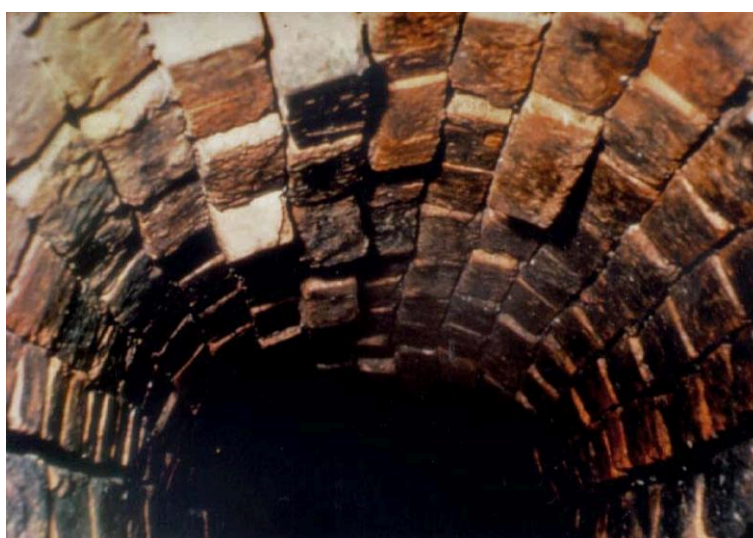
| Code | Characterisation | | Quantification | | Circumferential location | | Joint | Remarks |
|---|---|--|---|--|---|---|---|---|
| BAD | A | | | | 11 | 01 | | |
| BAE | | | | | 09 | 03 | | |

Figure F.13 — Example of defective brickwork or masonry (displaced bricks or masonry units)

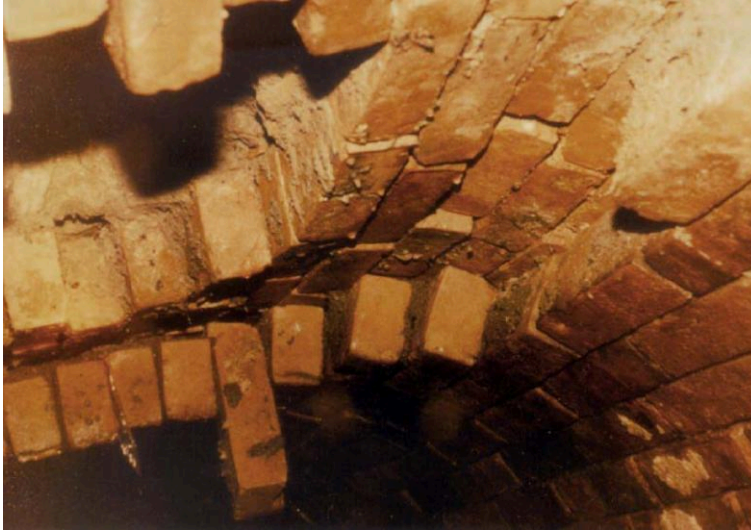
| Code | Characterisation | | Quantification | | Circumferential location | | Joint | Remarks |
|---|---|---|---|--|---|---|---|---|
| BAD | B | A | | | 11 | 01 | | Inner ring |
| BAD | B | B | | | 11 | 12 | | Outer ring |
| BAP | | | | | 11 | 12 | | |

Figure F.14 — Example of defective brickwork or masonry (missing bricks or masonry units)

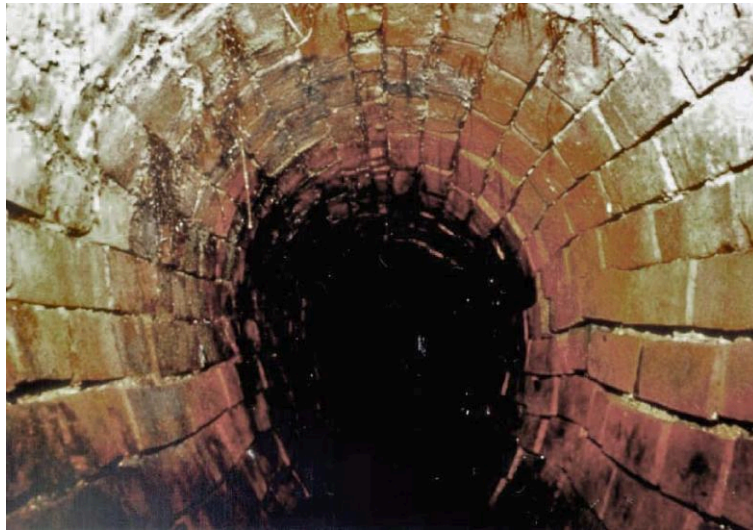
| Code | Characterisation | | Quantification | | Circumferential location | | Joint | Remarks |
|---|---|--|---|--|---|---|---|---|
| BAE | | | 15 | | 07 | 10 | | |
| BAE | | | 15 | | 02 | 05 | | |

Figure F.16 — Example of missing mortar

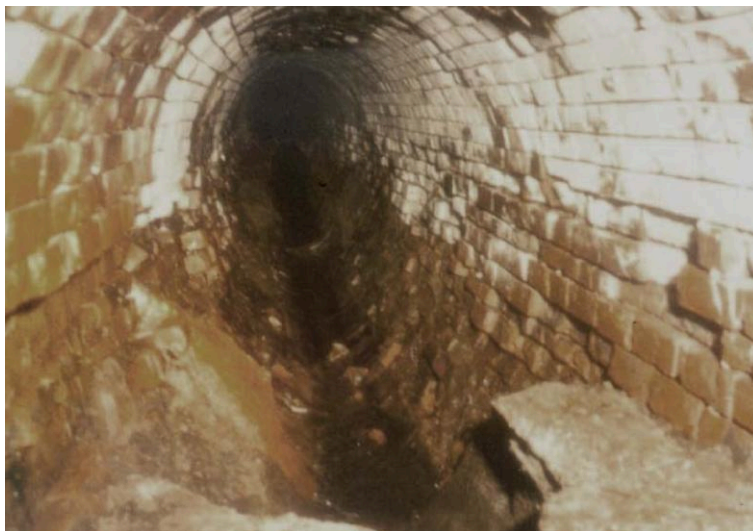
| Code | Characterisation | | Quantification | | Circumferential location | | Joint | Remarks |
|---|---|---|---|--|---|---|---|---|
| BAF | B | C | | | 07 | 05 | | |
| BBC | C | | 25% | | 04 | | | |
| BBC | B | | 5% | | 06 | | | |

Figure F.17 — Example of surface damage (spalling)

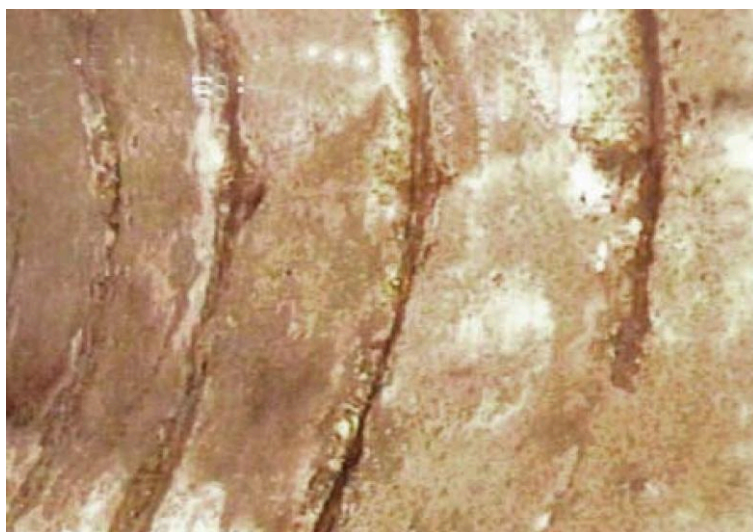
| Code | Characterisation | | Quantification | | Circumferential location | | Joint | Remarks |
|---|---|---|---|--|---|---|---|---|
| BAF | H | B | | | 02 | 05 | | |

Figure F.19 —Example of surface damage (reinforcement visible)

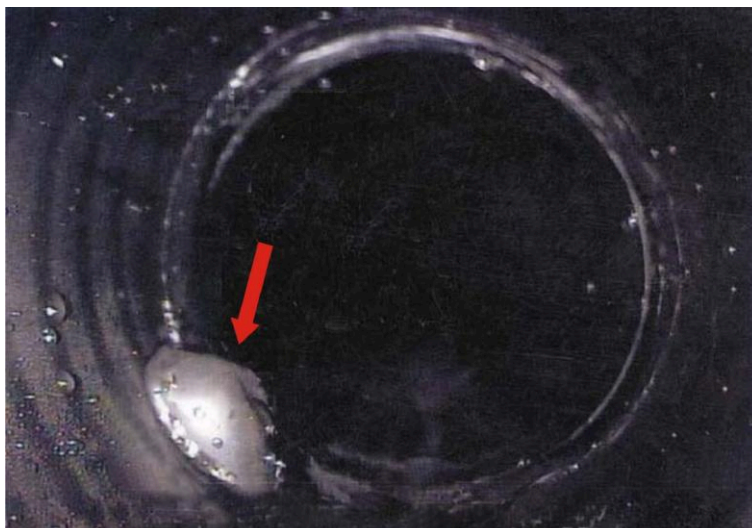
| Code | Characterisation | | Quantification | | Circumferential location | | Joint | Remarks |
|---|---|---|---|--|---|---|---|---|
| BAF | K | E | | | 07 | 08 | | |

Figure F.22 — Example of surface damage (blistering - internal bulge)

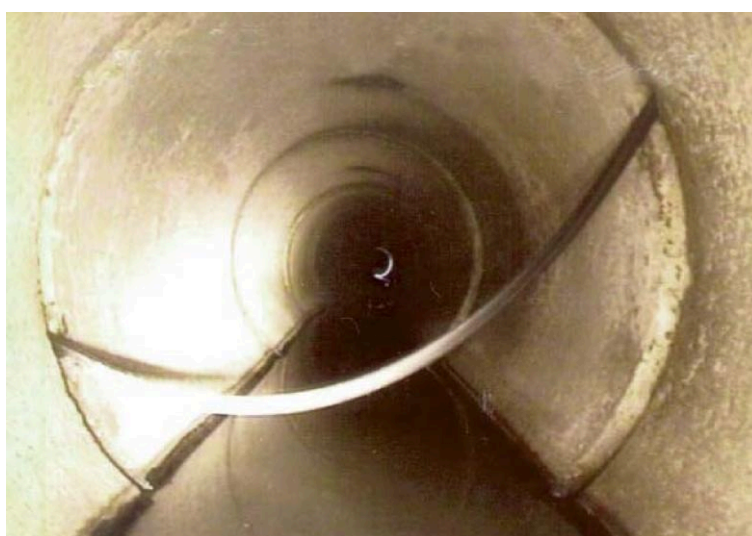
| Code | Characterisation | | Quantification | | Circumferential location | | Joint | Remarks |
|---|---|---|---|--|---|---|---|---|
| BAI | A | C | | | 09 | 02 | | |

Figure F.23 — Example of intruding sealing material (sealing ring hanging)

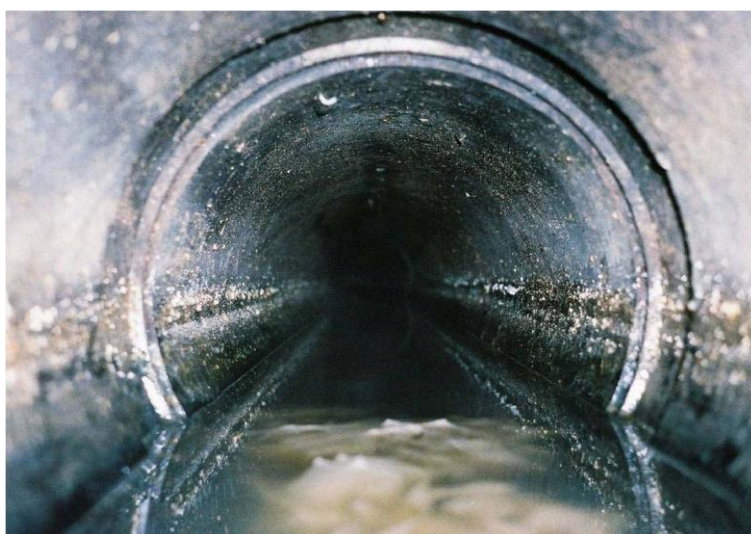
| Code | Characterisation | | Quantification | | Circumferential location | | Joint | Remarks |
|---|---|--|---|--|---|--|---|---|
| BAJ | A | | 20 | | | | A | |

Figure F.25 — Example of displaced joint (longitudinal)

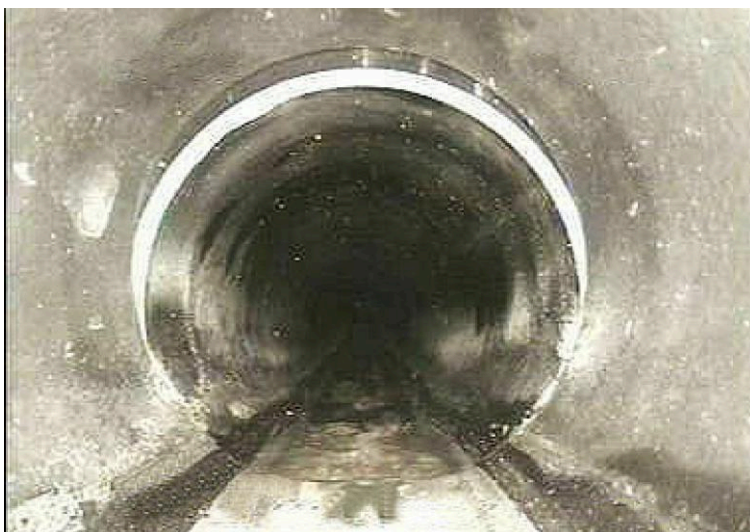
| Code | Characterisation | | Quantification | | Circumferential location | | Joint | Remarks |
|---|---|--|---|--|---|--|---|---|
| BAJ | B | | 50 | | 06 | | A | |
| BDD | A | | 5% | | | | A | |

Figure F.26 — Example of displaced joint (radial)

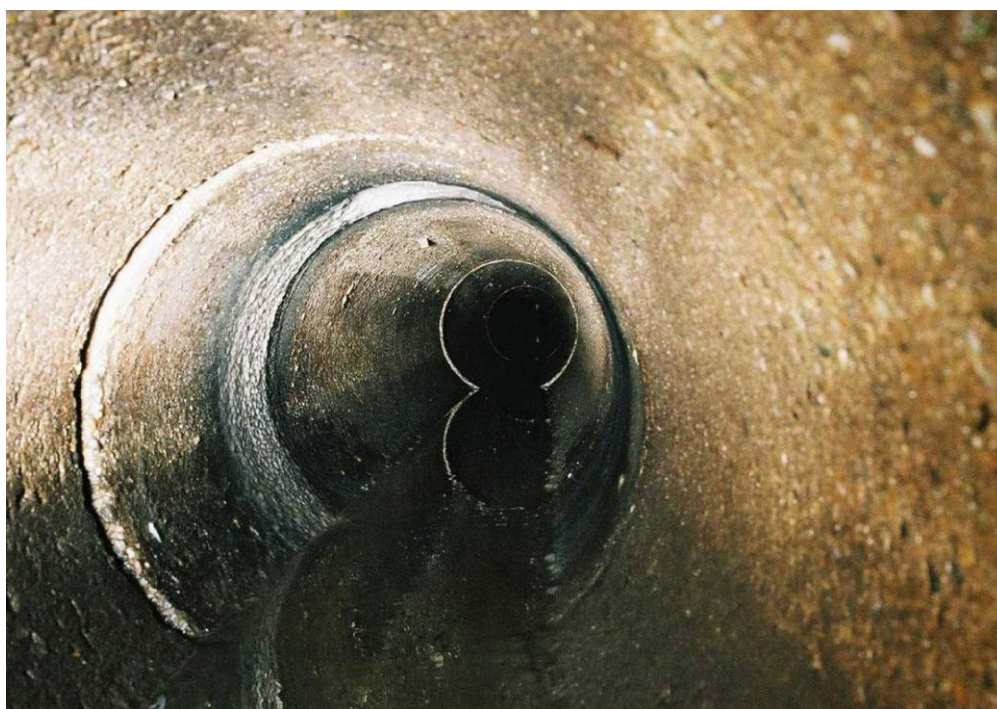
| Code | Characterisation | | Quantification | | Circumferential location | | Joint | Remarks |
|---|---|--|---|--|---|--|---|---|
| BAJ | C | | 15 | | 03 | | A | |

Figure F.27 — Example of displaced joint (angular)

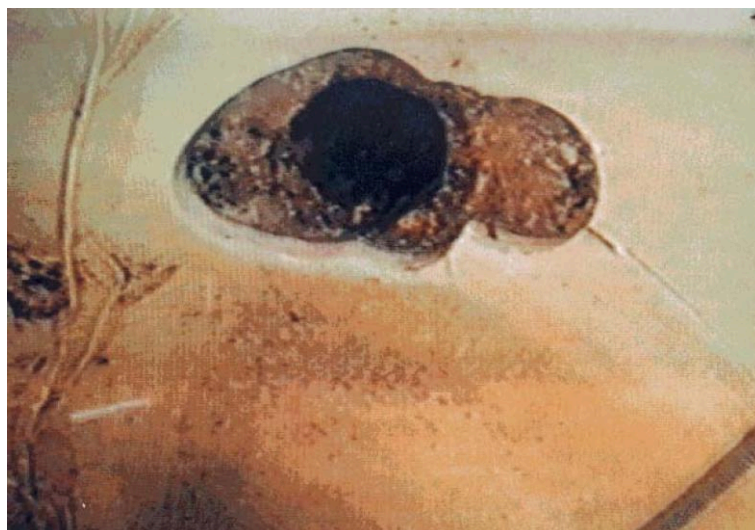
| Code | Characterisation | | Quantification | | Circumferential location | | Joint | Remarks |
|---|---|---|---|--|---|---|---|---|
| BAK | Z | | | | 01 | 02 | | Connection poorly cut |
| BAK | D | A | 5% | | 12 | 01 | | |
| BCA | F | A | 100 | | 12 | | | |
| BAH | E | | | | | | | Partially blocked by lining |

Figure F.28 — Example of lining defect (defective reopening of connection)

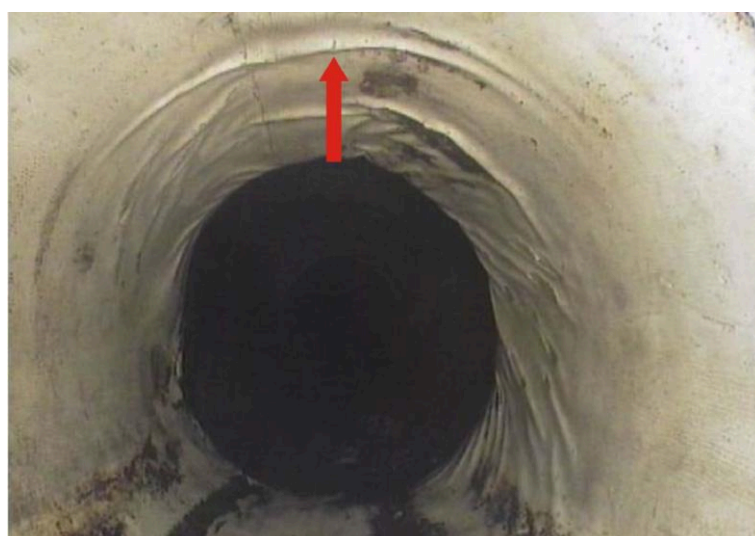
| Code | Characterisation | | Quantification | | Circumferential location | | Joint | Remarks |
|---|---|---|---|--|---|---|---|---|
| BAK | D | B | 5% | | 10 | 01 | | |

Figure F.29 — Example of lining defect (circumferentially wrinkled lining)

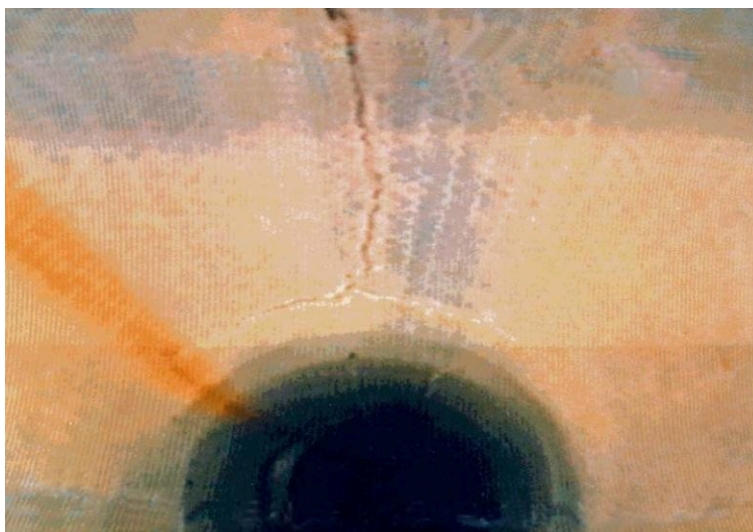
| Code | Characterisation | | Quantification | | Circumferential location | | Joint | Remarks |
|---|---|---|---|--|---|---|---|---|
| BAK | Z | A | | | 12 | | | |

Figure F.31 — Example of lining defect (crack in lining)
