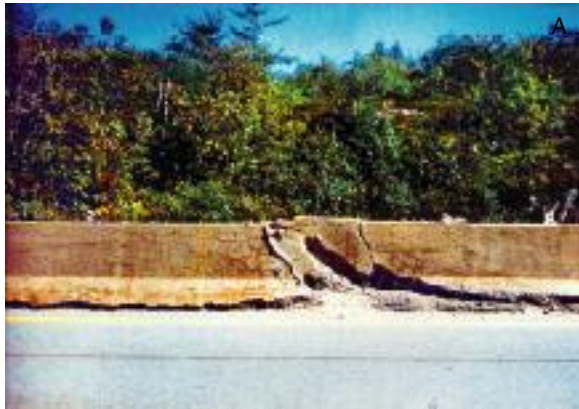
**(a)** Severe cracking and spalling of concrete due to AAR in a 20-year-old median highway barrier; freeze-thaw action has greatly influenced the extent of deterioration.

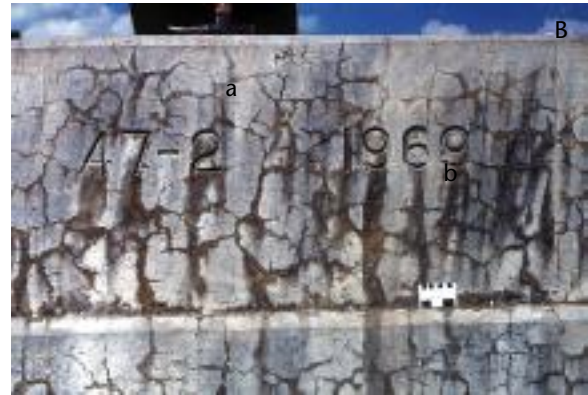
**(b)** Map-cracking due to AAR affecting the parapet wall of a 25-year-old highway bridge (a). Cracks show typical staining giving the appearance of permanent dampness (b).

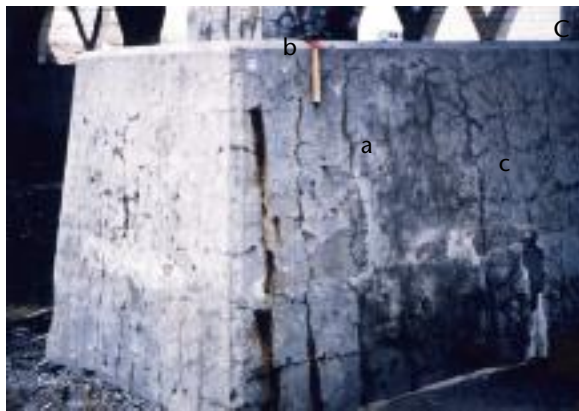
**(c)** Regular cracking pattern influenced by the presence of reinforcement in the massive concrete foundation of columns of a 25-year-old highway bridge affected by AAR (a). Cracking due to AAR accelerates deleterious processes such as corrosion of reinforcing bars (b). Gel exudations and efflorescence can also be observed (c).

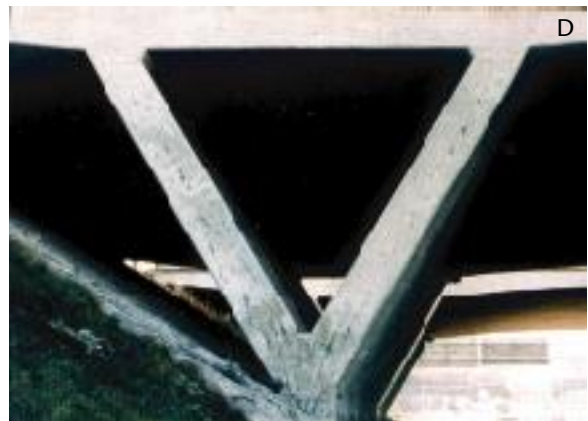
**(d)** Longitudinal cracking following the stress fields in reinforced concrete column of a 25-year-old highway bridge affected by AAR.

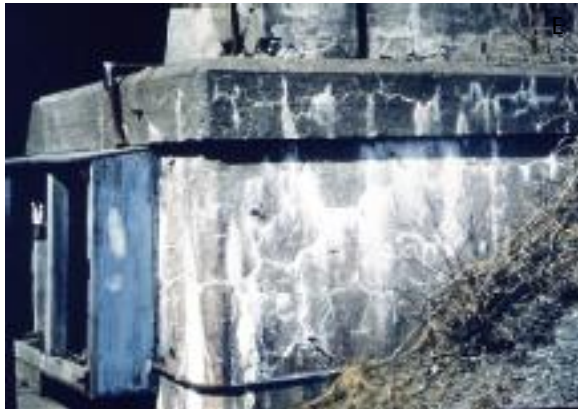
**(e)** Exudations of alkali-silica gel at the surface of a concrete foundation adjacent to a 25-year-old highway bridge.

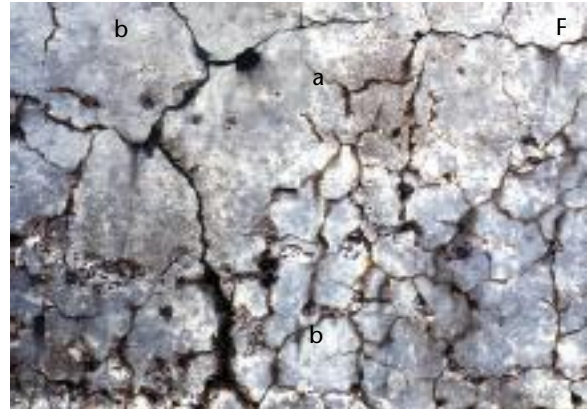
**(f)** Map-cracking (a) due to AAR. Frost-susceptible argillaceous limestone particles have caused popouts in the concrete surface (b).

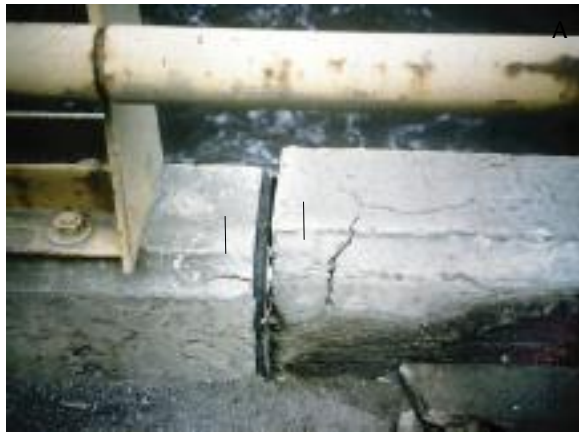
**(a)** Relative movements between pier blocks of a 15-year-old concrete dam affected by AAR; ASR cracking is also observed.

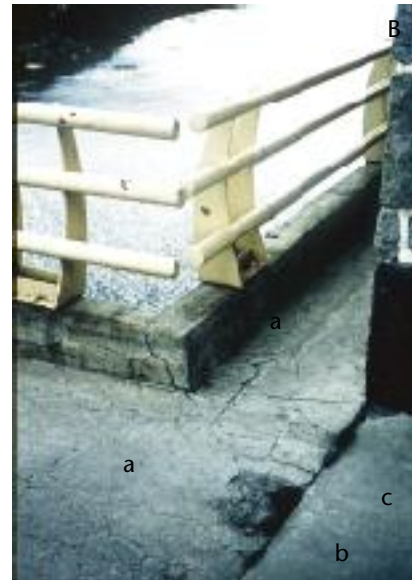
**(b)** Relative movement between a pier block shows cracks due to ASR (a) and the adjacent deck slab of the above dam causing spalling of concrete (b) and extrusion of sealing material along the joint (c).

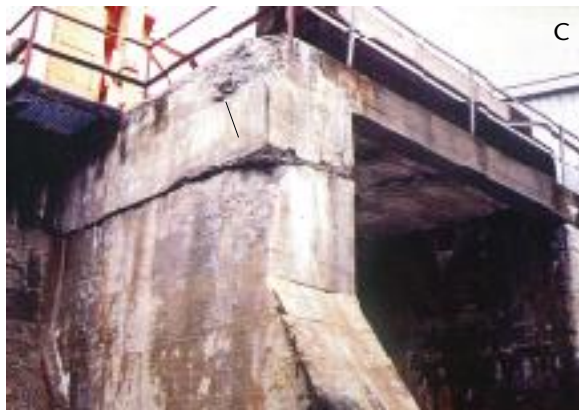
**(c)** Relative movement of a concrete pier caused by the expansive forces generated by the adjacent retaining wall (on the left).

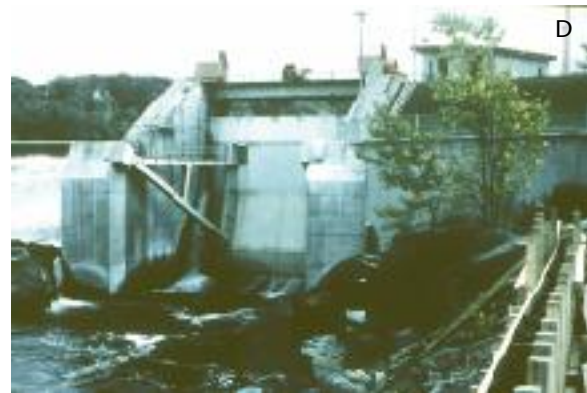
**(d)** Overview of a small concrete structure incorporating a sluice-gate.

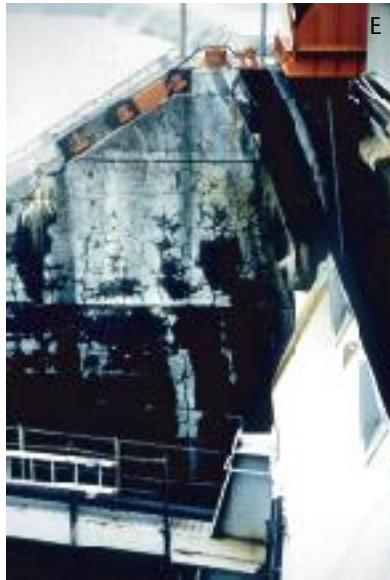
**(e)** Expansion and cracking due to AAR in a wing wall of the above structure, causing problems in operating the sluice-gate.

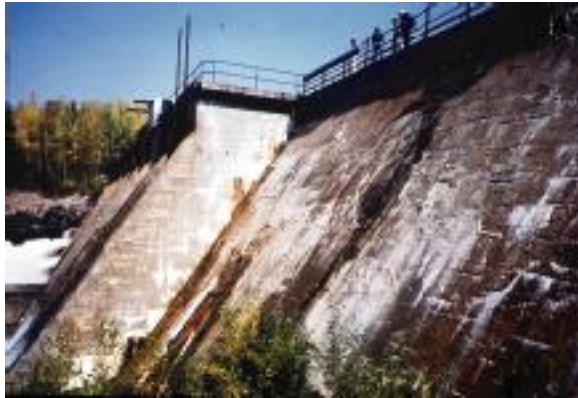
**(a)** Seepage of reservoir water along horizontal cracks and construction joints and associated leaching in a 50-year-old concrete dam affected by AAR.

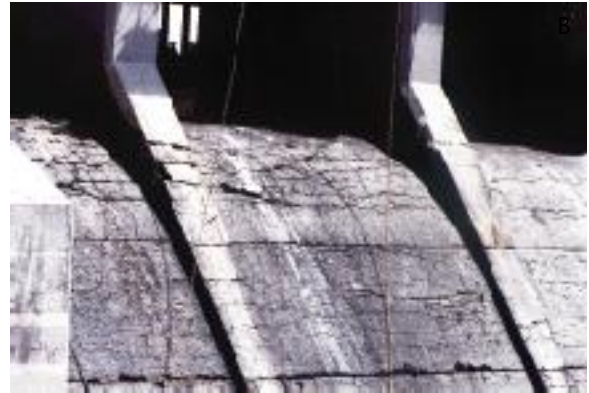
**(b)** Severe horizontal cracking in the spillway of a 15-year-old concrete dam affected by AAR.

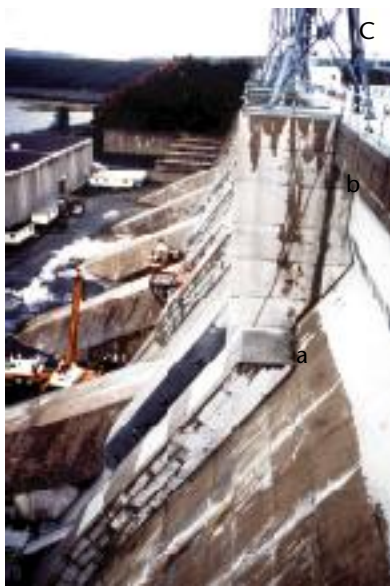
**(c)** Cracking on the downstream face (a) and in the upper part of a pier pedestal (b) of a 25-year-old dam affected by AAR.

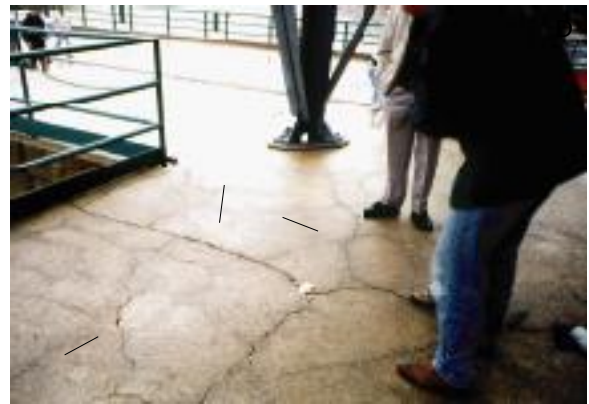
**(d)** Pattern-cracking on the top of a pier block of the dam shown in Figure 5(c).

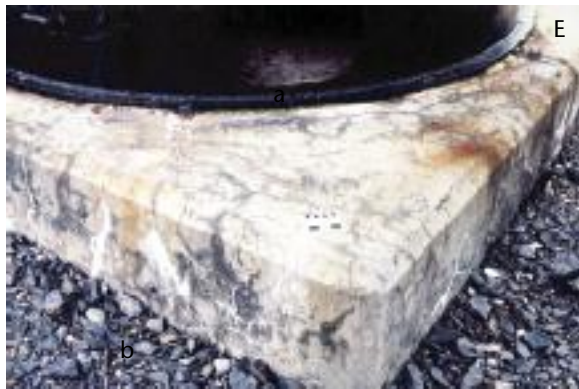
**(e)** Map-cracking (a) and associated leaching (b) in a 25-year-old transformer concrete foundation affected by AAR.

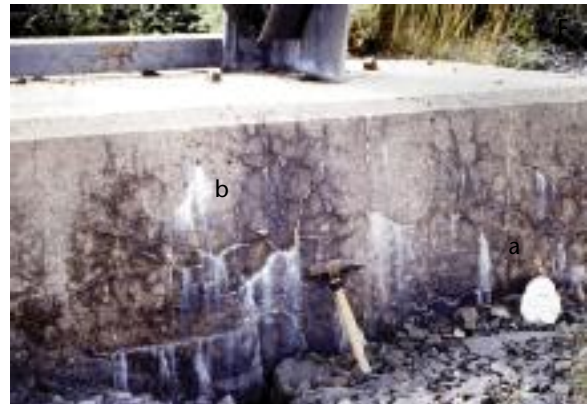
**(f)** Map-cracking (a) and gel exudation (b) in a 20-year-old electricity tower concrete foundation.

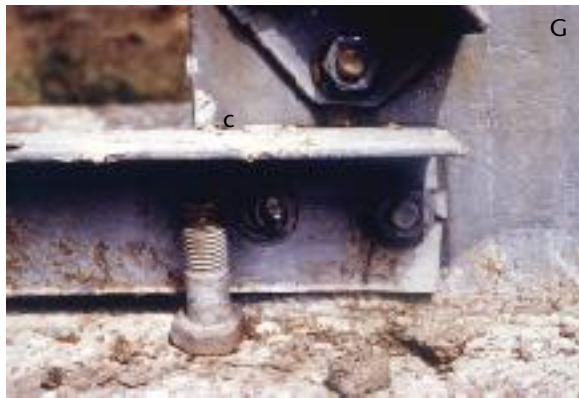
**(g)** Expansion of the concrete has caused shearing of steel bolts (c).
