3.1.1 <u>Wire Coating</u>

Corrosion of Welded and Chromated Galvanized Lath Reinforcement

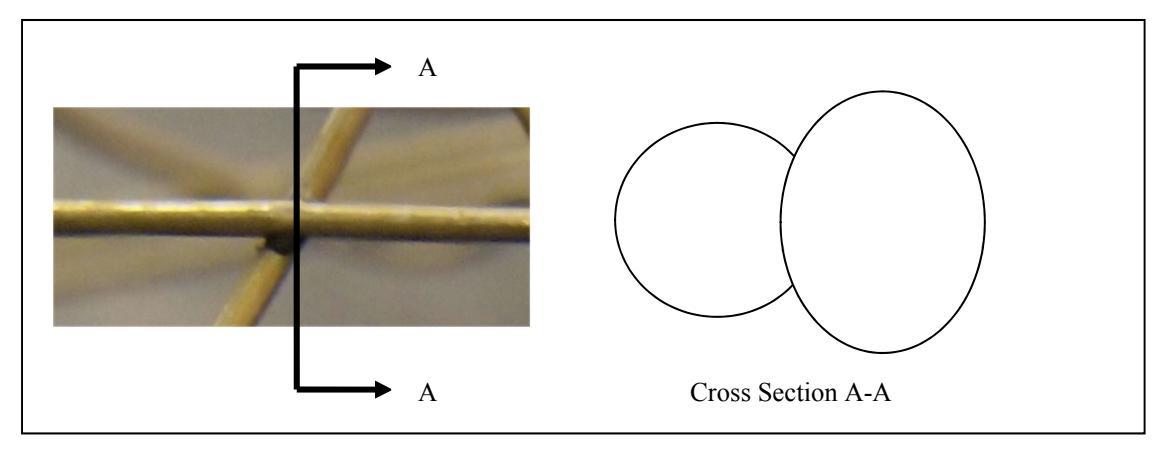
Figure 3-1 Schematic of analyzed cross section

Cross-sections of the welded wires as illustrated schematically in Figure 3-1, were cut from the samples provided for both the initial corrosion testing and the longer-term, accelerated corrosion testing and observed in the SEM, and analyzed by EDS. It should be noted that the chromated layer is too thin to be resolved in the SEM. The zinc layer in the first set of wires was found to be approximately $5[\mu m]$ (0.20[mils]) in thickness as shown in Figure 3-2 (a). Close to the weld, Figure 3-2 (b), the zinc appears oxidized but not removed by evaporation. A few isolated contamination particles of lead were observed embedded in the zinc.

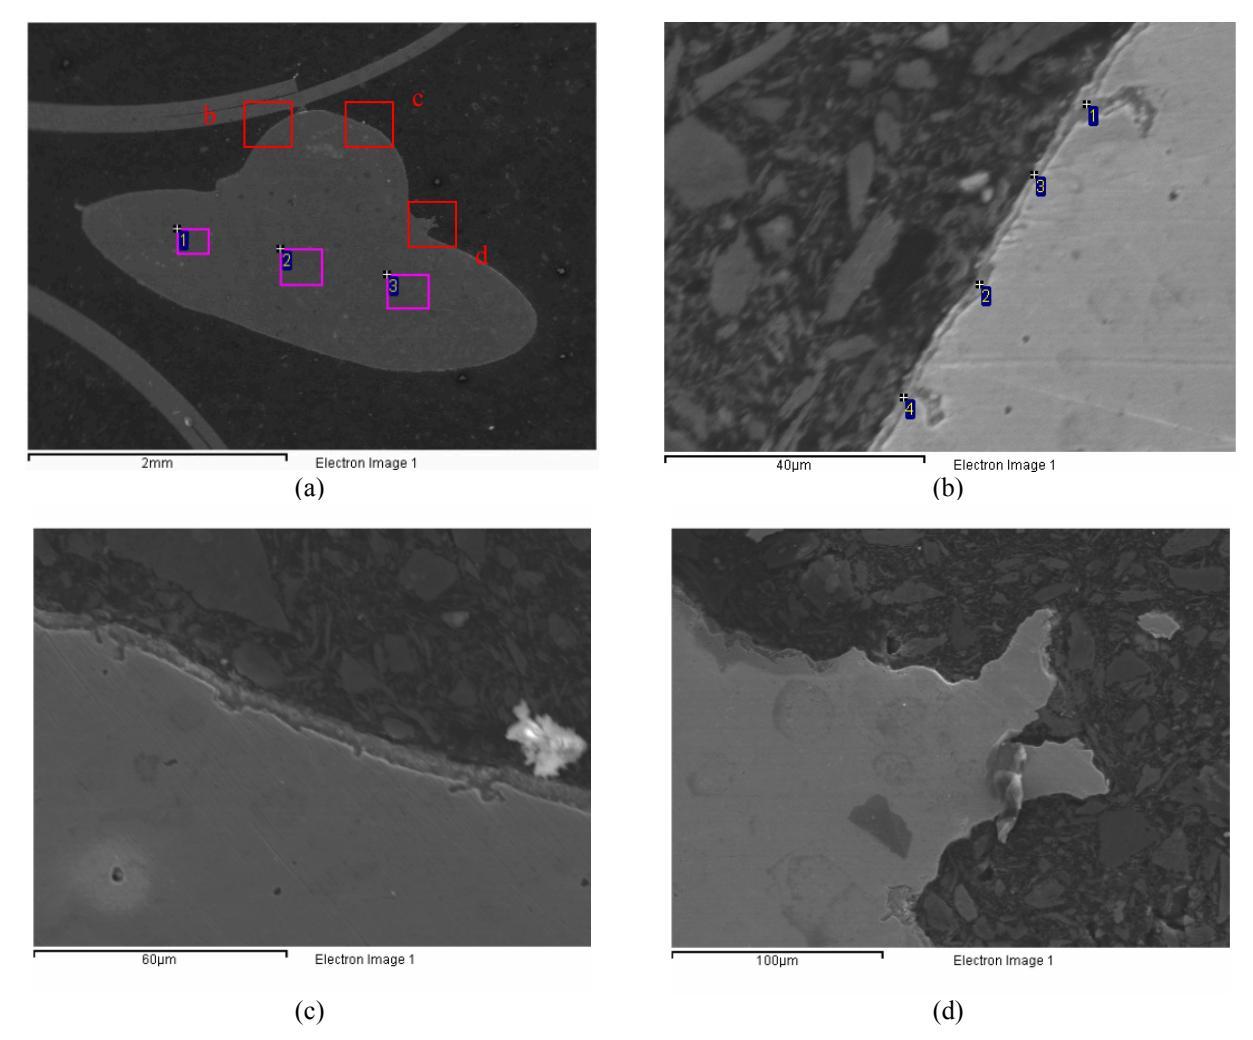
Figure 3-3 Accelerated corrosion testing SEM of wire cross-section (a) overview, (b) thin zinc coating (<5μm), (c) Thicker coating (~10 μm) and (d) weld expulsion. The numbers given in (a) and (b) refer to the areas for EDS analysis.

In contrast, the thickness of the coating in the welded corner sections from the longer term tests, shown in Figure 3-3, was more variable, ranging from below 1 μ m to approximately 10[μ m] (0.39[mils]) as illustrated in Figure 3-3 (b) and (c). Moreover, some of the welds exhibited weld expulsion with complete absence of zinc, Figure 3-3 (d).

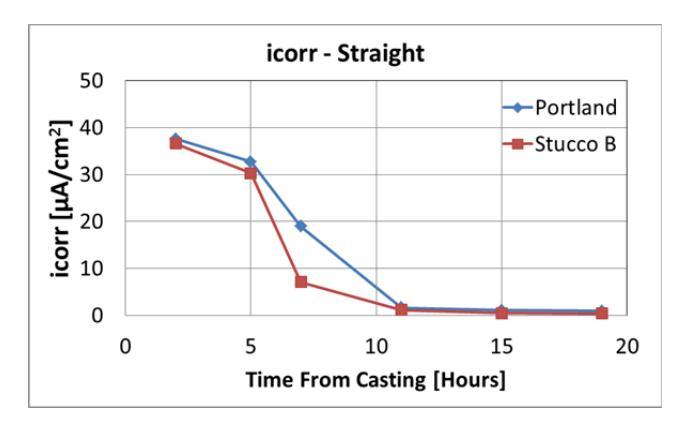
Figure 3-4 Initial corrosion current density vs. time: straight galvanized wire in OPC and Stucco B

Figure 3-4, Figure 3-5, and Figure 3-6 below show the results of the initial corrosion rates for the first set of cylindrical stucco samples in chloride-free lime water. The conversion of $1.0[\mu A/cm^2]$ ($6.5[\mu A/in^2]$) is equivalent to $15[\mu m]$ (0.59[mils]) zinc loss per year. The half-cell potential of the non-chromated specimens in both stuccos was initially ~-1600[mV_{SCE}], representative of bare zinc at high pH. The potentials then became more positive as the protective calcium hydroxyzincate formed and the corrosion rate decreased. Thereafter, it remained in the region of $-800[mV_{SCE}]$. For the chromated specimens, there was no initial low potential or high corrosion rate illustrating the efficacy of the chromate in protecting the zinc during the setting stage of the stucco.

Once submerged in the wet concrete the zinc and zinc oxide layer will be converted to $Zn(OH)_2^{-4}$. These zinc products then begin to react with the available calcium in the pore solution resulting in the formation of CHZ. This is observed between the second and eleventh day for the straight bars and the second and eight day for the welded bar.

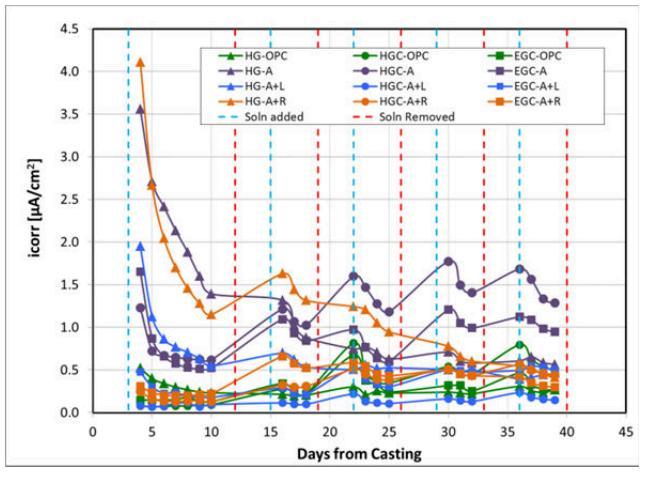
Figure 3-7 Average corrosion current density vs. time

Figure 3-7 below shows the average corrosion current density vs. time of all specimens for comparative purposes. Figure 3-8 through to Figure 3-11 below show the corroding current densities vs. time for the individual stucco mixtures.

The general trends observed for all specimens are the high initial corrosion rates upon immersion into the NaCl solution, both for the initial exposure to the solution and after every drying period. This is attributed to the high oxygen content provided during the drying period and, as this abundant oxygen is depleted in the subsequent wet period by the cathodic half-cell reaction accompanying the corrosion of the zinc, the corrosion rate decreases.

In all stucco mixtures, the wire with no post weld chromating treatment performed the worst within the first 10 to 15 days. The longest lasting effects were seen in the Stucco A mix with set-retarder. HGC and EGC wires in Stucco A exhibited a similar trend of poor performance within the first 10 to 15 days; however, the corrosion rates were lower than the Stucco A samples with set-retarder.

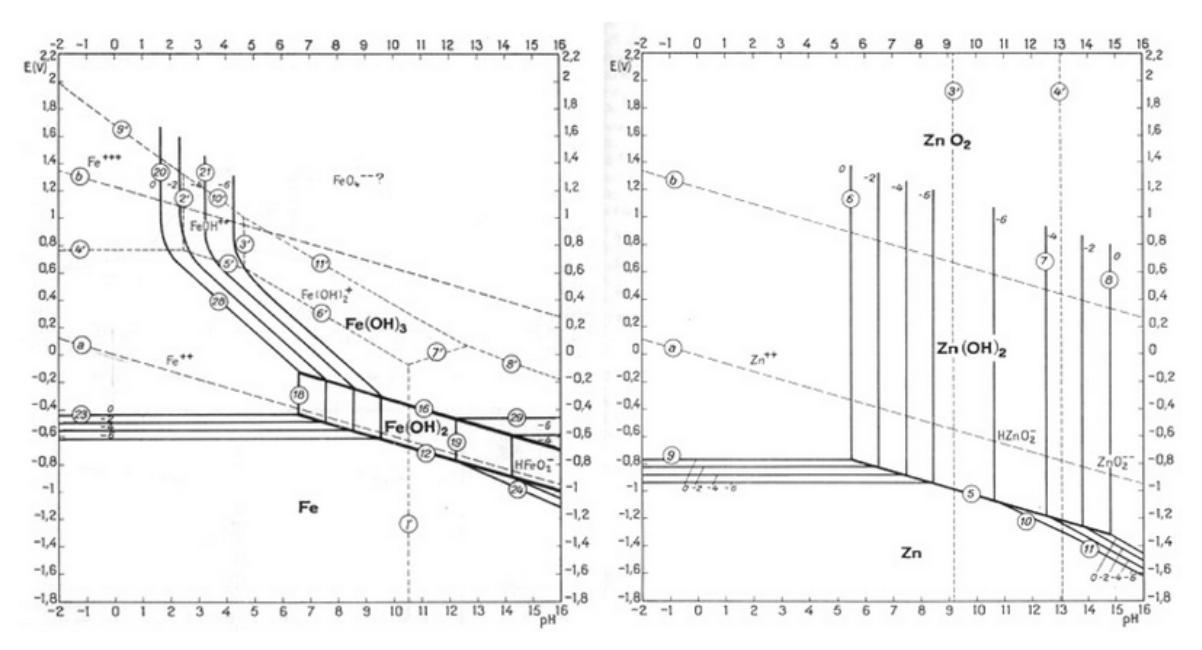
Figure 4-1 Potential (SHE) vs. pH, diagram of iron (left) and zinc (right) [7]

The pore solution in cured concrete typically maintains a pH between 12.6 and 13.7 due to the presence of excess hydroxides. In this pH and at potentials more anodic than $-1.2[V_{SHE}]$ zinc is not thermodynamically stable and will actively corrode as shown in Figure 4-1b.

The corrosion potentials for zinc and iron in the pH range of 13 are around $-1.2[V_{SHE}]$ and $-0.8V[_{SHE}]$ respectively. When these two metals are coupled and form a galvanic cell, the mixed corrosion potential lies between these two values.
