Preventative Maintenance Program for Cast & Ductile Iron Water Lines Reduces Leakage & Operating Cost

Sanitary Sewer and Underdrain Separation

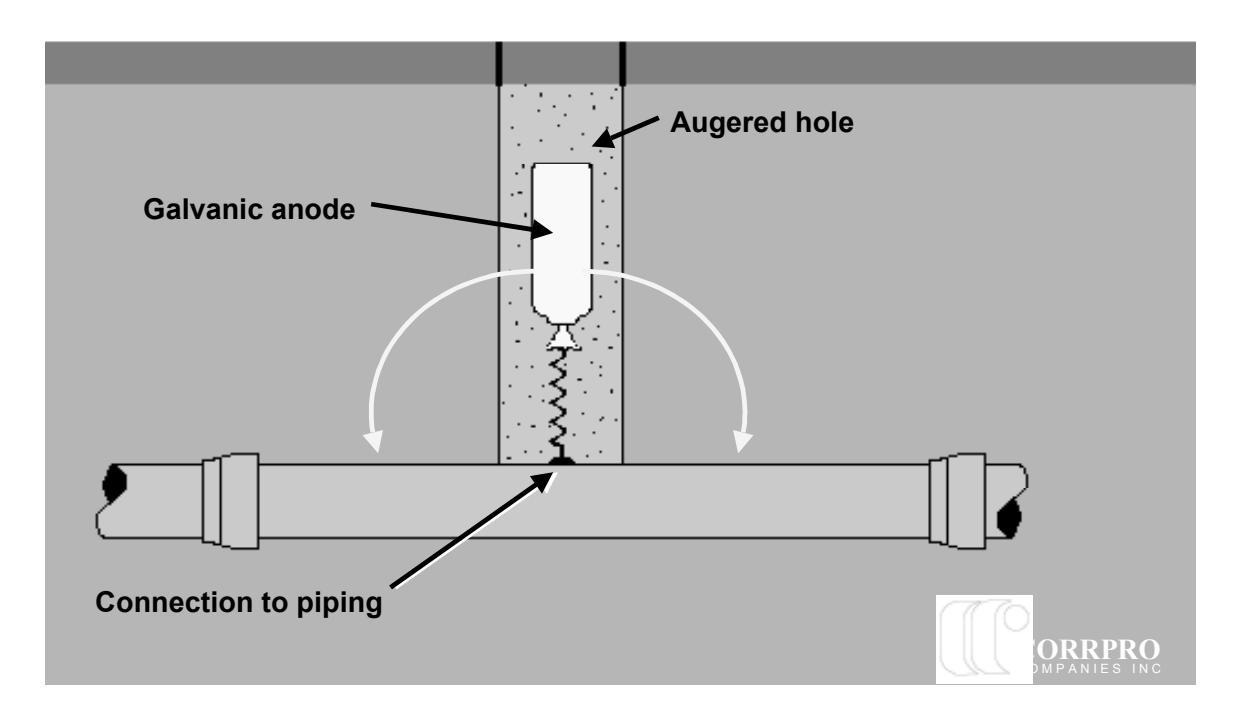
Figure 1. Anode Installation

Figures 1 through 4 show the typical installation of the galvanic anodes, on nominal 15.25 meter (50-foot) spacing. For the situation depicted, 14.5 kilogram (32-lb.) magnesium anodes, enclosed in cardboard containers and containing specially prepared backfill, are installed in augered holes immediately above the water main. Before inserting the anode in the augured hole, the electrical lead wire from the anode is silver-soldered to a 7.62 centimeter (3-inch) steel rod that is then welded to the water main using stud-welding apparatus. This procedure achieves the necessary good electrical connection between the anode and water main.

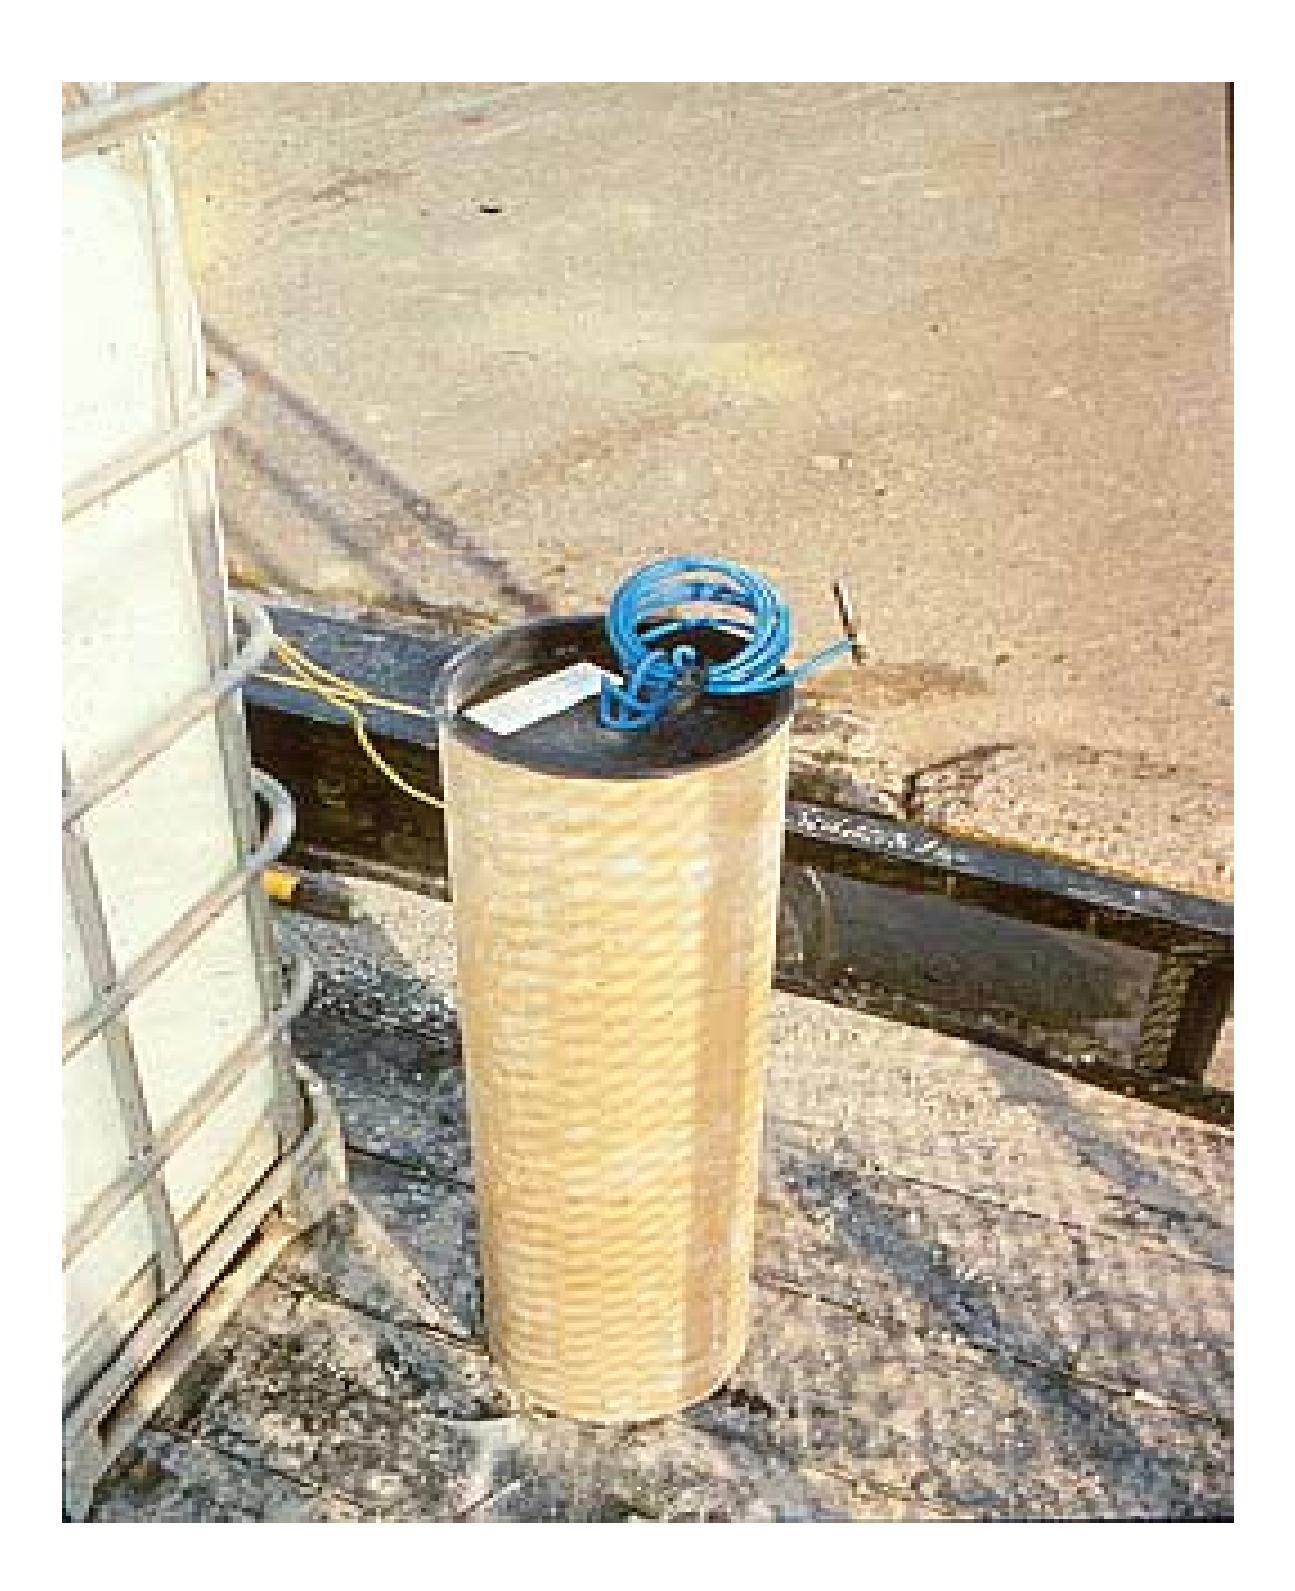
Figure 2. Galvanic Anode Packaged in a Cardboard Container with Prepared Backfill.

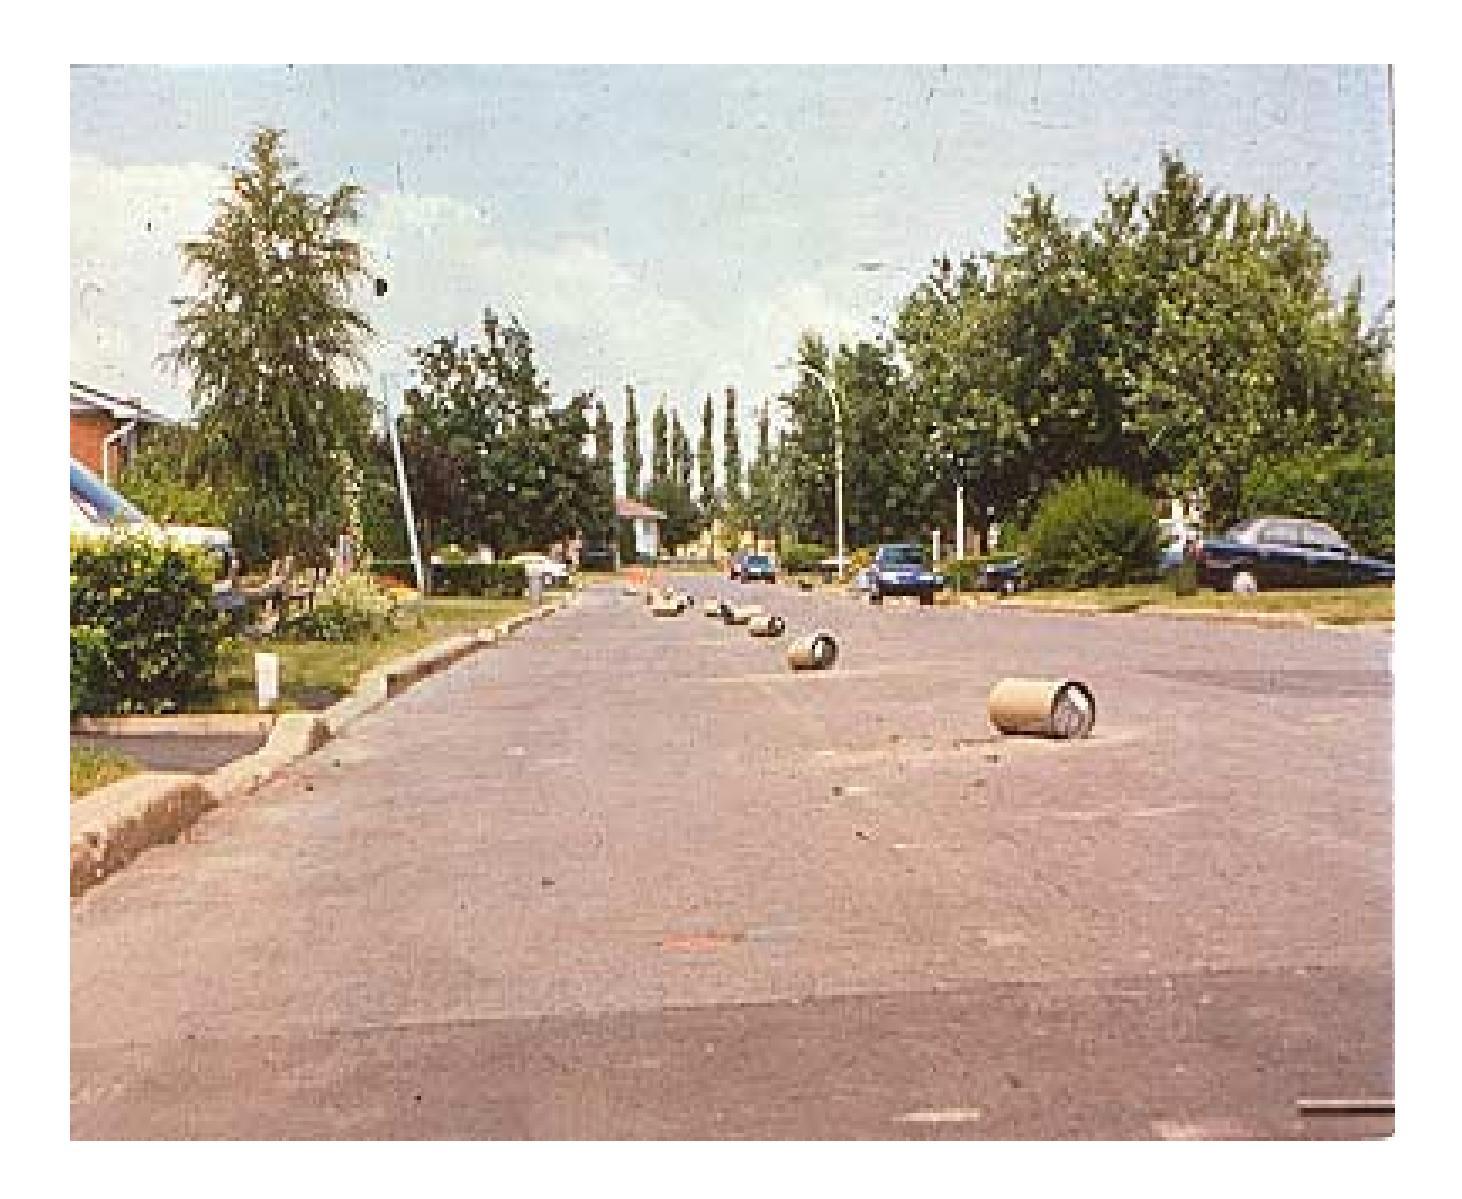
Figure 3. Lay-out of Pre-packaged Anodes Prior to Installation

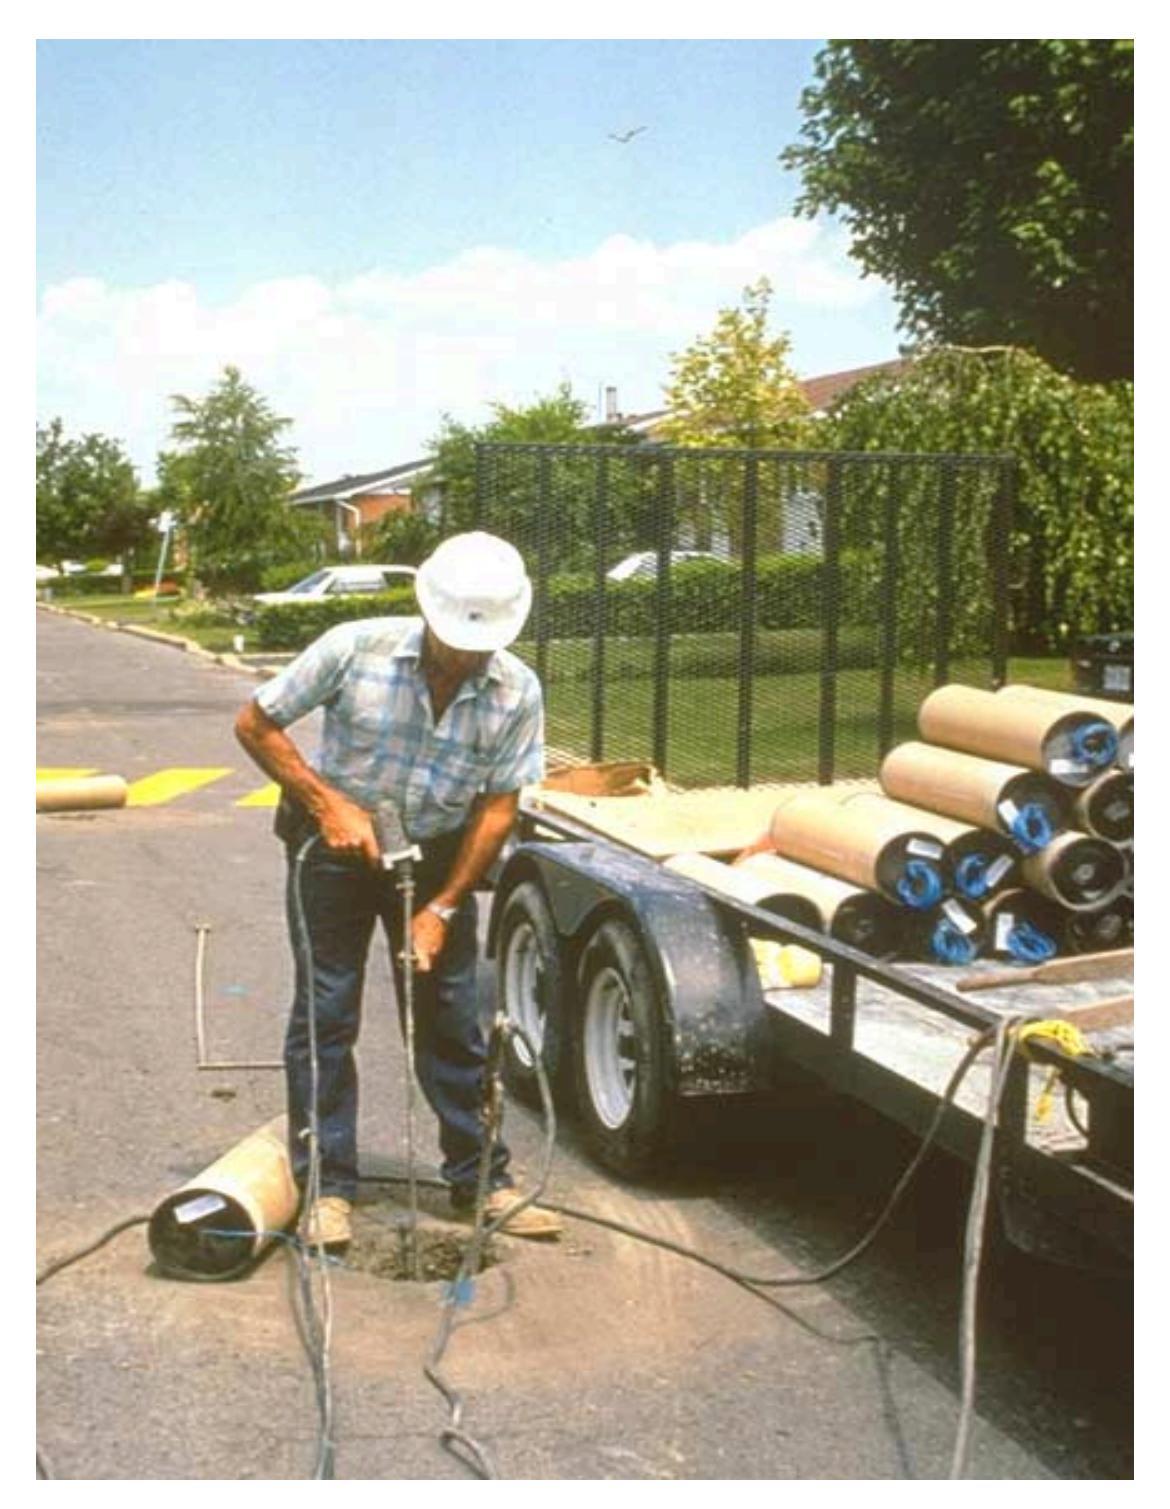
Figure 4. Stud-weld Connection of Anode Lead Wire to Water Main

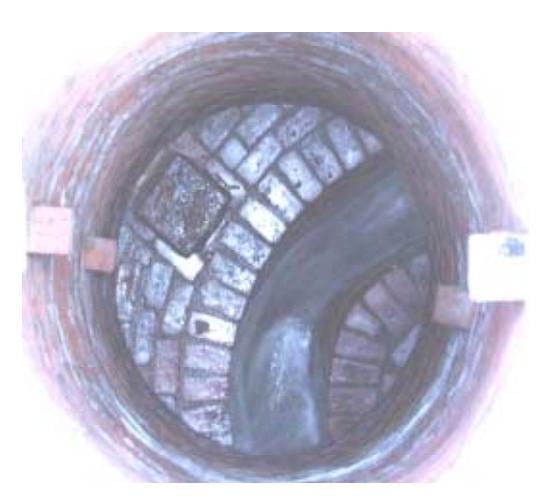
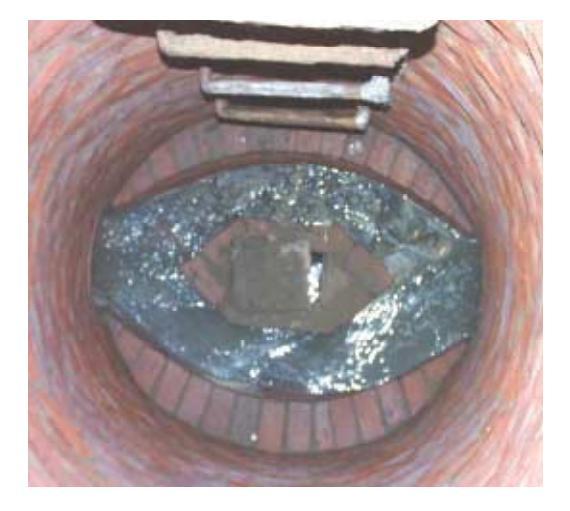
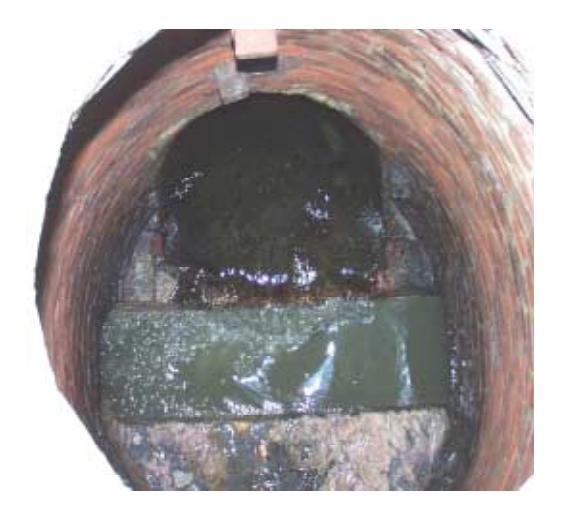
Figure 1. *Left* - Access point located on the manhole bench; *Right* - Access point located in the sewer invert; *Below* - Cavern type access point

A lack of maintenance over the last 100 plus years resulted in an underdrain system that no longer performs as it was intended. Access points located in sanitary sewer manholes, originally designed to provide access to the underdrain, deteriorated and provided a direct connection between the sanitary and underdain systems. These points allowed the two systems to mix, creating contamination of the underdrain and infiltration of groundwater to the sewer system. In other instances, portions of the underdrain system were deliberately rerouted and combined with the sanitary system. For example, when the Massachusetts Turnpike was extended into Boston through Newton in the 1960s, instead of relocating two separate pipelines, the flows were combined and conveyed across the Turnpike in a single crossing. In addition to direct connections, numerous indirect connections exist as wastewater exfiltrates through aging brick pipes to the underdrain.

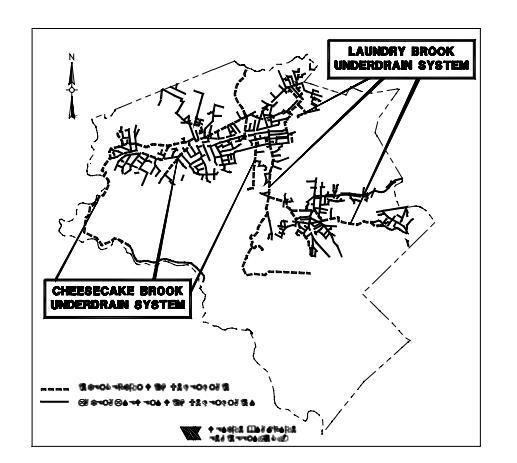
Figure 2. City of Newton map showing the project area and the extent of the underdrain system. The project areas are shown as bold lines and are labeled Cheesecake and Laundry Underdrain Systems. Other underdrain locations are shown tributary to these lines and as the Hyde Brook Underdrain System.
