# **BREACH CLOSURE: KATRINA CUT**

# TIDAL INLET CLOSURE: LITTLE LAGOON PASS

## **CONTAINMENT BOOM**

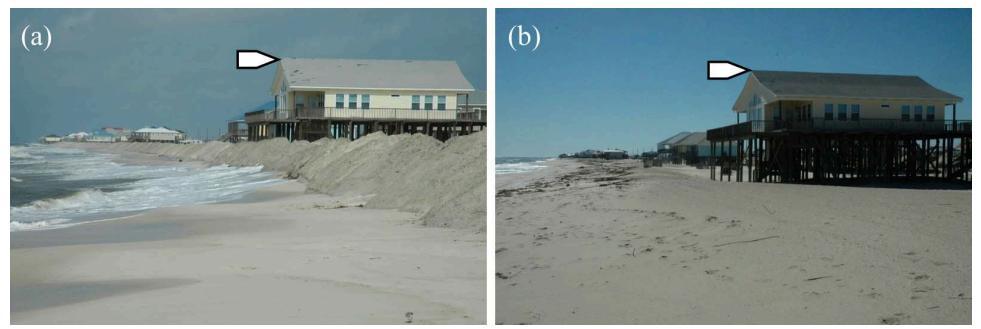
Figure 4. Photos taken of the frontal sand barrier on Dauphin Island (a) in May 2010 during placement, and (b) May 2011 one year after placement.

The elevation of the second, southern sand barrier/pile was reduced in the winter of 2010-2011 after the oil spill was contained and the threat of large surface oil slicks washing ashore was gone. The sand in that barrier, essentially a sand pile along the beach berm crest, was sifted and redistributed into a much flatter, more naturally-shaped beach berm. Figure 4 shows a comparison of photos of this feature during and one year after placement.

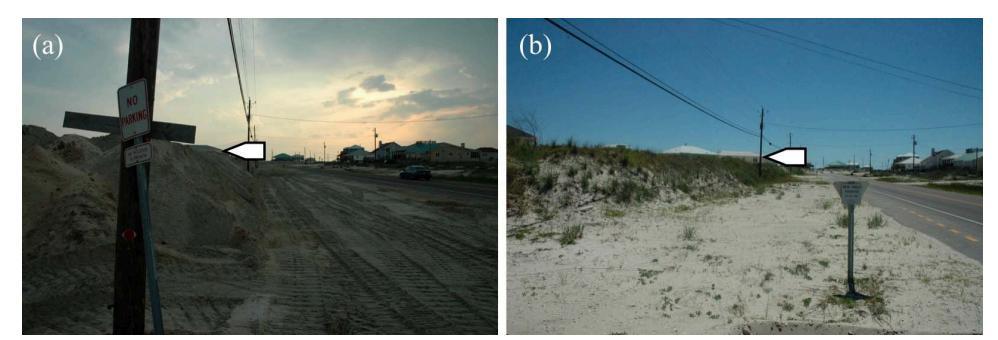
Figure 5. Photos taken of the initial, larger roadside sand barrier on Dauphin Island (a) in May 2010 during placement, and (b) May 2011 one year after placement.

The first, northern sand barrier/pile remains today and the Town has decided to maintain it as a sand dune. It was planted with native sand dune species in the summer of 2010 with the goal of stabilizing the sand. The vegetation has survived (see Figures 5-6), and six months of weathering has resulted in a much more natural looking feature.

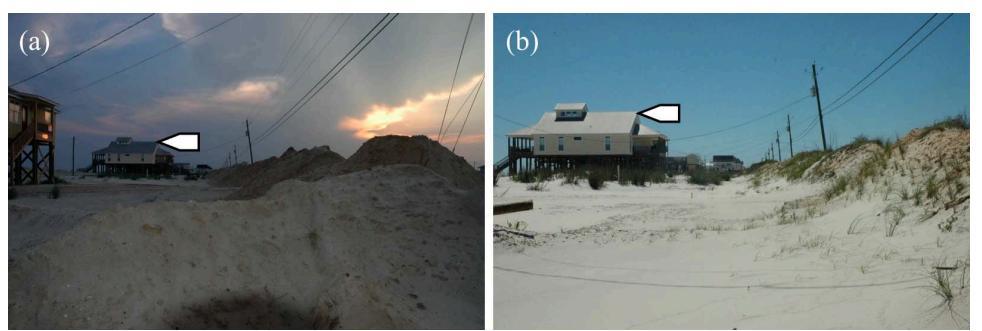
Figure 6. Photos taken of the initial, larger roadside sand barrier on Dauphin Island (a) in May 2010 during placement, and (b) May 2011 one year after placement.

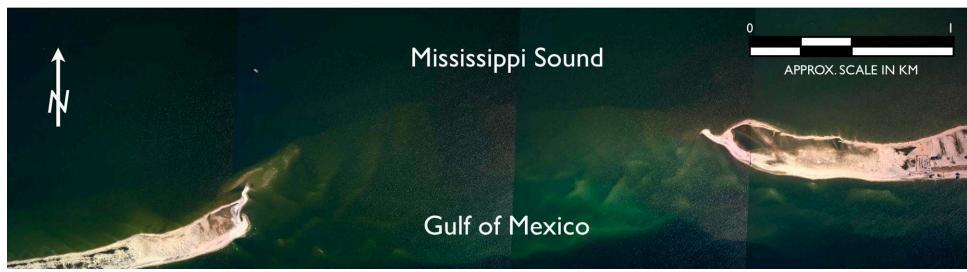
Figure 7. Tiled aerial imagery of Katrina Cut (Dauphin Island, AL) taken on May 9, 2010.

**Background.** Due to its relatively narrow width and low elevation, the western end of Dauphin Island has been overtopped and breached many times in the past 160 years of well-documented history. Over that same period of time, the western end of the island has actually migrated northward one entire island's width. In September 2004, Hurricane Ivan's storm surge and waves created multiple breaches through the undeveloped western portion of the island (Froede, 2006). Such breaches had historically healed through wave-driven longshore sand transport, but Hurricane Katrina in 2005 widened and stabilized the breach, growing to more than 2.5 km in width with an average depth of 2 m during the 5 years that followed (Froede, 2008). The breach was given the moniker Katrina Cut by the locals (see Figures 1 and 7).

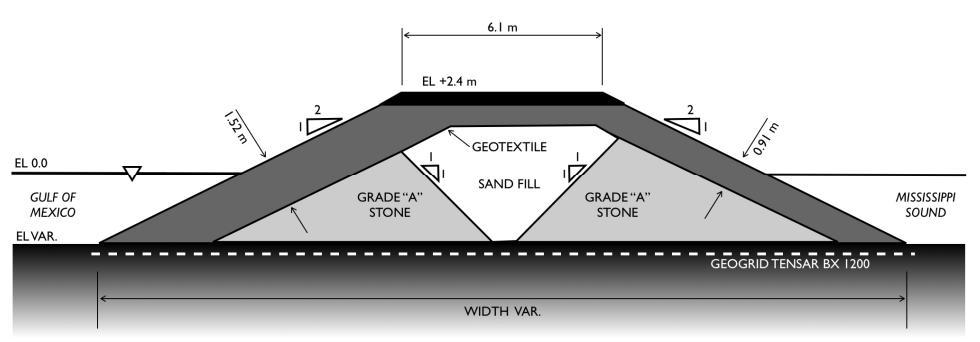
Figure 8. General cross-section sketch of the rubble mound structure constructed to close Katrina Cut.

**Results.** A sketch of the structure cross-section is provided in Figure 8. The rubble mound structure was built in stages: two, parallel internal sections were built first; good quality sand fill from a nearby borrow area was then pumped in between the rock structures and sealed within a geotextile fabric; finally, a nearly 1-m-thick layer of armor stone was applied and choked at the crest with a 0.3-m-thick layer of smaller stone. Placing 60 - 90 m of rock per day, the original construction timeline called for completion in 100 days. The two internal sections were completed in early November 2010, effectively sealing the breach.

The crest of the structure is approximately +2.4 m NAVD. The armor stone is specified as an ALDOT Class 5 riprap, which has a median weight of 454 kg (1000 lbs). Assuming some nominal values and considering the 2:1 structure side slopes, the median weight of the armor stone should accommodate wave heights up to 1.5 m according to Hudson's equation (USACE, 1984). The structure base is 26 m wide in some locations and rests on a Tensar BX 1200 geogrid. A total of nearly 215,000 metric tons of rock were used to build this structure. Other structure quantities include: 54,000 m<sup>2</sup> of geogrid; 47,000 m<sup>2</sup> of geotextile fabric; 100,000 metric tons of armor stone; 20,000 m<sup>3</sup> of sand fill; 108,000 metric tons of stone for the two internal structures; and 7,000 metric tons of #57 stone to choke the structure crest. A Type III floating turbidity barrier was used throughout the project.

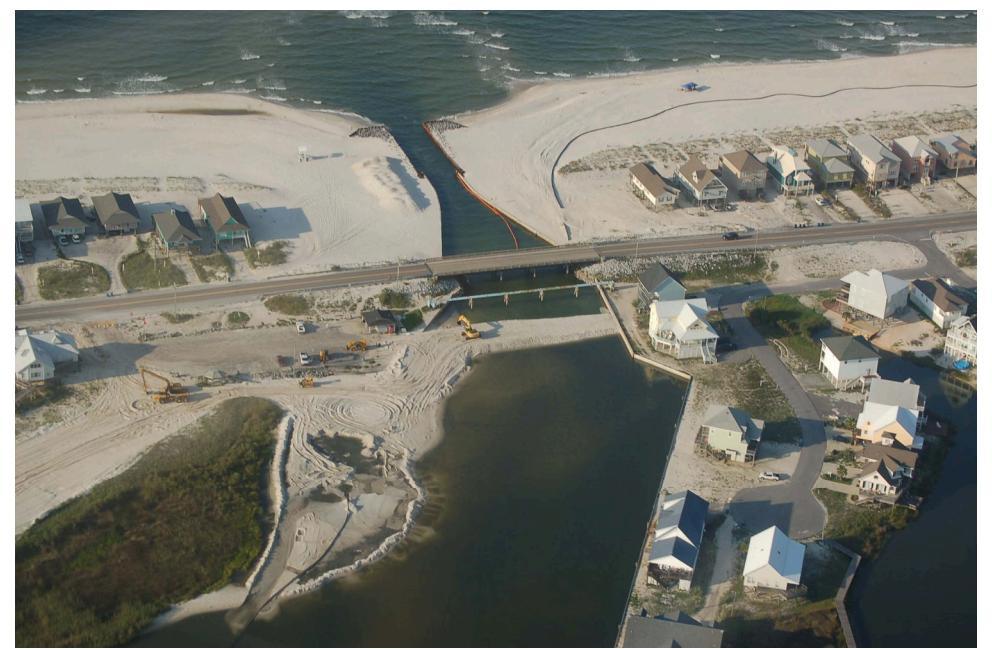
Figure 9. Aerial photo of the sand barrier in Little Lagoon Pass. The estuary is in the foreground while the Gulf of Mexico is in the background. The road visible is West Beach Boulevard, AL 182. Photo courtesy: Mark Acreman, City of Gulf Shores.

**Strategy.** Although the tidal connection of Little Lagoon is highly restricted, officials in the City of Gulf Shores were concerned about the potential environmental impacts and the difficulty of cleaning large amounts of oil from within the estuary. City officials elected to plug the tidal pass with sand rather than battle what may have been a continuous tending of ocean boom on the gulf side of the pass. The pass was initially plugged in early May using over 4500 m<sup>3</sup> of sand fill, as shown in Figure 9.

**Results.** City officials were very pleased with their decision to plug the pass. The estuary did not receive any reports of visible oiling with the barrier in place. Indeed, the barrier was installed prior to Baldwin County beaches receiving their first major oiling. As seen in Figure 9, some boom was deployed on the gulf side of the sand

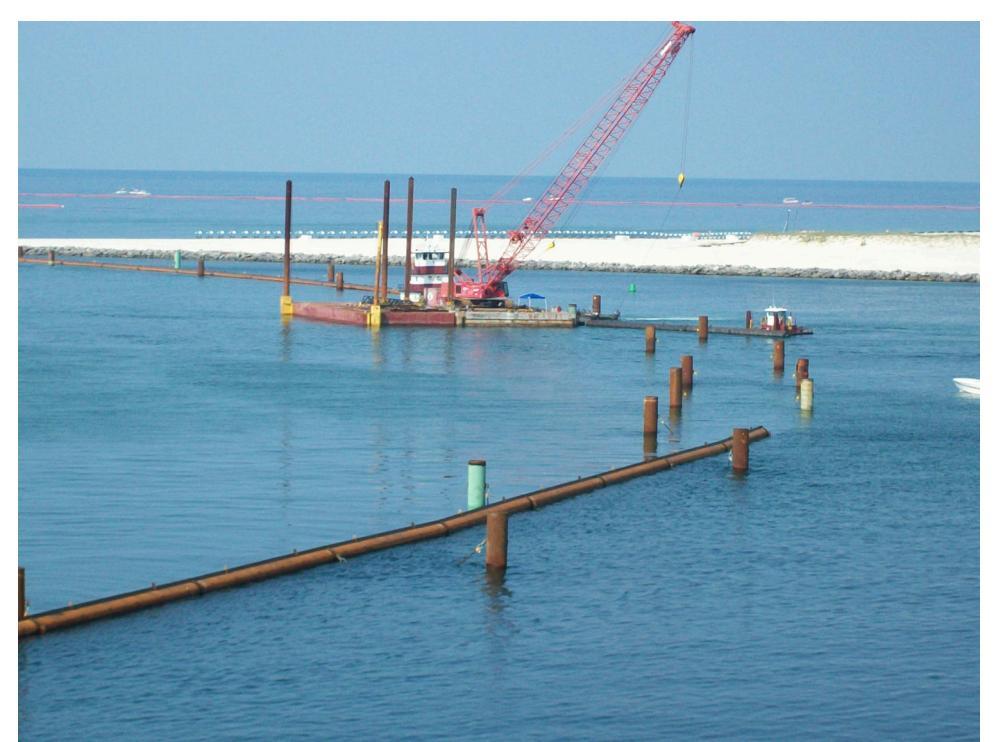
Figure 10. Photo of the polystyrene foam-filled 1 m dredge pipe used as oil training boom in Perdido Pass, Alabama. The Gulf of Mexico is in the background and the image is shot looking toward the west-southwest. Orange ocean boom can be seen in the distance below the horizon. Photo courtesy: Phillip West, City of Orange Beach.

A local engineering firm was contracted to design, build, and install a boom system that would train surface oils to extraction locations while allowing for safe navigation through the pass. The plan called for nearly 1000 m of 1 m diameter steel dredge pipe to be filled with polystyrene foam to aid in flotation, and to be anchored with chains affixed to a number of 1 m diameter steel pipes driven into the seabed. A photo of the boom during construction is provided in Figure 10. The system also included a steel

curtain and dampers affixed to the bottom of the floating pipe to capture and train oil entrained in the upper portion of the water column to extraction points.
