### **Overview of Failure Modes**

# CASE STUDY COMPARATIVE PERFORMANCE

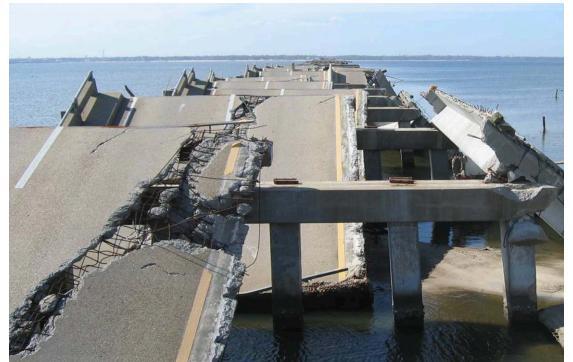
Figure 2. East end of US-90 Bay St. Louis Bridge, showing collapsed spans associated with surge-induced loading.

The US-90 Bay St. Louis Bridge (Figure 1) suffered severe damage due to a combination of surge and wind/wave-induced loading sufficient to unseat a majority of the spans. This bridge is a four-lane, 3.06 km (1.9 mile) long, concrete girder bridge with parallel decks simply supported by high-type steel bearings. The spans are low-lying with water navigation permitted through the use of a movable bascule. The bearings were severely damaged and nearly all connections between the deck and bent caps were lost resulting in free movement of the decks. All of the spans on the western half of the bridge completely unseated and were submerged in the Bay. On the eastern half, the north decks (westbound) were submerged and the south decks (eastbound) had shifted north and were partially submerged. This bridge required complete replacement.

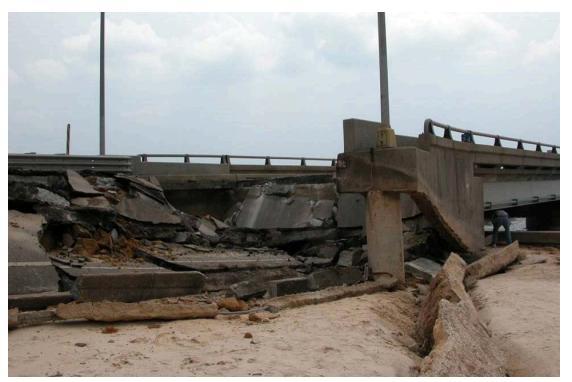
Figure 4. Eroded approach slabs on Pontchartrain Causeway (Courtesy of LADOT)

an example, the abutments for the southbound roadway approach of the 24-mile long Pontchartrain Causeway were eroded as shown in Figure 4, requiring temporary repair of abutments and erosion control measures. Following underwater investigations, further scour related damaged was revealed at intermediate piles for some structures, such as the Chef Menteur Bridge in Orleans Parish, LA for with removal of five north approach spans and supporting bents was required due to the effects of slope failure attributed to scour.

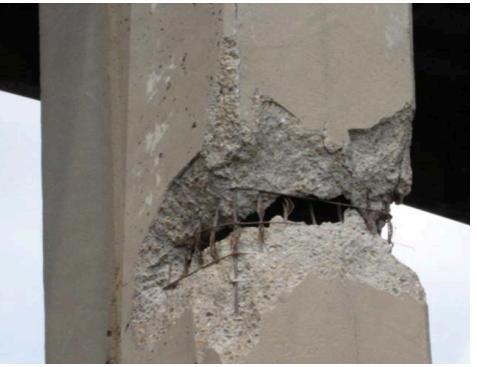
Figure 3. Pile damage on the Biloxi Back Bay Bridge due to barge impact.

Impact damage from barges, tug boats, oil rigs and other types of debris also occurred along the waterways in the Gulf Coast. The impact resulted in span misalignment and fascia girder, fender, and column damage. An example of impact related damaged occurred at the Biloxi Back Bay Bridge in Mississippi. The Biloxi Back Bay Bridge carries four total lanes of I-110 over the Biloxi Back Bay, and served as the only primary route to Biloxi, due to the closure and damage to US-90 and the Biloxi-Ocean Springs Bridge from Katrina. The bridge was damaged due to barge impact, shearing the easternmost pile of the bent directly south of the bascule, which supports a span of pre-stressed girders as well as the bascule anchor span. Other minor damage was sustained, such as guardrail, sidewalk, and drawbridge gate arm damage, as well as differential settlement of the north approach and abutment.

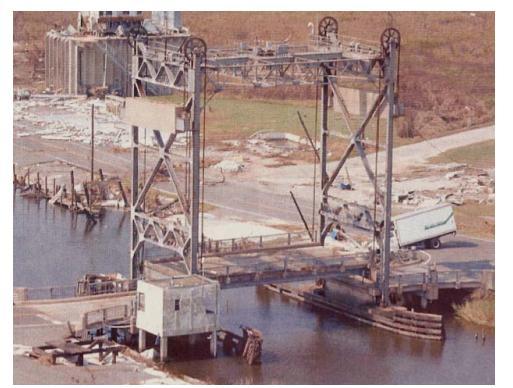
Figure 5. Wind inundation leading to damage electrical-mechanical equipment of movable bridges, such as Yscloskey.

There is a considerable percentage of movable bridges along the Gulf Coast and in the Katrina exposed region. Several of these movable bridges suffered damage to submerged electrical and mechanical equipment. Debris accumulation also affected the functioning of the mechanical gears along with some cases of bent pivots, fractured mechanical parts, or damaged traffic control gates. Non-engineered operator houses also suffered damage due to high winds. Figure 5 shows the Yscloskey Bridge on Route LA 46 in St. Bernard Parish, which sustained damage due to water inundation. The high waters at the location of the bridge submerged the electrical and control systems in the operator house and completely damaged the system. In addition, the surge itself elevated the movable deck approximately 2.4 m (8ft) and caused it to be skewed and stuck in the lifted position as shown in the Figure.

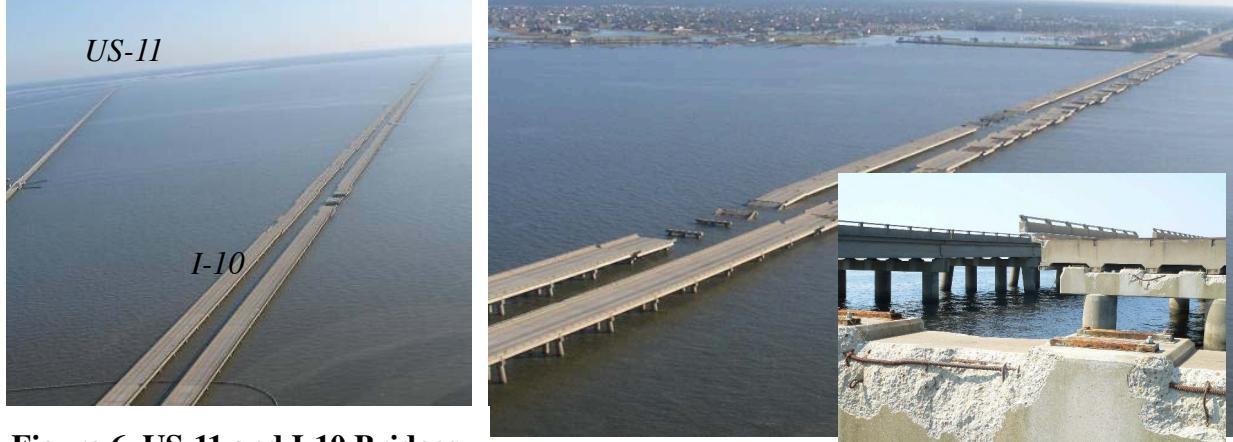
Figure 6. US-11 and I-10 Bridges

Figure 7. I-10 Lake Pontchartrain bridge damage

The I-10 Lake Pontchartrain Bridge suffered the most damage (Figure 7) of any one bridge in Louisiana, with a total of 473 spans shifted and an additional 64 spans completely unseating and collapsing in the water. Significant damage to barrier railings and bent beams also resulted. Only minor damage was observed on the US-11 bridge, including erosion at the abutment and draw bridge damage. However, unique features of the construction relative to I-10 are attributed to potentially reducing the damage. For example, the US-11 bridge had continuity across the spans, while the I-10 bridge was simply supported, and positive connectivity between the deck and bent beams was provided for US-11 as seen in Figure 8. This positive connection refers to the deck-beam connection which provides resistance to uplift of the deck. Vent holes were also provided in the diaphragms which help mitigate buoyant forces are also believed to be contributing factor to the relatively small damage.

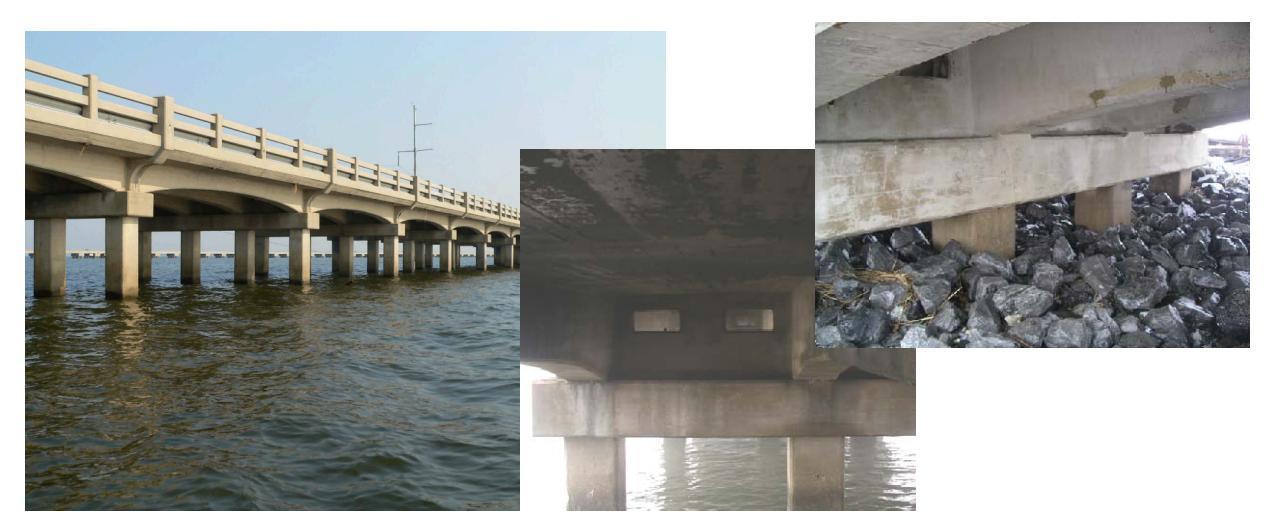
Figure 8. Construction details of US-11 bridge with continuity, air vents, and positive connection.

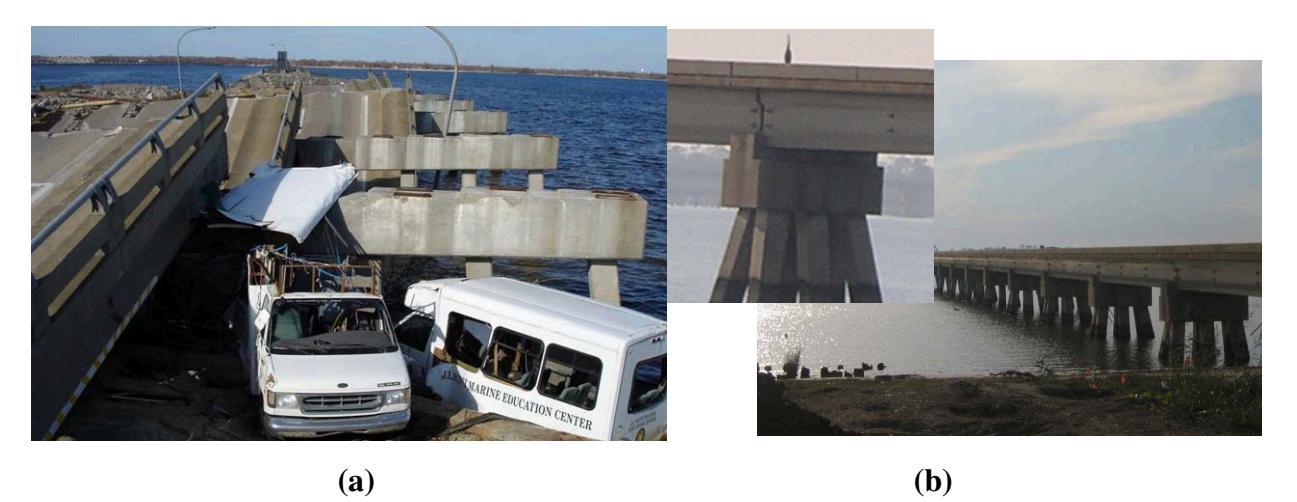
Figure 9. (a) Damage to US-90 Biloxi-Ocean Springs highway bridge compared to (b) the superior performance of the Biloxi Bay Railroad Bridge with transverse shear keys.

Study of the US-90 Biloxi-Ocean Springs Bridge in Mississippi reveals that it performed poorly relative to an adjacent railway bridge (CSXT Biloxi Bay Railroad Bridge). The highway bridge which carries four lanes of US-90 between the two cities over the Biloxi Bay suffered complete damage during Hurricane Katrina. While this bridge had a movable section, the damaged spans included the lower elevation multi-span pre-stressed concrete girder sections near the ends of the bridge. Numerous spans were shifted and unseated due to the storm surge which rose to levels in excess of 6.58 m (21.8 ft) at the bridge site, as well as washout of abutment backfill and settlement of the approach slabs. The damaged bearings were steel sliding bearings with bronze cores which provided no apparent positive connection between the substructure and superstructure. The damage required complete replacement of the bridge.

The adjacent CSXT Biloxi Bay Railroad Bridge suffered limited damage, despite the large surge at that location. Though the rails and ballast were cast into the Bay during the storm, the superstructure remained intact, unlike the highway bridge. The Biloxi Bay Railroad Bridge is composed of four simply supported precast I-girders with a cast-in-place deck, and supported on pile caps with battered piles. While other characteristics inherent to designing railway bridges relative to highway bridges may contribute to difference in the realized design and performance under surge-induced loading (such as weight of the deck), specific features of the CSXT Biloxi Bay Railroad Bridge design details likely resulted it its superior performance. For example 38.1

cm (15 inch) high shear keys restrain the superstructure from lateral movement and 3.2 cm (1.25 inch) diameter through-bolts provide a positive connection and lateral stability to the girders. These types of lateral restraint and connection details are not present in the US-90 Biloxi-Ocean Springs Highway bridge which had considerable longitudinal and transverse deck displacement.
